The WRIA 9 Marine Shoreline Monitoring and Compliance Pilot Project

April 2014

King County

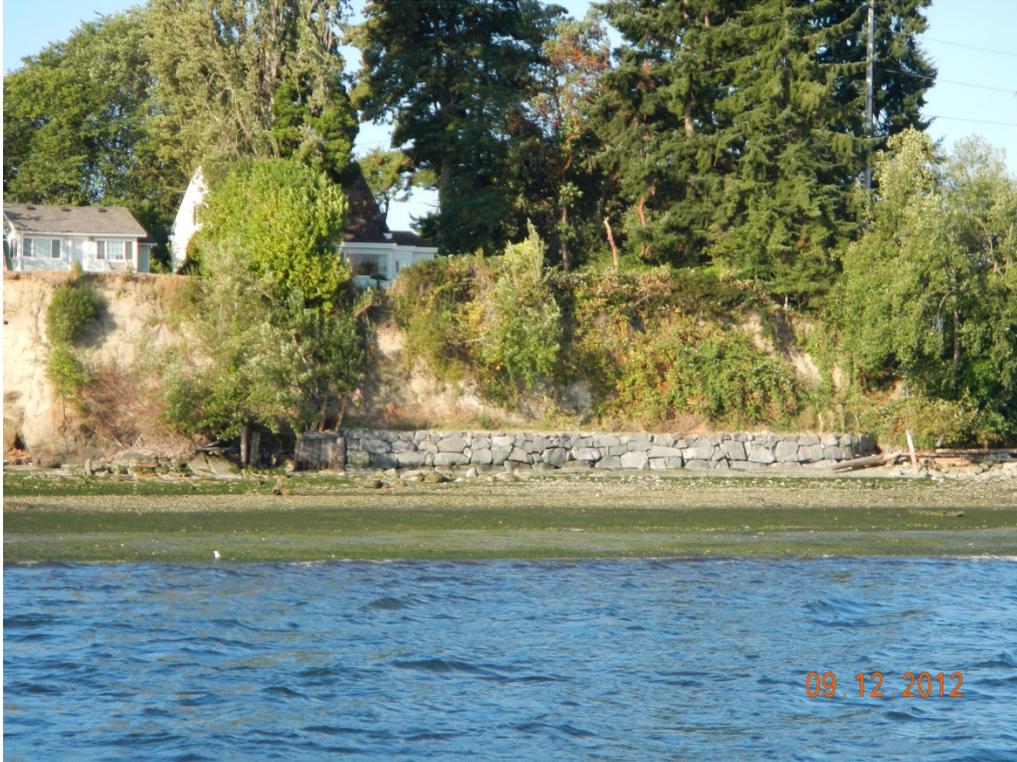
Figure B-1. An example of a rebuilt or major repair bulkhead.

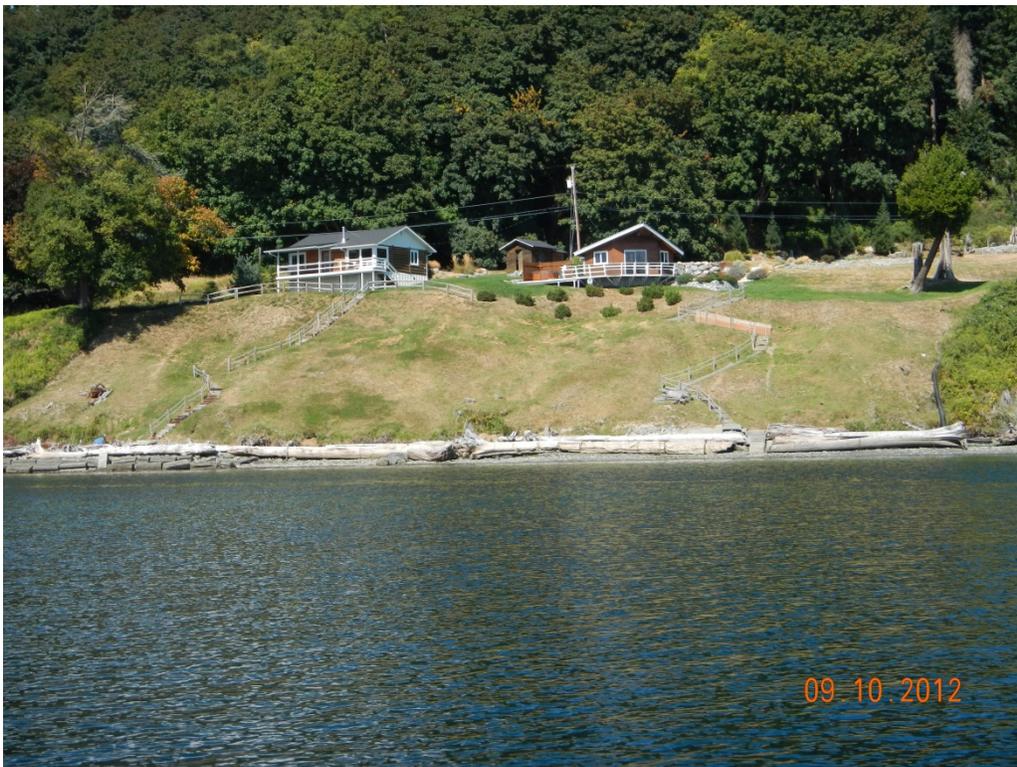
Figure B-2. An example of a new bulkhead.

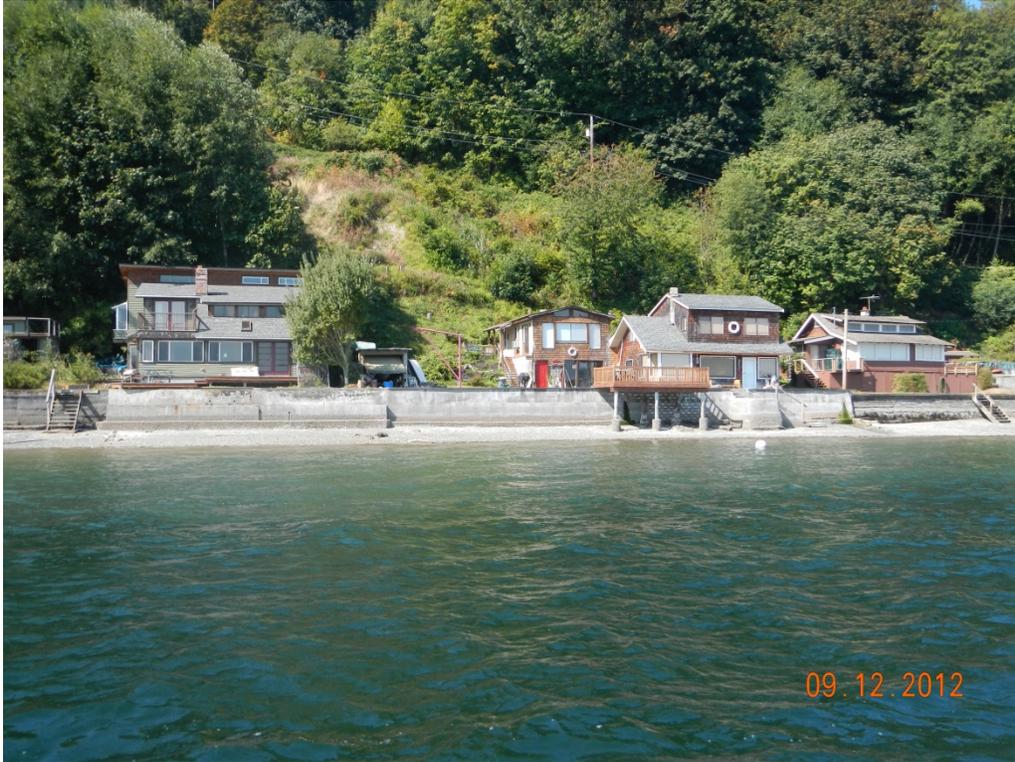
Figure B-3. An example of a major repair to a bulkhead and a new overwater structure.

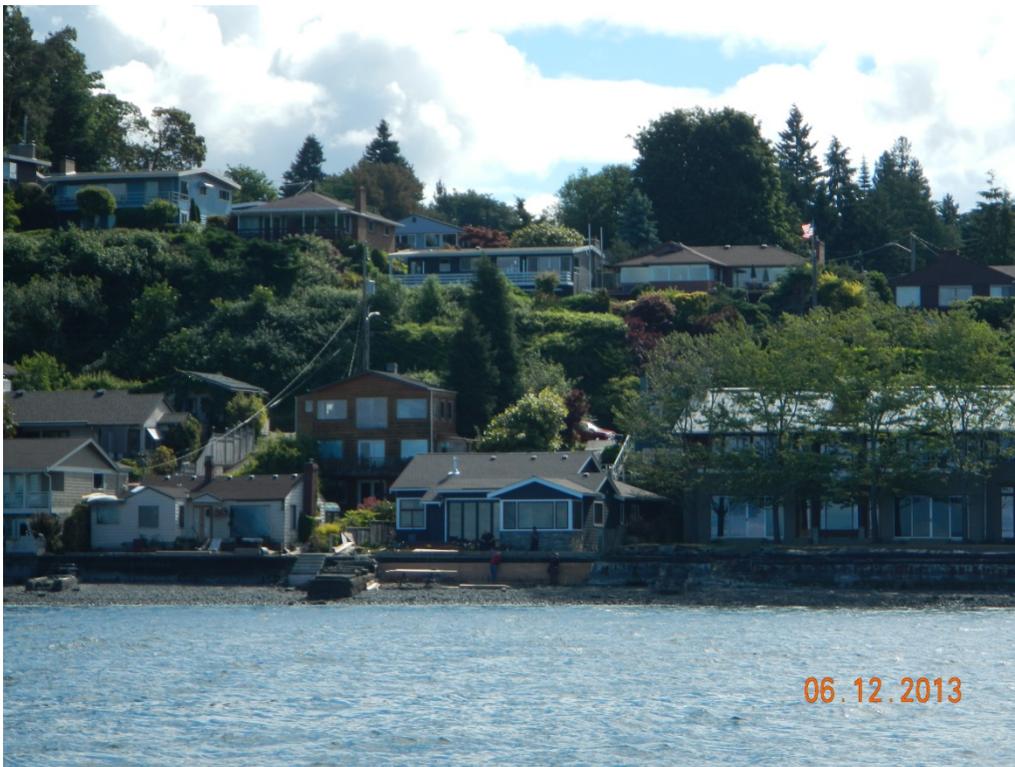
Figure B-4. An example of a permitted minor repair to a concrete bulkhead occurring at the time of the survey.

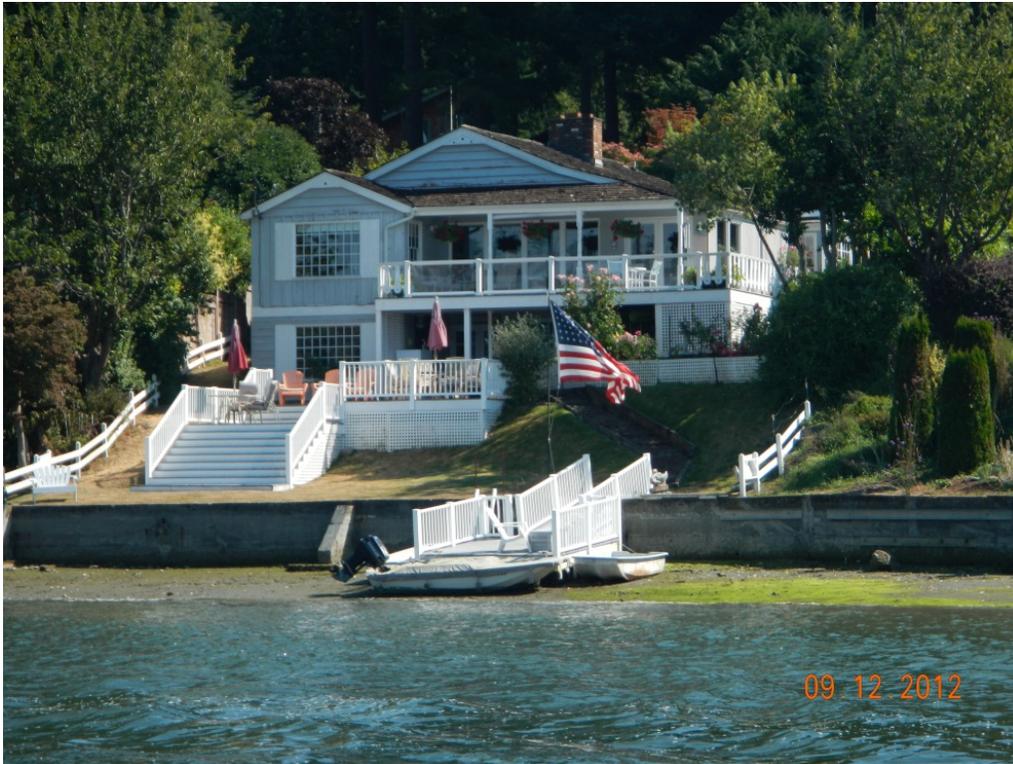
Figure B-5. An example of a new dock.

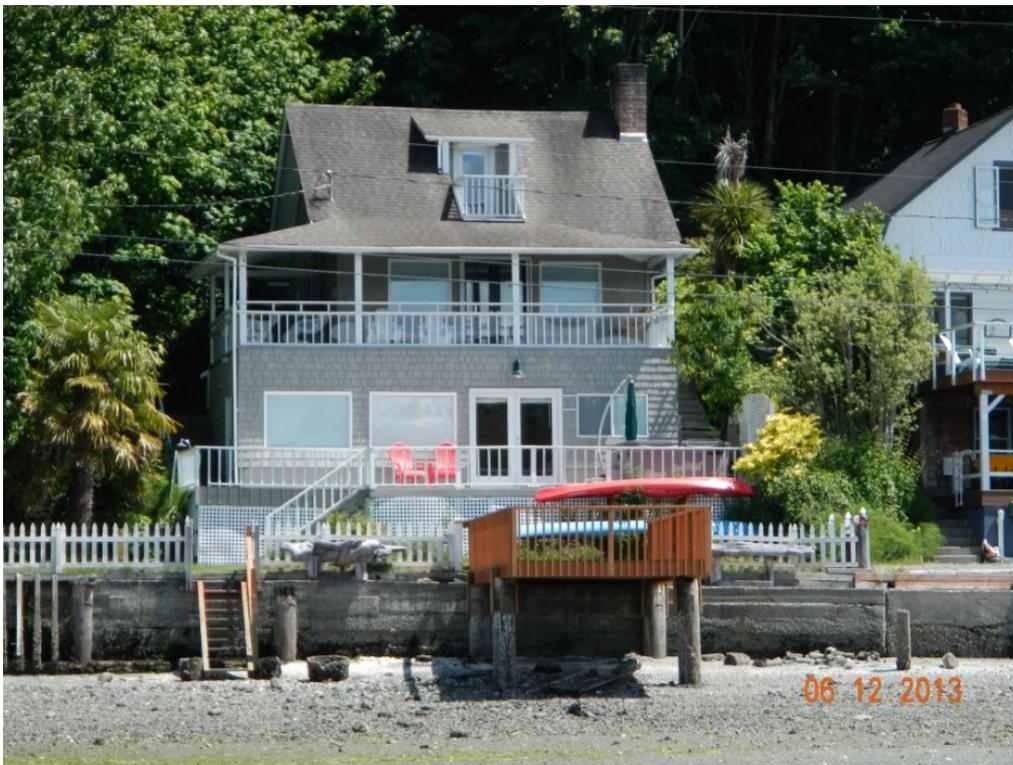
Figure B-6. An example of a rebuilt dock.

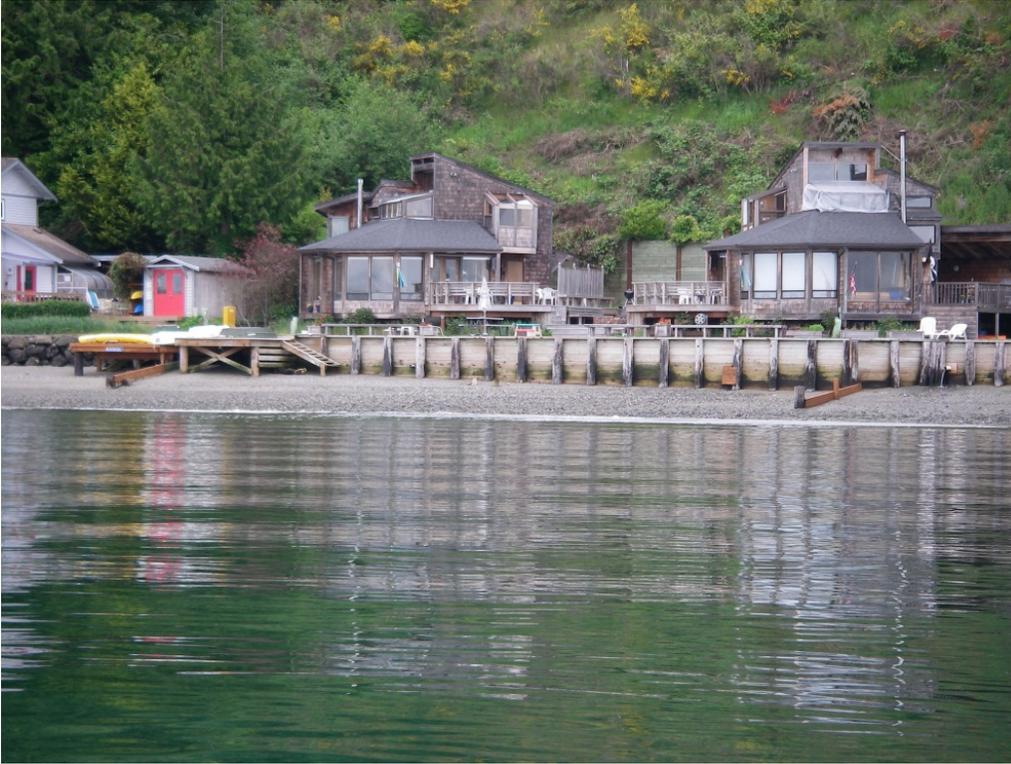
Figure B-7. An example of new wooden groins.

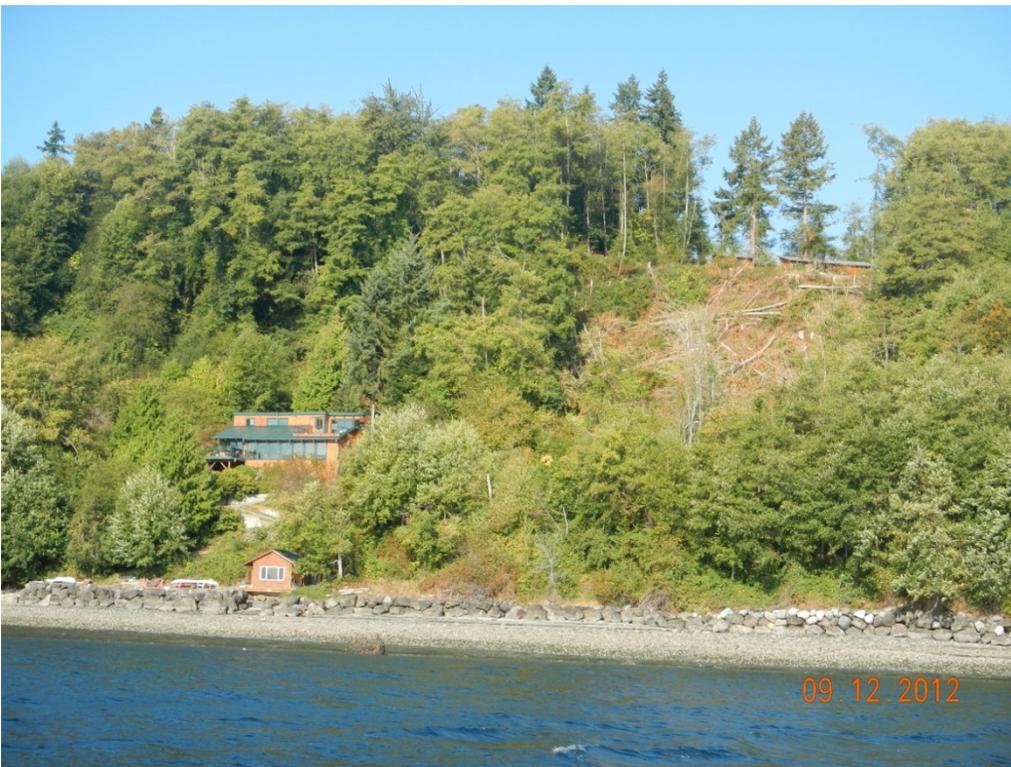
Figure B-8. An example of clearing of trees on a steep slope.

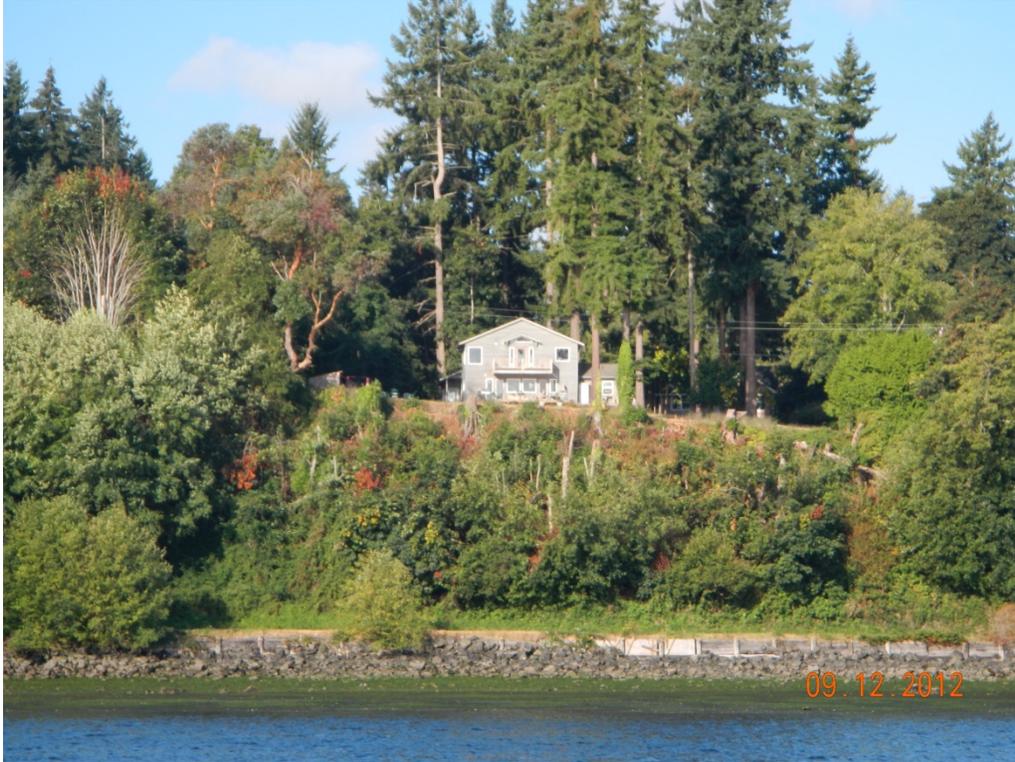
FigureB-9. An example of clearing and tree topping along a steep slope above a public road.

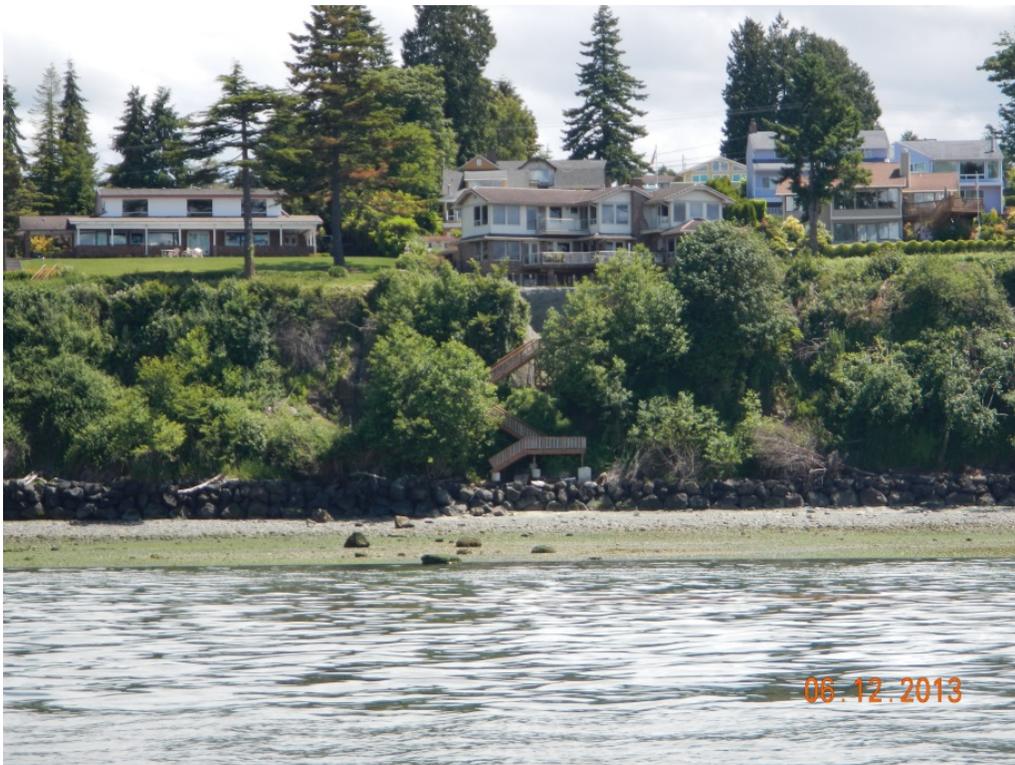
Figure B-10. An example of a site with a rebuilt set of stairs.

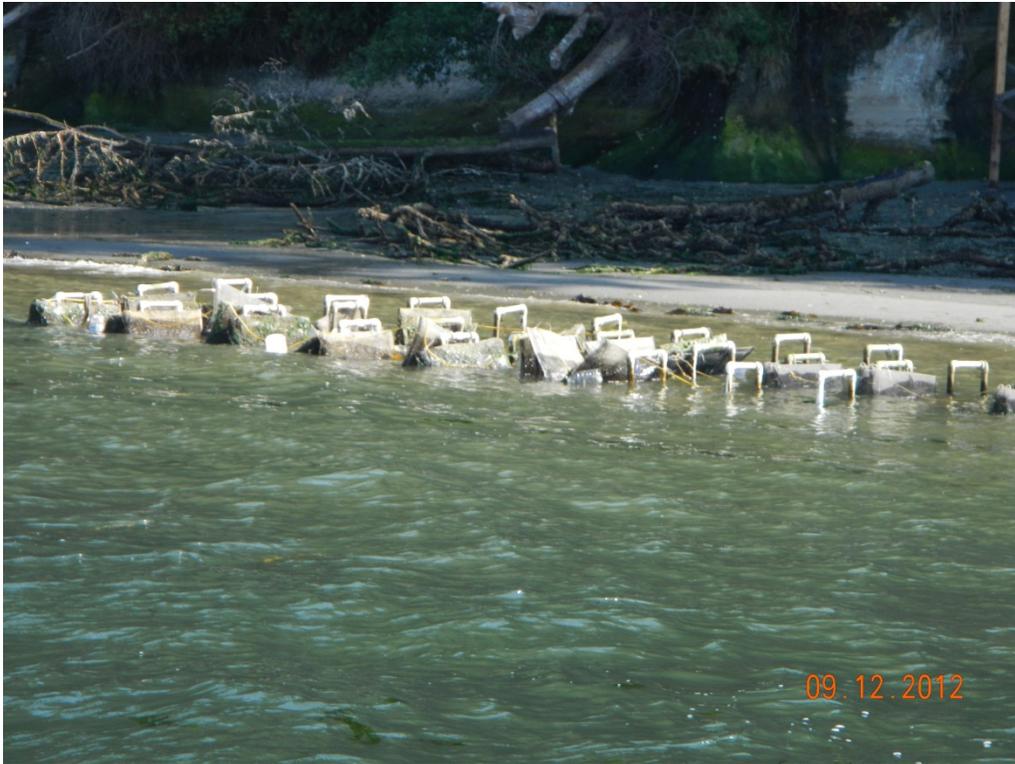
Figure B-11. The one example of an aquaculture operation.

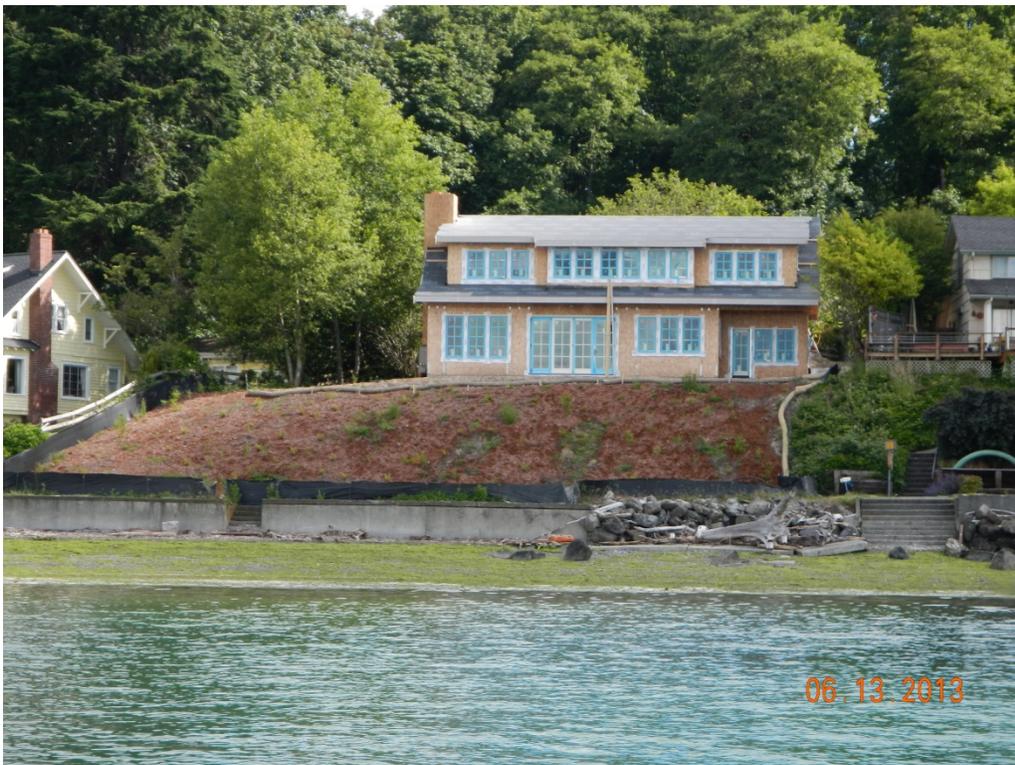
Figure B-12. An example of a new house and associated clearing.

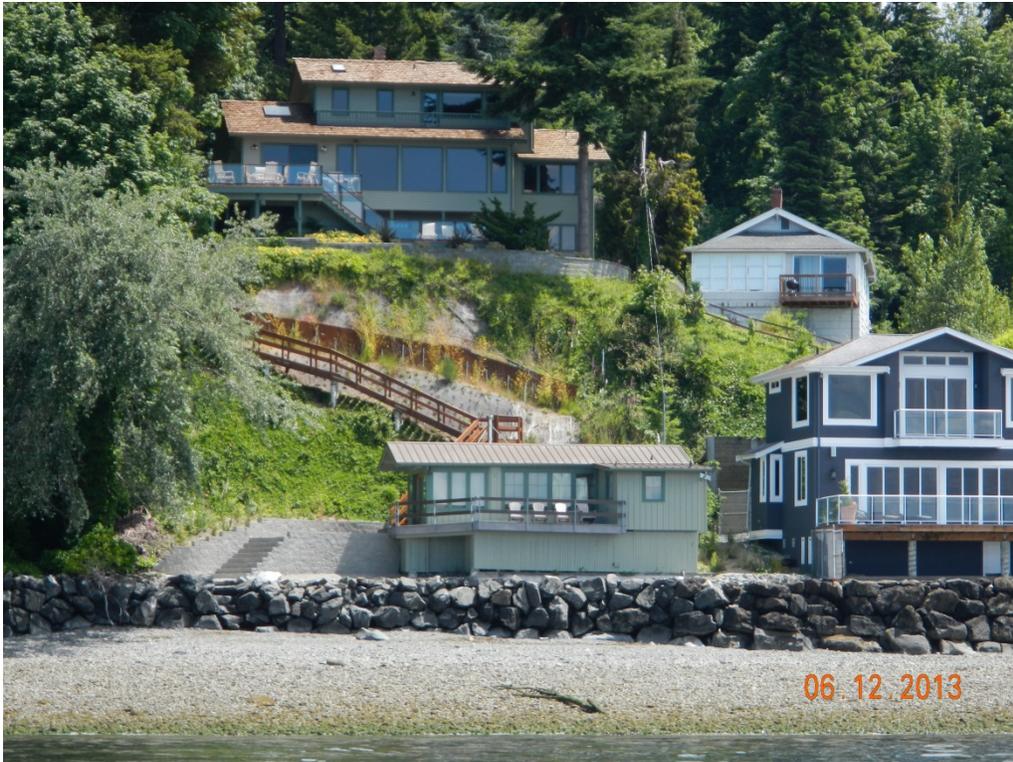
Figure B-13. An example of new retaining walls.

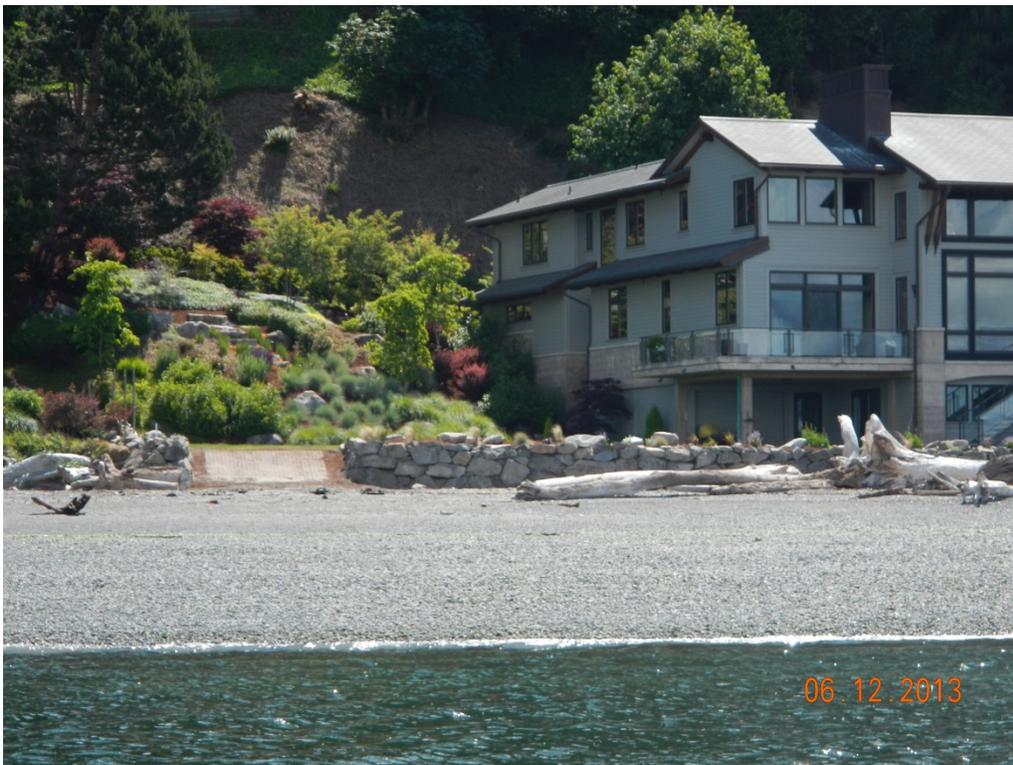
Figure B-14. An example of a new boat ramp.
