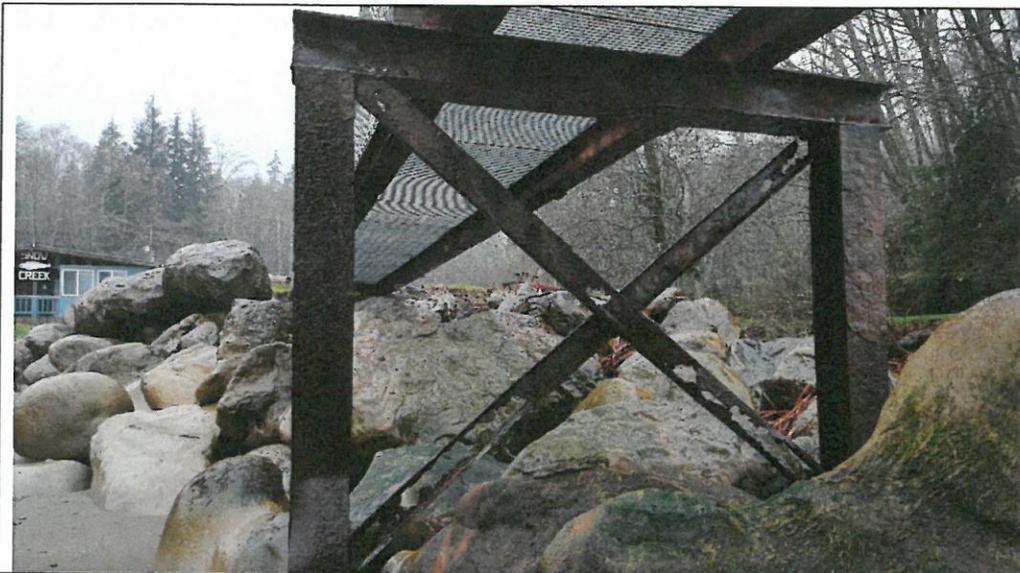
Rotten cross braces on bent # 4

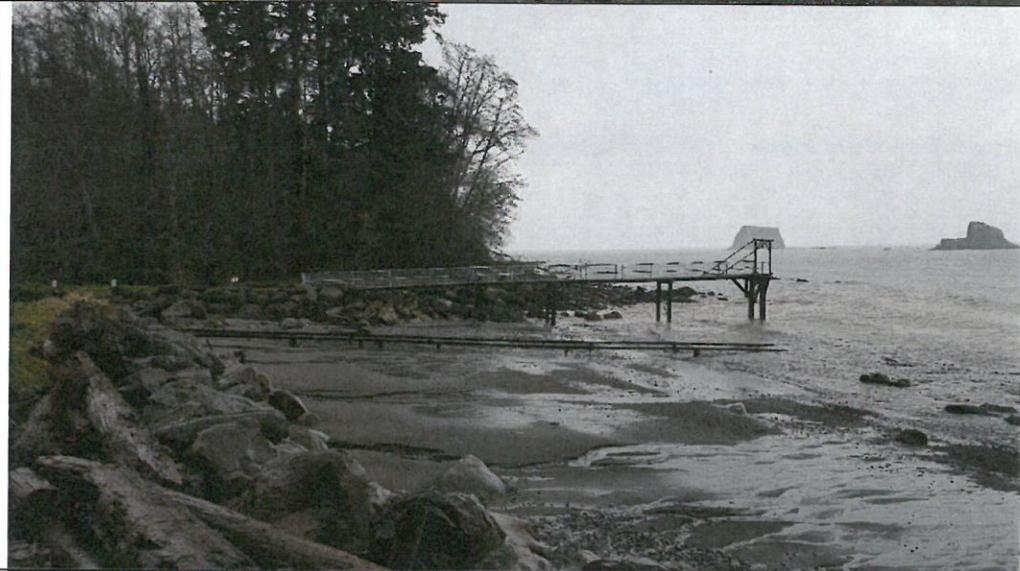
Side view of the pier and the rail launch.

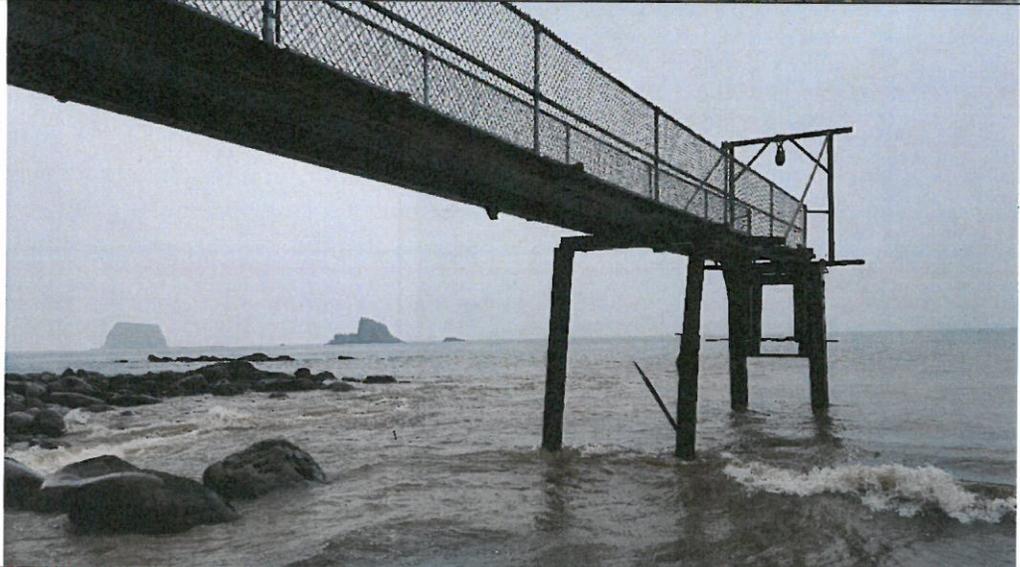
The second bent is missing its cross bracing and leaning hard. The third bent fell over causing the beams to span too far between support.

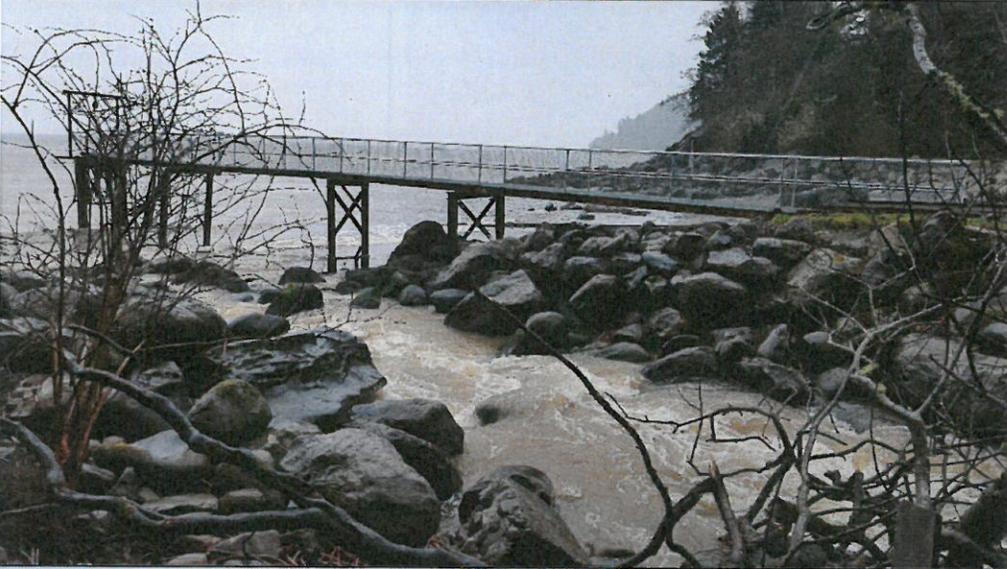
Pier looking at it from the opposite side of the creek

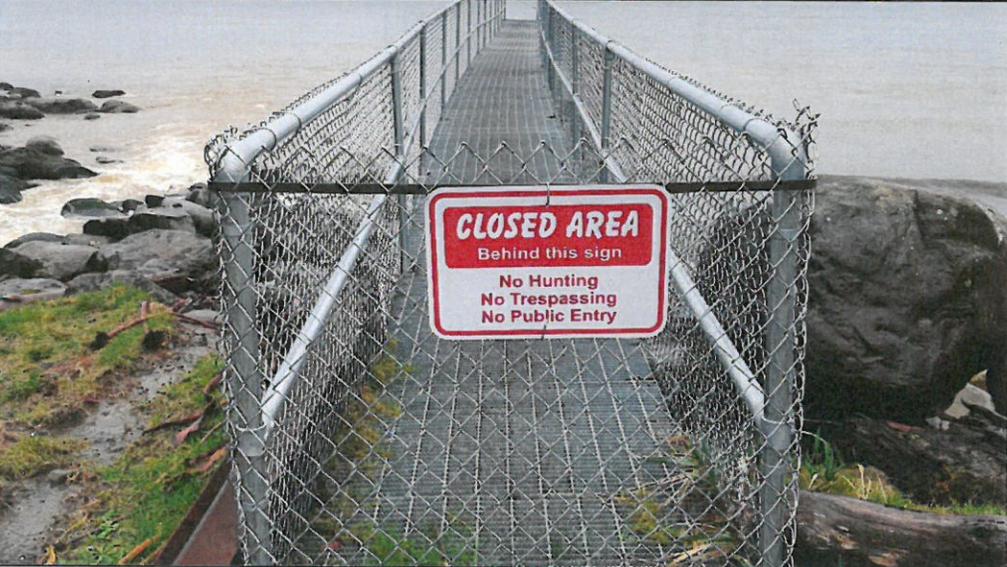
The Pier was closed off last summer because it was determined structurally unsafe.
