SITE INFORMATION

Site Identifier : BA1RB2 **Landowner Type :** Federal
Site Name : Zander Cr **Landowner Name :** USFS
WRIA : 03.1774X **Address :**
Region : NS **Address2 :**
Trib to : Bacon Cr **City :**
River Mile : 3.75 **State :**
River System : Bacon Cr **Zipcode :**
Legal Description : SE1/4S6T36NR11E **Phone :**
County : Skagit
Habitat Type : man-made impoundment

Field Survey Information

Date : 10/27/1997 **Observer :** Olis **Survey Type :** initial

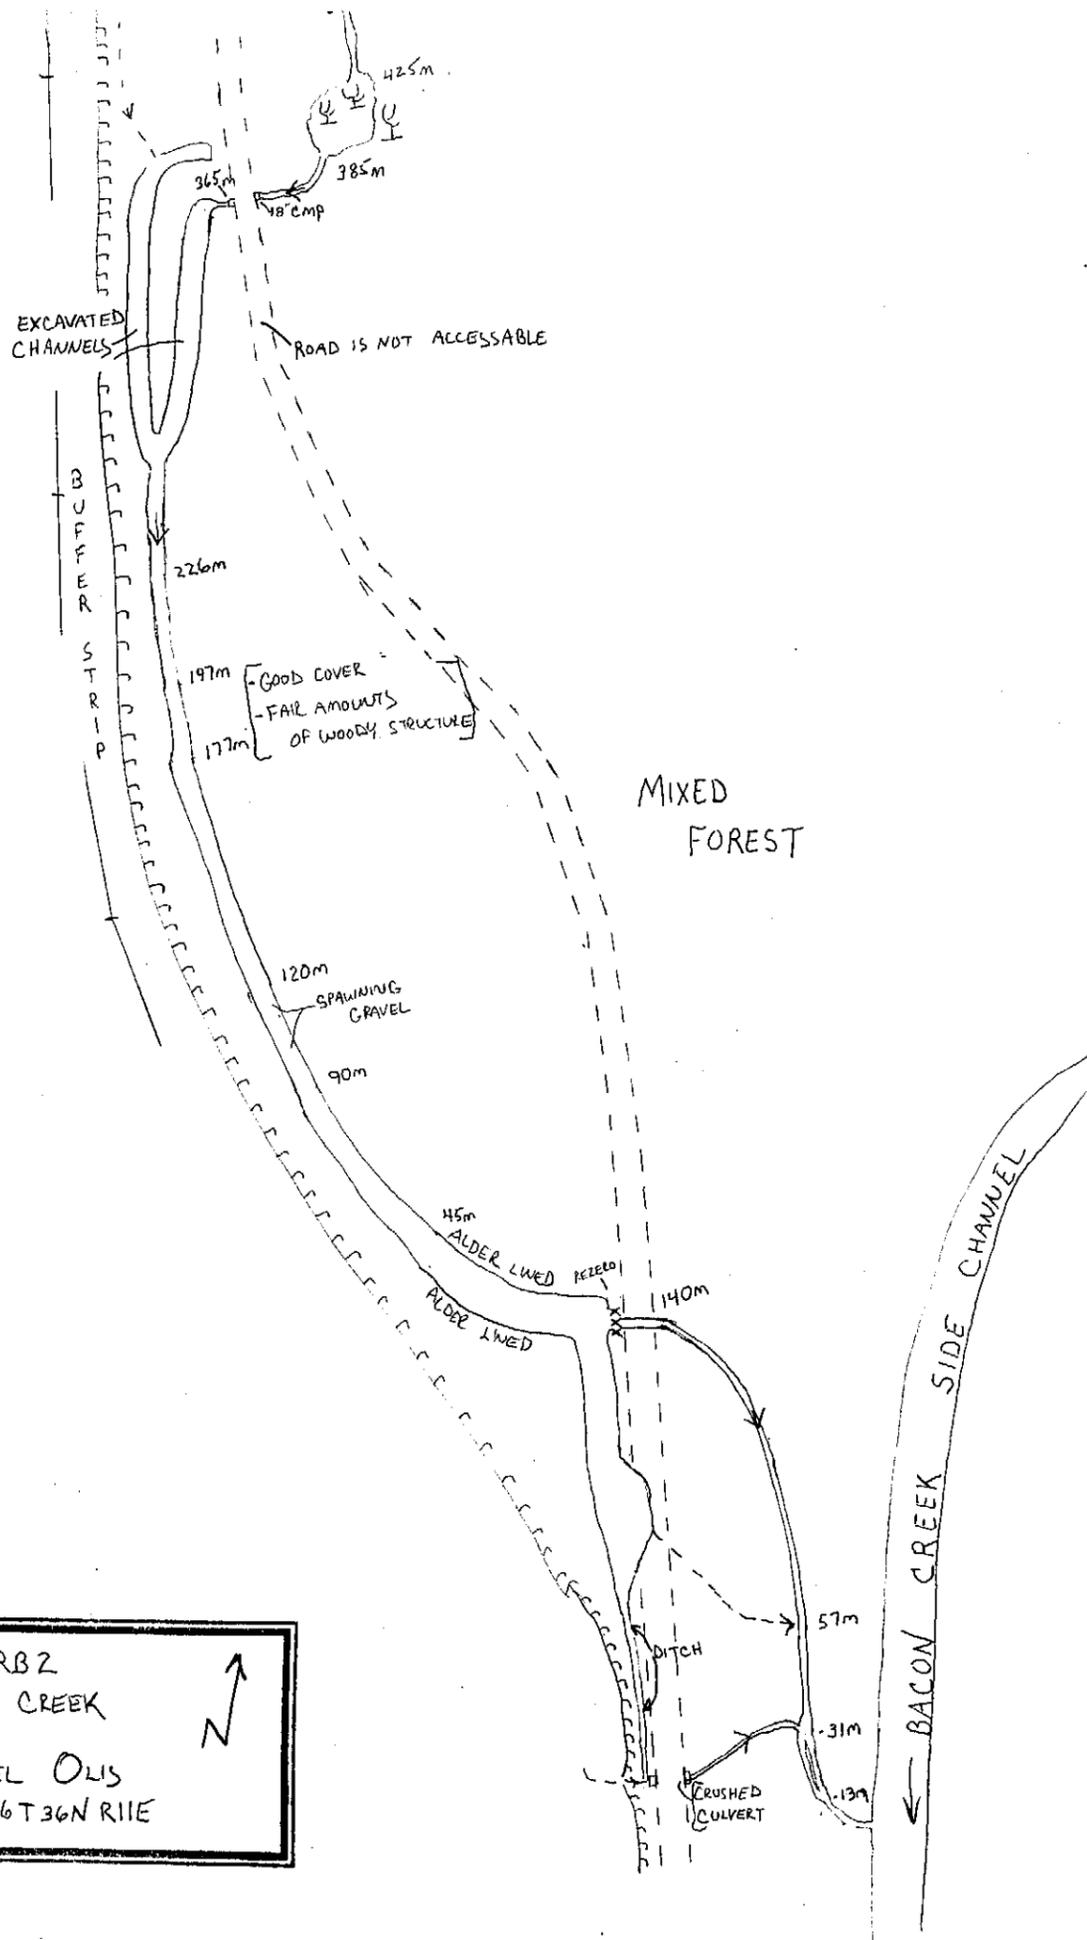
Site id. code: BA1RB2
Site name: ZANDER CREEK
Scale: 1" = 45m
Observer(s): MICHAEL OLIS
Legal location: SE 1/4 S6 T36N R11E

BROOM OR SIDE CH.

O.O ENTRY

STEM TEMP - 47°
REC. WTR TEMP 48°
FLOW - 1 CFS
ACCESS - GOOD

13m WW 2m

- RIFF
- P-GR SAND SUBSTR

3m → BRAIDED CH.

WW 2m EACH
- RIFF - 6" - 10" DEEP
- 1" GR → P GRAVE
- 2cm² OF SP HAE.
- TRIB - ON RB

31m ... TRIB IS
- NOT ACCESSABLE
- IT GOES STRAIGHT UP
TO ROAD AND 3' CMP.

57m WWS 3m
- SLOW MOVING
- SILT/SAND SUBS. P
W/SOME BOULDERS
- WT. TRIB ON RB

140m WWS 2.5m
- 60/40 P/R
- WOODY DEBRIS
CREATING POOLS
- COUPLE 2-4" GR. POOLS
- (1) RD. 4m...

... BUR DAM
CHANNEL APPEARS
TO FORK
- WILL REZERO &
GO UP R-FORK.

28m WWS 8m POOL
ALDER LINED

40m WWS 17m
- RD FLOODED FROM
BUR DAM. WATER
SPILLING OVER EDGE
LAND FLOWING BACK
TO MAINSTEM
- MANY FALLEN ALDERS

92m WW 1.5m

- DITCH ALONG SIDE OF RD.

- WTR FLOWING OF HILL AND THERE IS NO

MORE ACCESS

- ALSO @ CULVERT @ START OF ZAUNDER

- WTR TEMP 46

GOING BACK TO LFRR
E REZERO

45m WW 10m

POOL

- ALDERS FALLEN IN POOL

- SUBSTR. MUCKY
LEAVE FILLED

- SOME GR ALGAE PR

90m WW 6m

- CHANNEL CHOKED W/ WOODY DEBRIS

- IS MOSTLY POOL

- EXC STRUCTURE IN POOLS

- @ BASE OF SLOPE

120m WW 6m

- SHALLOW

- 4m² SR GR

- ON LARGE SIDE

- LOOKS LIKE IT WAS

ADDED TO SYSTEM

- CHOKED OF DEBRIS

177 m. WW 6M

- POOL
- GOOD STRUCTURE
- COVER
- MUCK SUBSTR.
- 6" TROUT SEEN
- WTR 10" DEEP

179 m. WW 4M

- @ 6M LEOW BUR
- DAM ACCESSABLE

226 WW 4M

- 2M² SP GRAVEL
- GOOD GRAVEL - BRUSH

275 m. WW 3M

- SLOW MOVING
- @ MAN-MADE ?
- BERM W/ LEOW BUR
- DAM ON IT - IS
- ACCESSABLE

365 m. TWO EXCV.

- CHANN; 6M EACH
- @ 18" CAP, 6"
- DEEP
- CHANNEL 1-2M
- DEEP
- FAIR AMOUNTS OF
- WOODY DEBRIS
- GRN ALGAE ON
- BOTTOM

385m WW ZM
RIFF
VELY BRUSHY

405m 15m WW
- BRUSHY SWAMP
ARE
HIGH WATER

445m WW ZM
- WATER SEEPING
OUT OF GROUND
- WTR TEMP 15.5
- WTR FLOW THROUGH
LEAVES & BRANCHES
