SITE NUMBER: ED-L4-04
LOCAL NAME: Sandy Creek
WRIA: 20.0120A

NORTH COAST OFF CHANNEL SITE INVENTORY DATA

RIVER SYSTEM: E. F. Dickey **DATE:** 3/26/91 **OBSERVER:** Nettnin

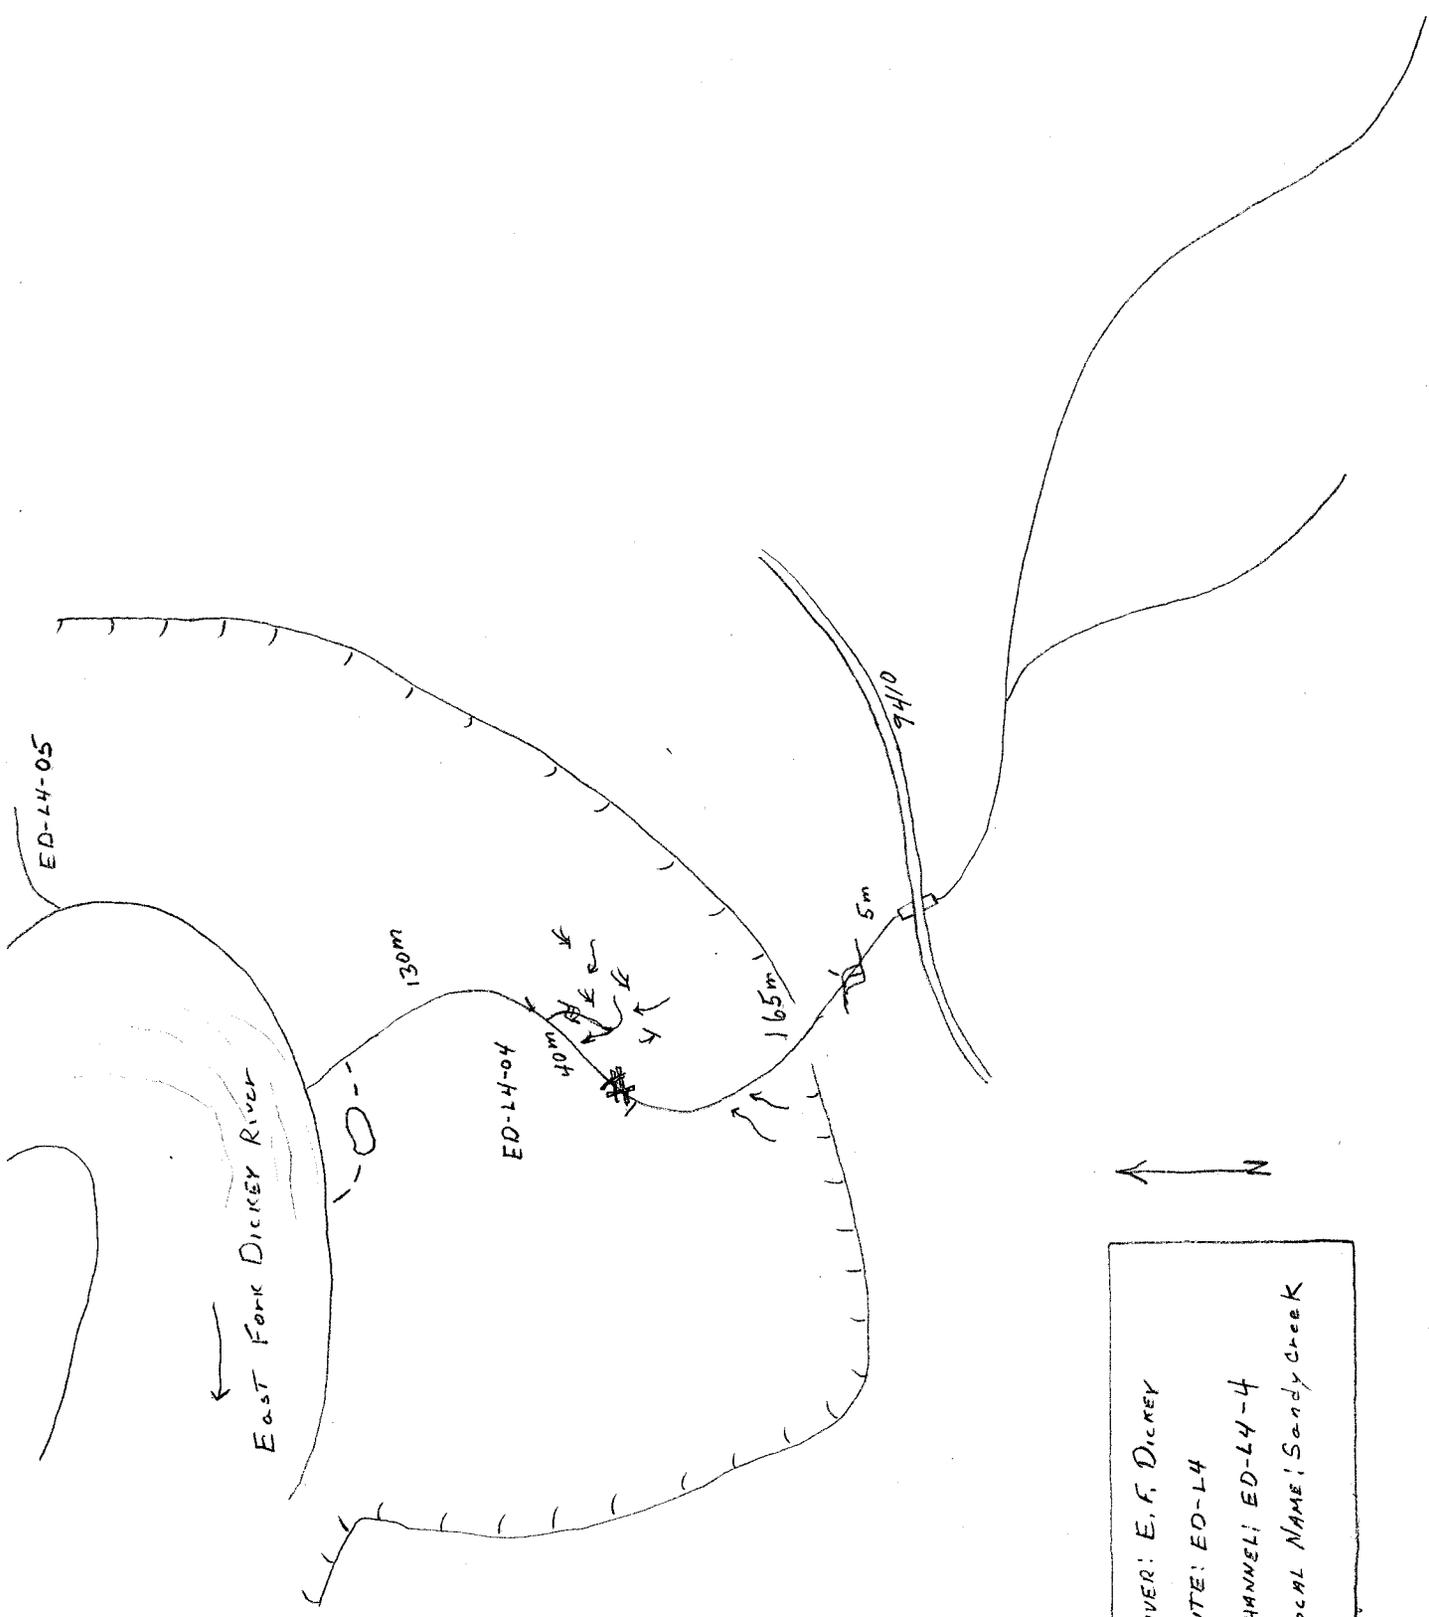
RIVER: E. F. DICKEY
 SITE: ED-14
 CHANNEL: ED-14-4
 LOCAL NAME: Sandy Creek

COMMENTS & RECOMMENDATIONS: ED-L4-04 enters the river on the outside of a hard, sweeping bend. This causes debris and bedload from the river to accumulate at the mouth of the channel. This creates only a minor fish passage problem at present and may even enhance entrance conditions at higher flows. The stream bed of ED-L4-04 appears stable. There is no indication of large bedload movements. The substrate is parent soil (clay) in the faster flowing reaches and gravel in the slower reaches. The channel of ED-L4-04 is incised 2 to 3 meters deep along the entire reach that was surveyed. About 130 m above the mouth of ED-L4-04 there is a nice looking marsh on the right bank, but outflow from this marsh enters the channel over 1.1 m fall.

The 100 m reach of ED-L4-04 above the marsh egress has the best looking rearing habitat. A smolt-sized fingerling was observed near the log jam in this reach. There may be passage problem at this jam.

Continuing upstream, as the channel cuts through the terrace, a 1.1 m falls has developed. Above this falls and below the culvert at the 9410 road there were ten 0+ fry which appeared to be salmonids. According to Roger Mosley (WDF), no spring out planting has been done yet this spring. These fry were probably spawned above the falls.

- Still flowing throughout despite record dry March.
- 18" drop out of 36" CMP blocks 0+ migration above 9410 road.
- Coho fry seen throughout below 9410.
- Smolts seen in pool just below culvert and in channel just above.
- Need to improve passage at culvert by placing riprap at outlet.
- Lower and upper channel could use some controls to improve pool to riffle ratio.
