**Site Identifier :** HN1LB3 **Landowner Type :**  
**Site Name :** **Landowner Name :**  
**WRIA :** 03.0268X **Address :**  
**Region :** NS **Address2 :**  
**Trib to :** Red Cr **City :**  
**River Mile :** 0.40 **State :**  
**River System :** Hansen Cr **Zipcode :**  
**Legal Description :** NE1/4S17T35NR5E **Phone :**  
**County :** Skagit  
**Habitat Type :** man-made impoundment

**Date :** 2/18/98 **Observer :** Barkdull **Survey Type :** initial

Site id. code: HN1LB3

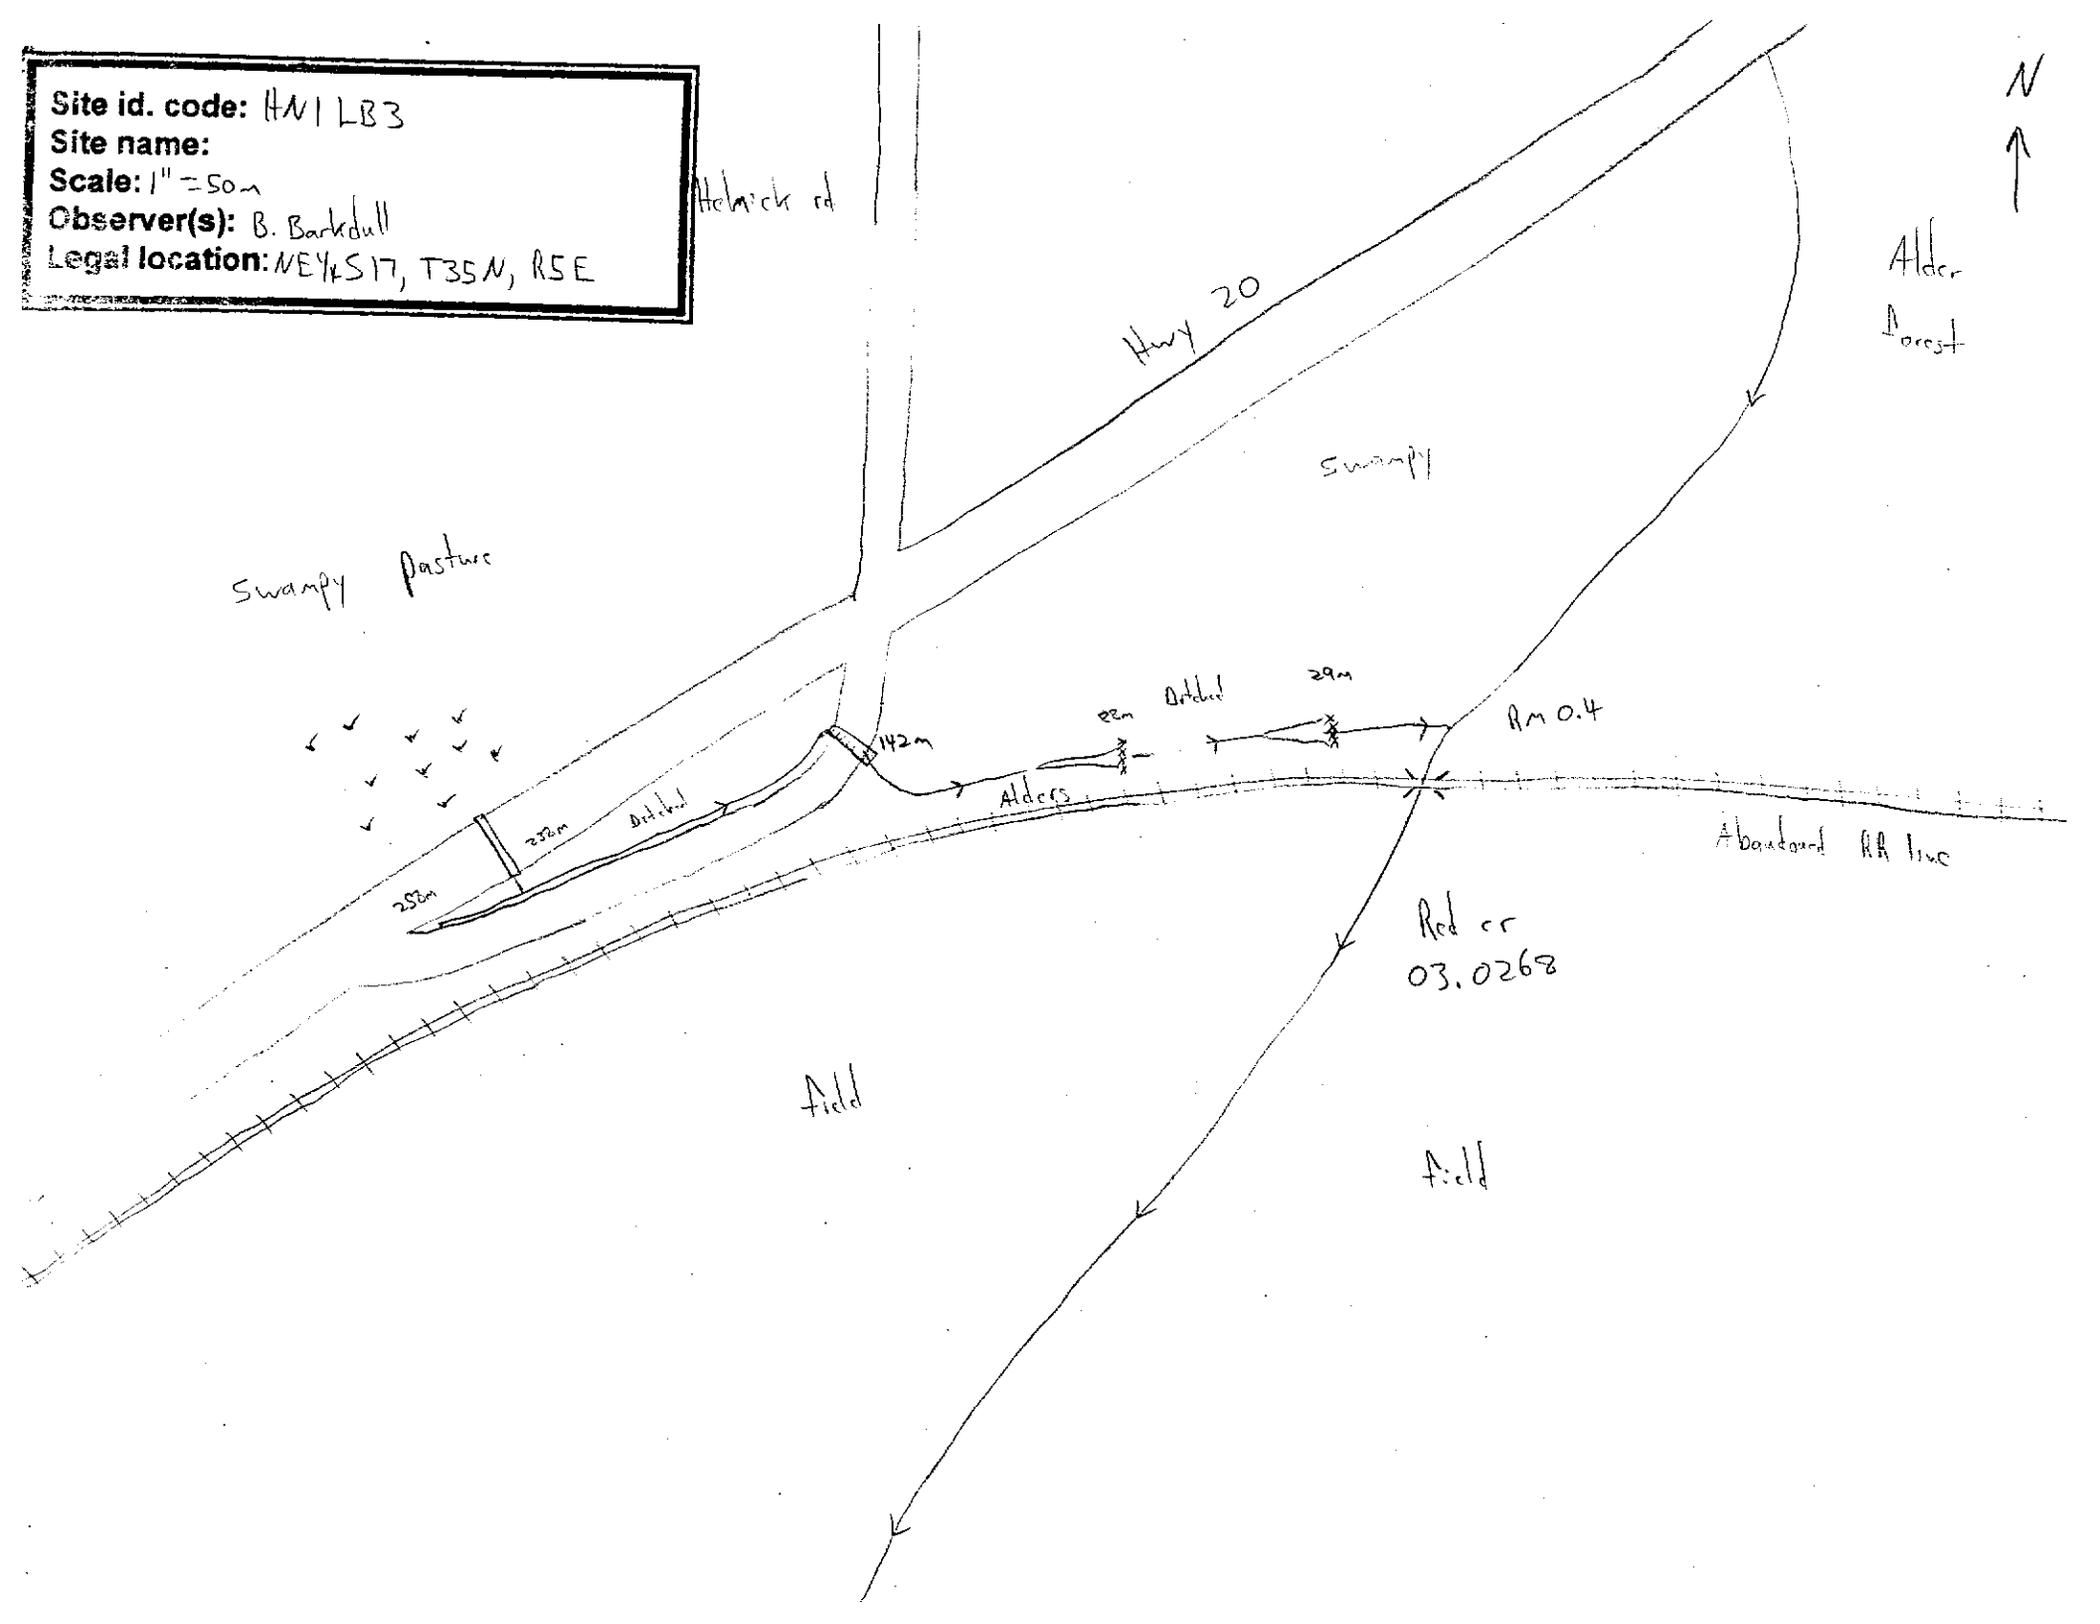
Describe pond and other rearing habitat: The ditch is impounded by a series of small beaver dams in the lower half with also have a good overhead canopy. The upper half of the site is a roadside ditch dominated by canary grass.

Describe: Entry conditions are excellent to the site but the flapper gate on Red Creek limits access.

ADDITIONAL COMMENTS: Site was electroshocked on 2/23/98 and no fish of any species were found. Red Creek was also shocked and no fish were found leading me to believe the flapper gate on Red Creek was a barrier to juvenile fish this fall. Adult coho were observed this winter upstream in Red Creek, but it is unknown if there was adult access in 1996. The flapper gate, installed to eliminate back flooding of lower Red Creek by Hansen Creek appears to be significantly reducing fish production in the Red Creek basin.

Project type: Flapper Gate removal
