**SITE NUMBER:** B-L5-01  
**LOCAL NAME:** Smith Rd Channel  
**WRIA:** 20.0240A

**NORTH COAST OFF CHANNEL SITE INVENTORY DATA**

**RIVER SYSTEM:** Bogachiel **DATE:** 4/18/89 **OBSERVER:** Young

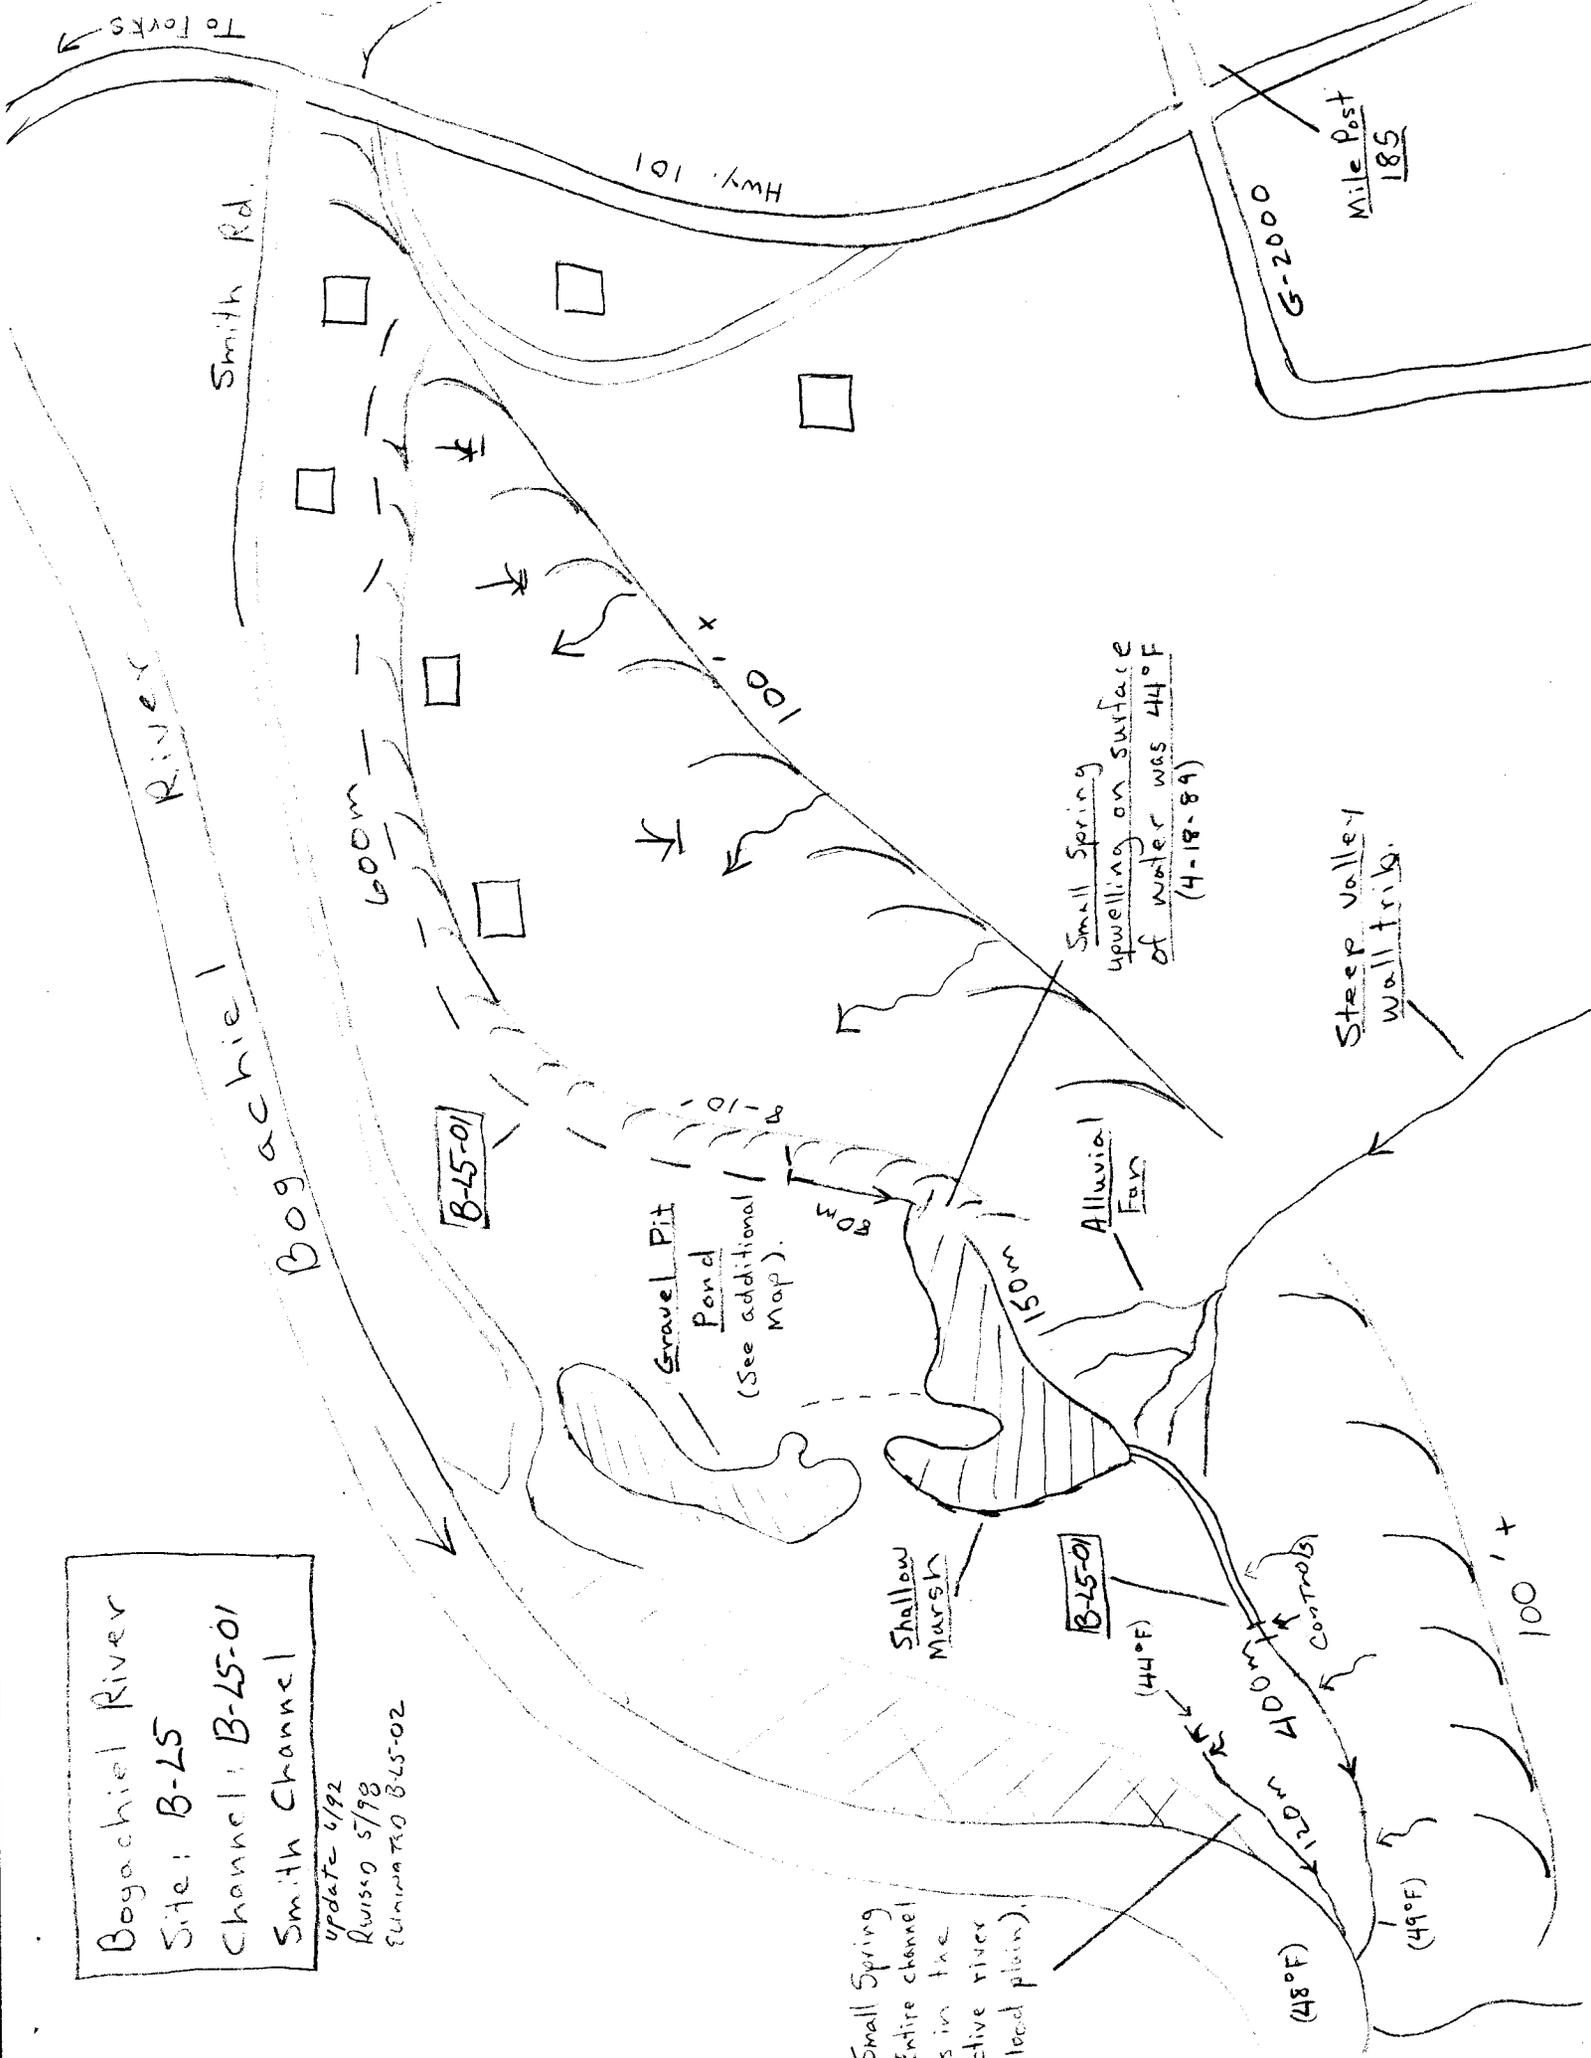
Bogachiel River  
 Site: B-25  
 Channel: B-25-01  
 Smith Channel

Small Spring  
 upwelling on surface  
 of water was 44°F  
 (4-18-89)

Steep valley  
 wall trib.

Small Spring  
 Entire channel  
 is in the  
 side river  
 local plain)
