**SITE INFORMATION**

| <b>Site Identifier :</b> | SK1RB4 | <b>Landowner Type :</b> | Private |

**Field Survey Information**

**Date :** 1/10/01 **Observer :** Olis **Survey Type :** initial

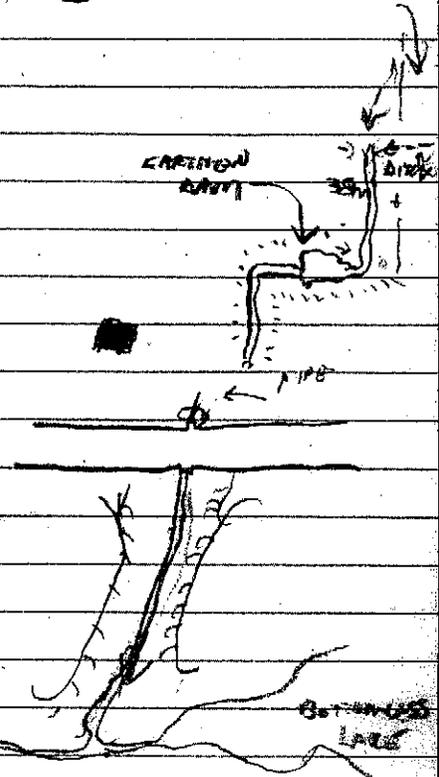
O.O ENTRY  
FLOW - 0.2  
WT - 43° UP  
RW - 41°  
ACCESS - POOL @ ENTRY

71m W/W 1.3m  
- CLAY CURST,   
- W/CSPT BANKS / GOOD BRUSH  
- 5% GRADE

112m W/W 1.3m  
- GRADIENT IS 7%  
- BEGINNING OF MALLOW BUTTER

- MUD-SUBSTR.
- @ 5% GRADE
- @ 1' DROP OVER LAL.
- MOSTLY POOLED

- SOME PER. GR / LOTS OF WOOD
- @ ROAD & CULVERT
- 0.46 CAL - > 1% SLOPE
- NO MAT. - OUTFALL DROP 0.8
- W/DEPTH 0.05

- 1m OF ROAD FILL
- DWINGYR 3m IS DOWNSTREAM
- CULV. L-12m
- FERRERSON RD.

- 0.31 PCC NO MAT.
- VIS. > 1% SLOPE
- 0.25 DROP
- 0.8m OF FILL OVER PIPE
- W/DEPTH 0.05

② EXISTING DAM WITH  
OHL PEE EULV. 5m L

- WATER IS STOPPING  
THRU DAM, NOT CULVERT

DAM SEEMS TO BE

FAILING.

DAM 16m L x 3m W 2m H
