**SITE INFORMATION**

**Site Identifier :** SK3RB1 **Landowner Type :** Private  
**Site Name :** **Landowner Name :**  
**WRIA :** 03.0294X **Address :**  
**Region :** NS **Address2 :**  
**Trib to :** Minkler Lake **City :**  
**River Mile :** 1.10 **State :**  
**River System :** Skagit R **Zipcode :**  
**Legal Description :** NE1/4S13T35NR5E **Phone :**  
**County :** Skagit  
**Habitat Type :** terrace tributary

**Date :** 02/25/1997 **Observer :** Olis **Survey Type :** initial

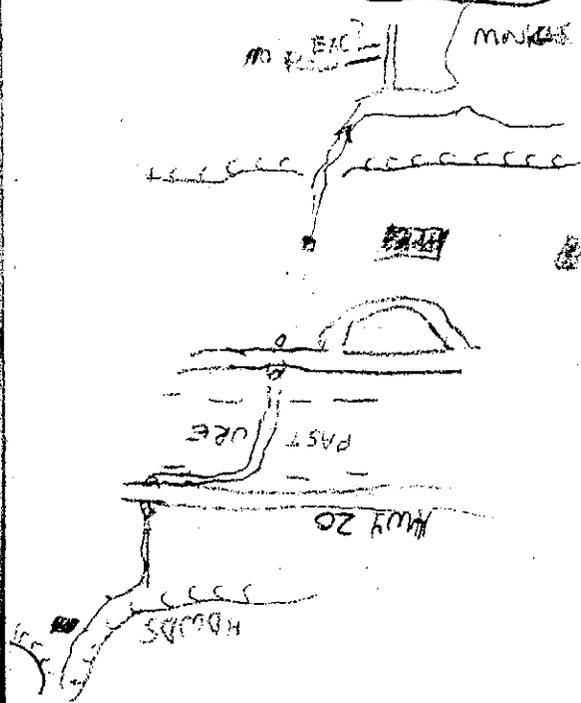
SK3RBI

0.0 ENTRY

- WTR TEMP 49°
- REC WTR -
- FLOW - POOL
- EASY ACCESS

120m ww 4m POOL

- 1' DEEP - GREEN ALGAE
- POOL HAS BEEN PART. DRAINED BY NEIGABOR
- @ SMALL CASCADE W/ 0.1 CES

- MUD SKIPPERS
- MUDDY SUBSTR.

160m ww 0.5m

- RIFF
- LANDSCAPED BANKS

160m... @ 12" PCP  
- SUBSTR. FIRM SILT/GRD.

208m @ OPEN CONCR.  
CATCH BASIN & SOUTH  
SIDE OF ROAD - STREAM  
STILL IN CULVERT.

221m @ UPSTREAM END  
OF CULVERT - 2' CONCR.  
CULVERT

409m WW 2m  
- SLOW-MOVING POOLS  
- 5' DEEP - MUD BOTTOMED  
CHOKED W/ RUSH & SOME  
OTHER AQUATIC VEG. (WATER CRESS)  
- @ OLD WOODEN PC.  
450m ALONG HWY 20

520m WW 2m  
540m OUT OF PASTURE  
MORE LIKE DITCH ALONG  
HWY 20 SILT BOTTOMED  
NO VEG.

671m WW 1m SILT BOTT.  
@ 5' CONCR. CULVERT  
UNDER HWY 20.

- NO DEEP - NOT A BARRIER  
- 692m @ UPSTREAM END OF  
CULVERT

- 705m WW 1.5m  
- SHALLOW, SOME GR.  
SHOWING UP

- 742m WW @ 1.5m  
- RIFF SILT/GR SUBSTR  
CHOKED W/ BLACK BERRIES  
- @ BASE OF HILL

839m @ SW PROBLEMS HERE

- WW 1m SILT LADEN  
RIFE

861m ww .5 @

- 1 FOOT FALLS  
- INCISED BANKS

905m ww 1m

- IN BRUSH BEHIND  
HOME

- SLOPE ON LB NOW

974m ww 1m

10/20 P/R  
- COBBLE & LARGE GR  
SHOWING UP IN SILTY  
SUBSTR.

- THICK W/ BERRY BRUSH

- @ OD CEDAR STUMP...

in CREEK FLOWS UNDER

1066m ww 1

- HEAVY BRUSH

- MUCH LWD

- @ 1 FOOT FALLS

- INTO A BUFFERED  
AREA NOW

1191m ww 1m

- FEW BOULDERS SHOWING  
UP

- GRADE INCREASING

- 0.1 CFS - WTR TEMP. 74.5

- SEED ON LB

1273m ww 0.5m

- ALDER CHECKED

GULLY - 3 FOOT DROP / GLIDE  
END OF JOV. ACCESS

1390m<sup>.5m</sup> END OF  
THE LINE. 0.1 CFS  
FLOW -  
TO HIGH GRADIENT
