Site id. code: SK9 RB1  
 Site name: Ebing cr  
 Scale: 1" = 25m  
 Observer(s): B. Barkdull  
 Legal location: NWS, T35N, R8E

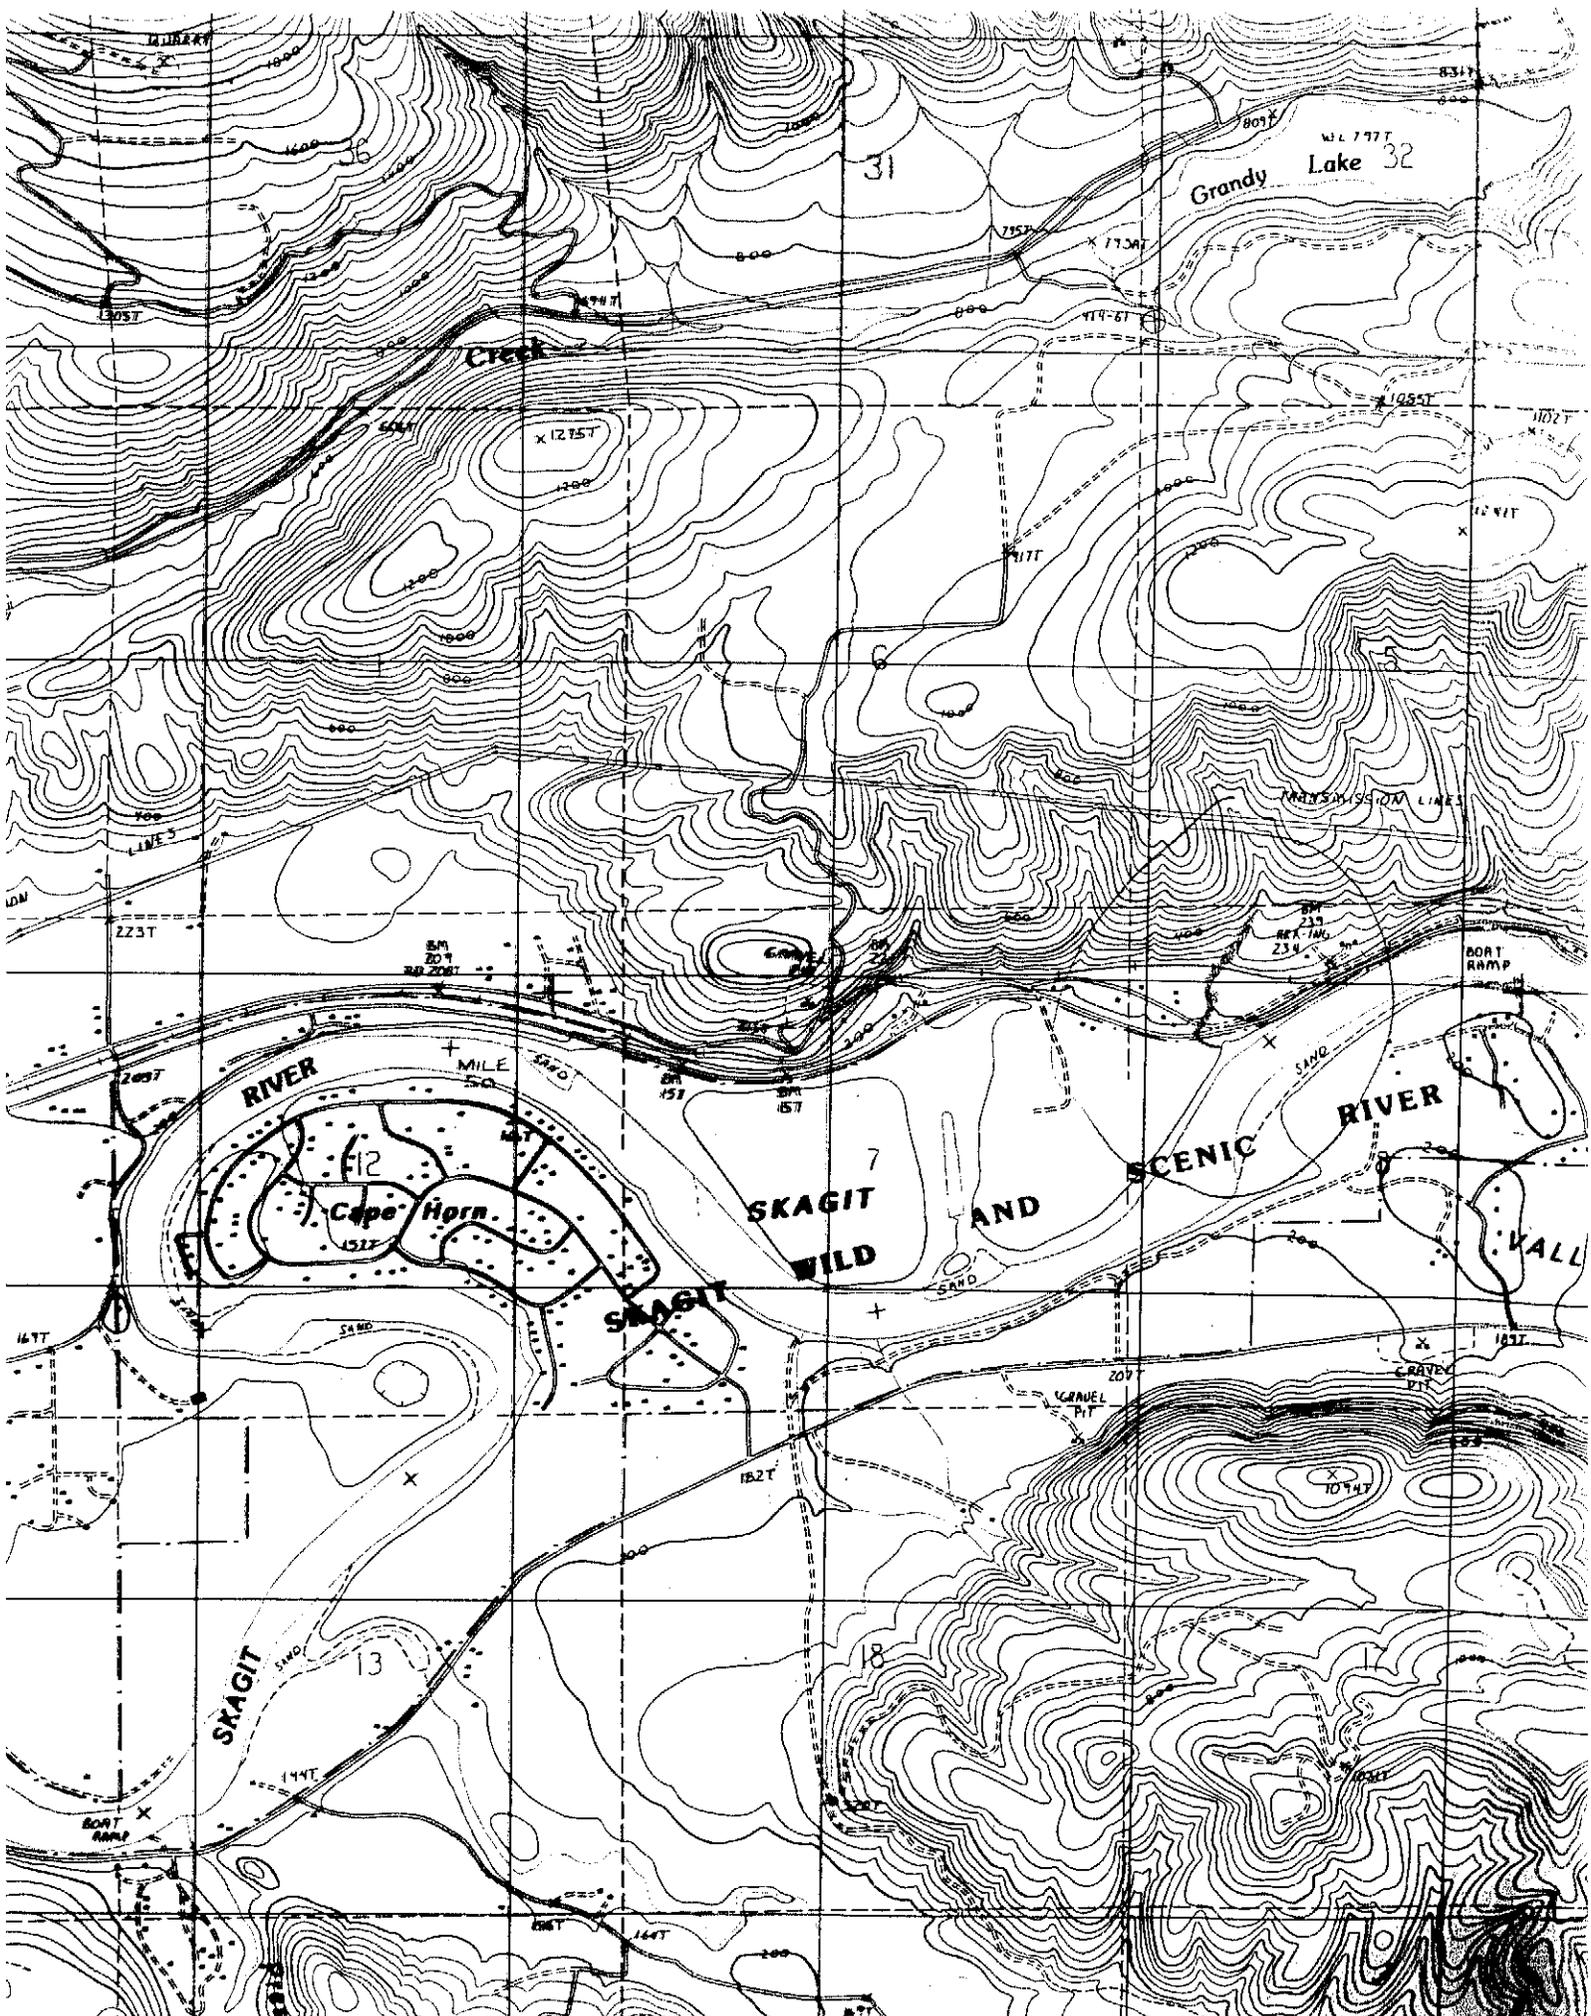
1/12/97 Ebig of River 37, or 39  
0, 1m at River

31 m 1m 6% grade, and

corner, gully starts 10m

21m 1.5 m wide, grade

23m 1m wide steep cascade  
at 18" CC Road & route
