SITE INFORMATION

Site Identifier : SU6LB2 **Landowner Type :** Federal
Site Name : Pedestal Ponds **Landowner Name :** USFS
WRIA : 03.0710X **Address :**
Region : NS **Address2 :**
Trib to : Suiattle R **City :**
River Mile : 19.60 **State :**
River System : Suiattle R **Zipcode :**
Legal Description : NW1/4S19T32NR12E **Phone :**
County : Snohomish
Habitat Type : man-made impoundment

Date : 07/25/1995 **Observer :** Barkdull **Survey Type :** initial

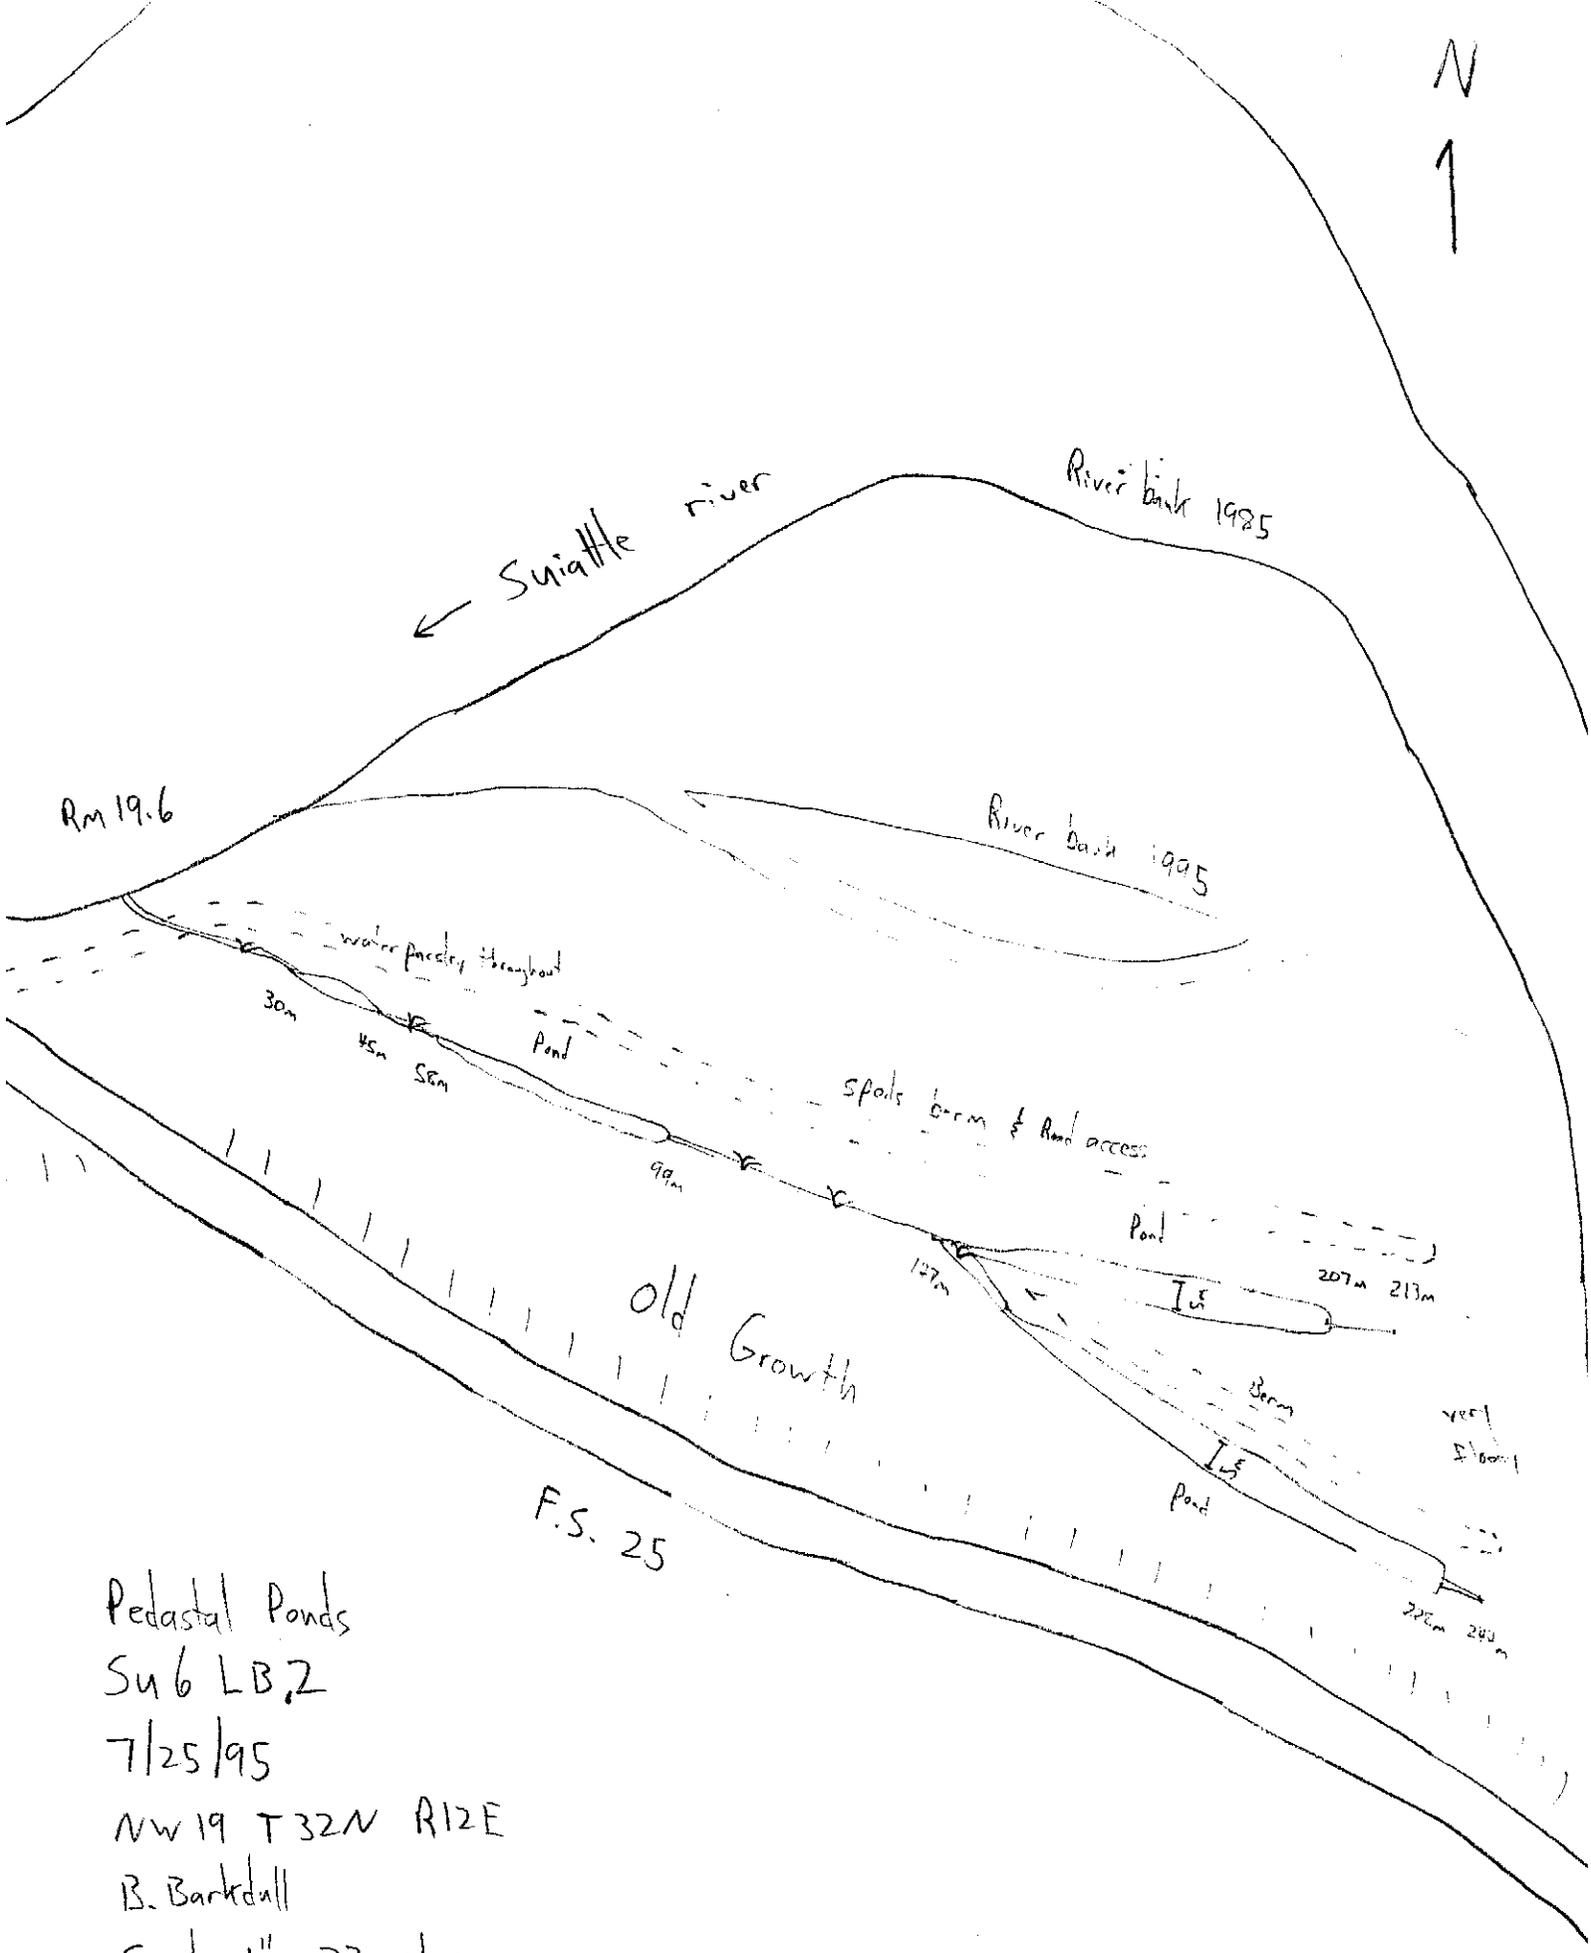
Pedestal Ponds

River bank 1985

River bank 1995

water facility throughout

Spoils berm & Road access
