SITE INFORMATION

Site Identifier : WN1LB3 **Landowner Type :** Private
Site Name : **Landowner Name :**
WRIA : 03.0253X **Address :**
Region : NS **Address2 :**
Trib to : 03.0253 **City :**
River Mile : 0.75 **State :**
River System : WF Nookachamps **Zipcode :**
Legal Description : NE1/4S16T34NR4E **Phone :**
County : Skagit
Habitat Type : terrace tributary

Field Survey Information

Date : 2/24/00 **Observer :** Olis **Survey Type :** initial

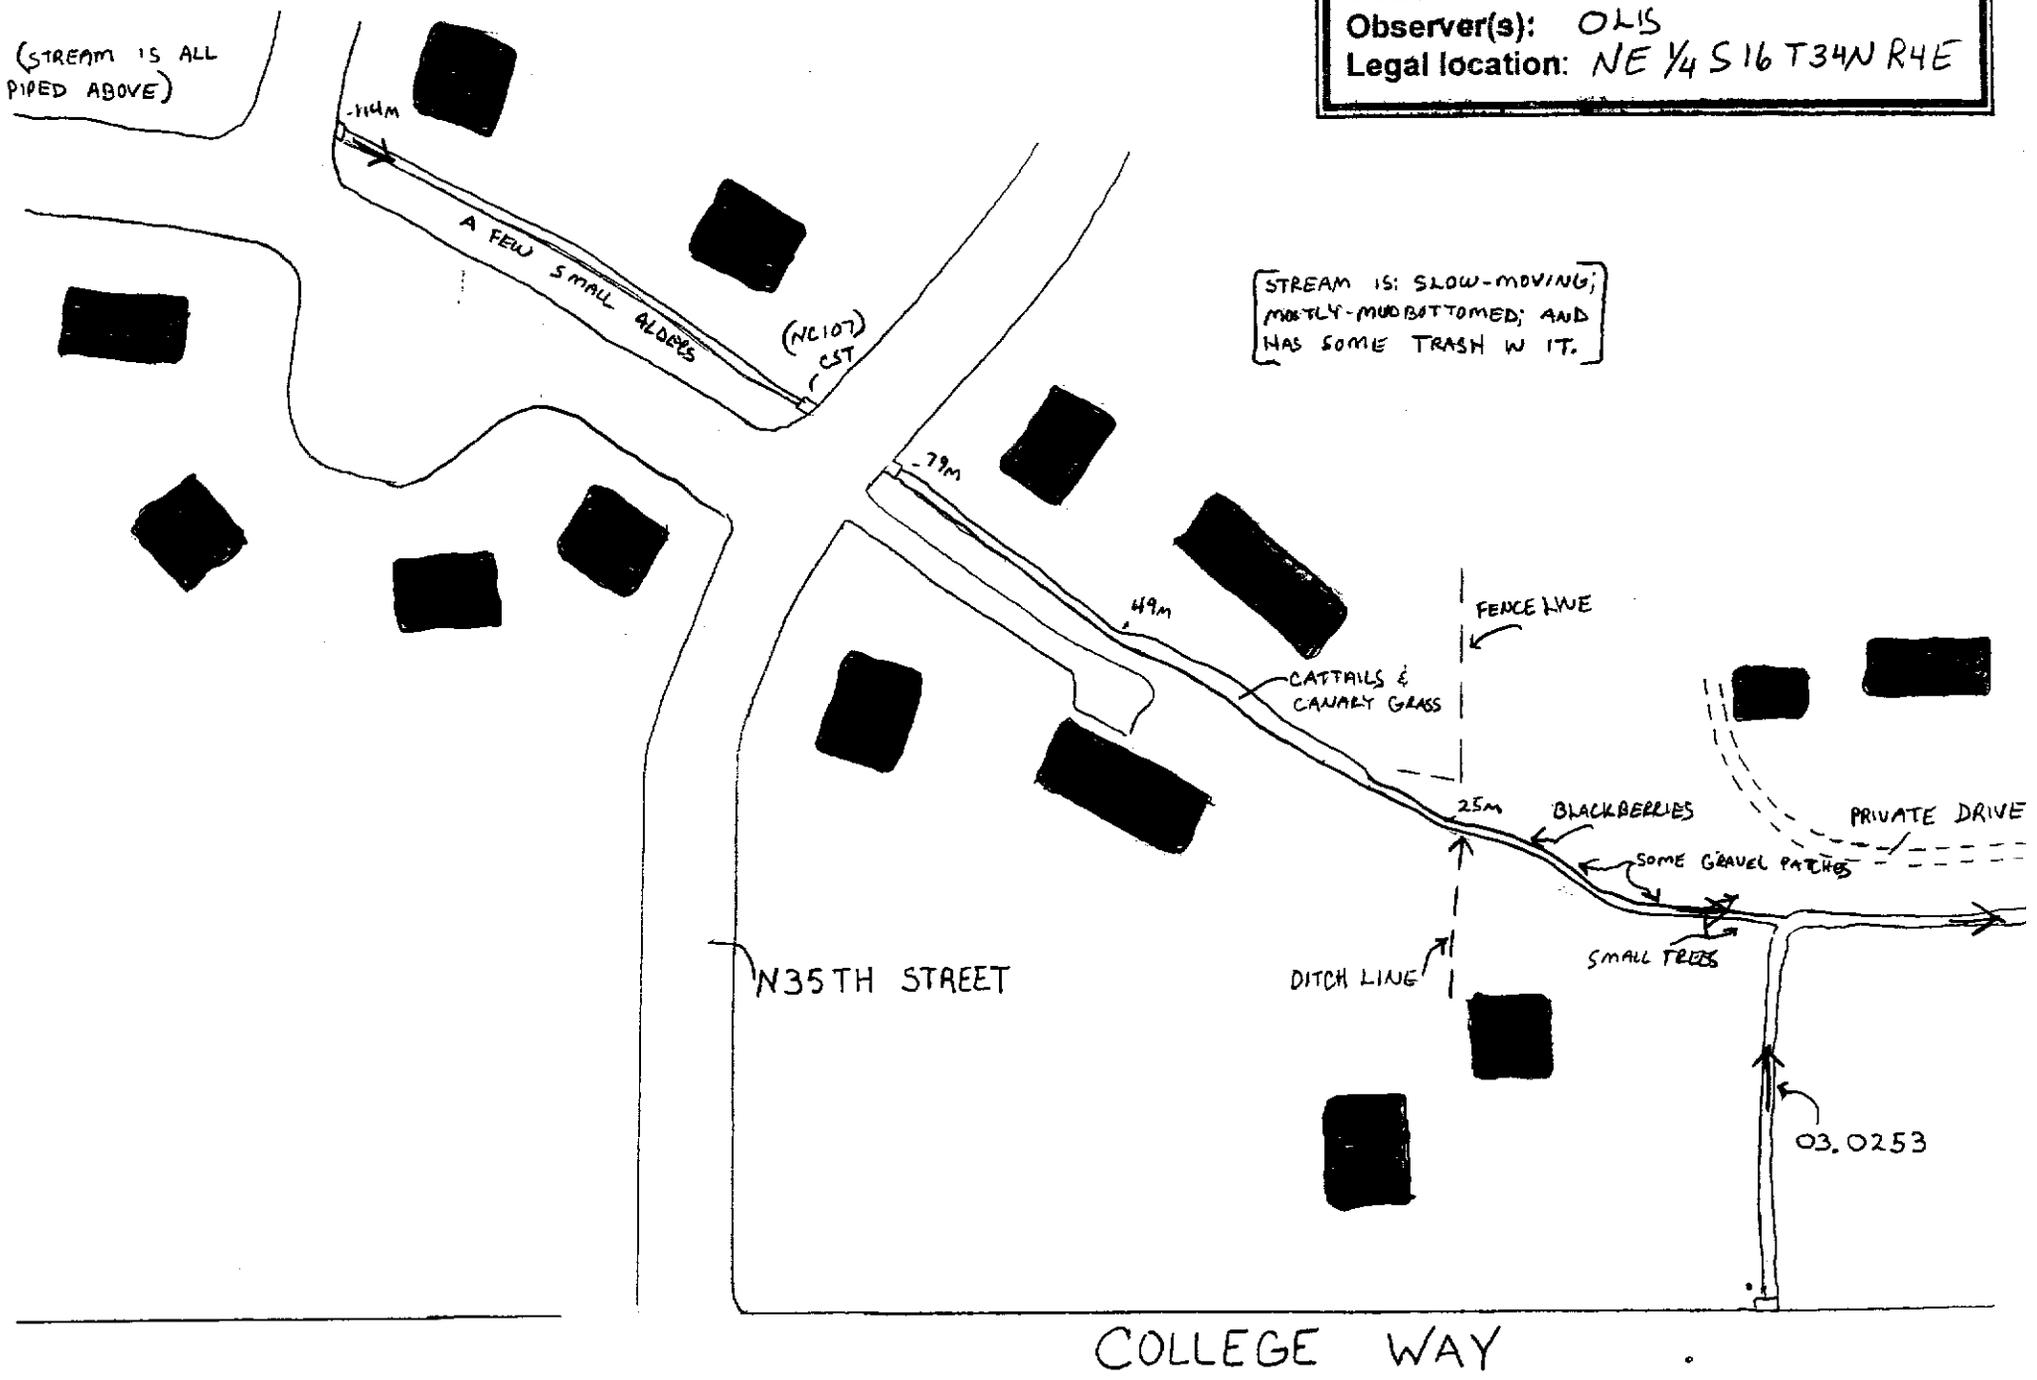
Site id. code: WN1LB3
 Site name:
 Scale: 1" = 12M
 Observer(s): OLS
 Legal location: NE 1/4 S16 T34N R4E

(STREAM IS ALL
PIPED ABOVE)

STREAM IS: SLOW-MOVING;
 MOSTLY-MUD-BOTTOMED; AND
 HAS SOME TRASH W IT.

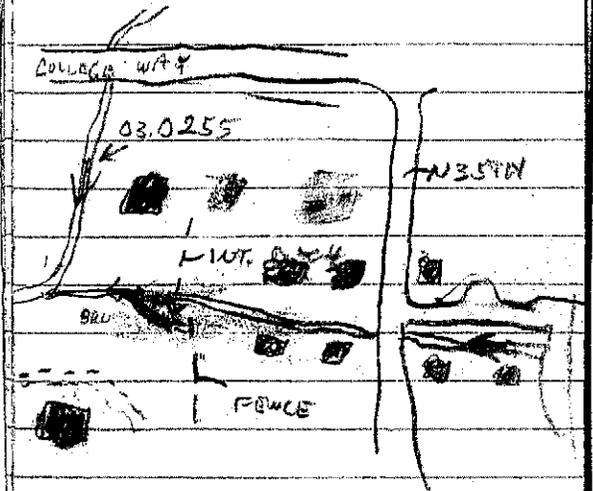
WN1LB3

ACCESS - NICE POOL

25m was 1m

SLOW-MOVING

1/2" GR/ MUD SUBSTR.

- GOOD COVER FLOW

40m was 1.5

79m ww 1m

114m ww 0.8m

- RIP RAP W/ STREAM

- SOME GRAVEL BUT
DOES NOT LOOK LIKE
SPAWNING HAB.

- POOR WATER QUALITY

- RECEIVES LOTS OF
ROAD RUNOFF

- WATER LOOKS CLOUDY
