**HABITAT PROGRAM
TECHNICAL APPLICATIONS DIVISION**

**Sunnyside Wildlife Area Fish Passage Barrier and Fish Screen Scoping and
Correction Report**

December 6, 2006

By Alex Uber

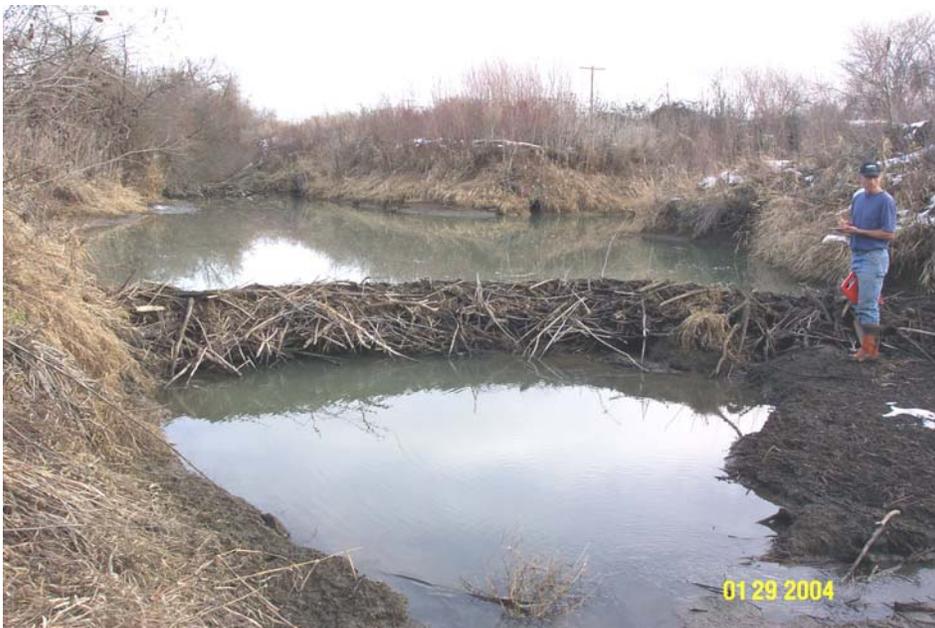
Photo 1: Wendell-Phillips Canal (DID 7) between sites 981382 and 981380, within the Sunnyside Wildlife Area.

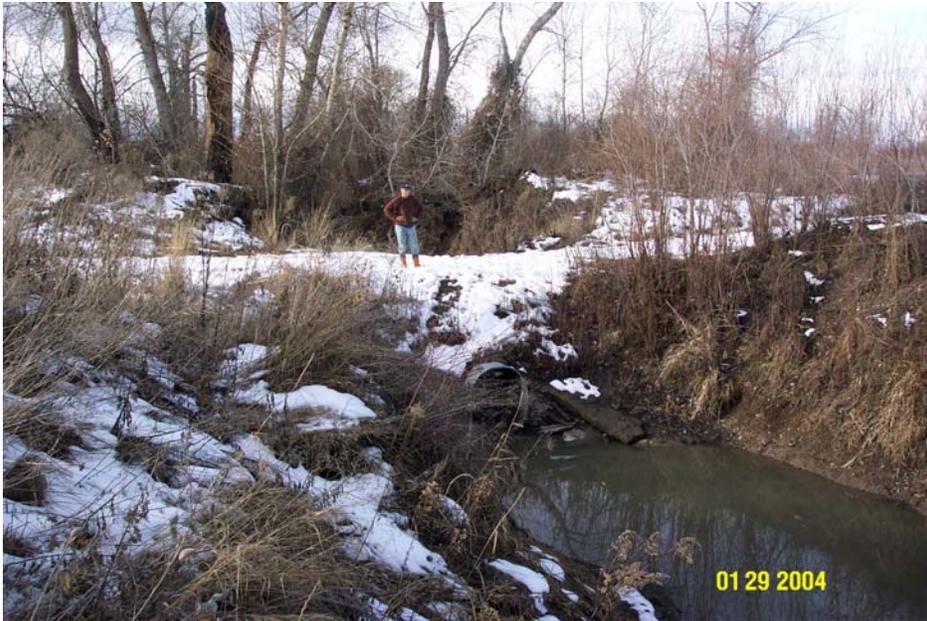
Sites 981378, 981380 and 981382 are located within 850 meters of the confluence with the Yakima River and are the downstream-most features on the DID 7 canal (Figure 2). Site 981382 is an agricultural access road crossing located 78 meters upstream of the confluence with the Yakima River. Site 981380, is a diversion dam located 823 meters upstream of the confluence. Site 981378 is a diversion pump, located 838 meters upstream of the confluence, which is used to divert water out of the DID 7 canal and into an adjacent wetland for waterfowl habitat enhancement.

Following discussions with Region 3 personnel and review of water quality assessment efforts upstream of the SWA on the DID 7 canal, it was agreed that removal of the access road culvert (Site 981382) held potential benefit to rearing juvenile salmonids, originating from the mainstem Yakima River. However, the potential detrimental effects on fish, if allowed access above the dam (site 981380) and into the upper reaches of the DID 7 canal was identified as a concern in light of current degraded water quality, habitat conditions, and fluctuating flows. The SWAFR reported that 5611 m² of physical rearing habitat, and no spawning habitat, exists upstream of site 981382.

Photo 2. Site 981382, prior to access road crossing removal.

In September 2004, after permits were obtained from appropriate agencies, the culvert and associated road fill at site 981382 was removed from the canal prism by WDFW crews (see photos 2 and 3).

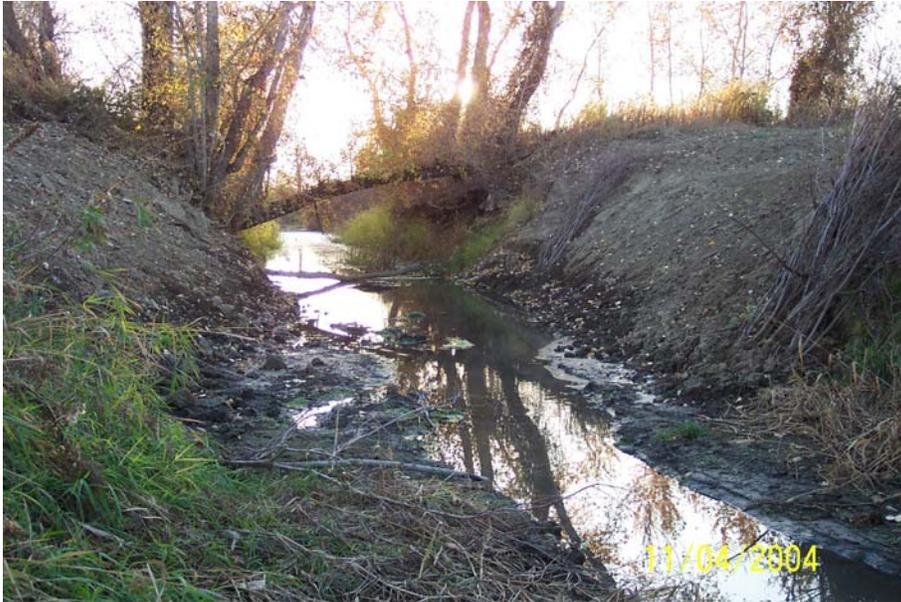
Photo 3: Site 981382 following culvert and road fill removal.

While the removal of the culvert barrier at site 981382 on the DID 7 canal provides potential benefit to fish through the restoration of approximately 1,900 m² potential off-channel rearing habitat⁹, it should be viewed as a first step toward improving access to habitat within the DID 7 canal. Until a serious effort is undertaken to achieve an improvement in water and habitat quality on the DID 7 off WDFW-owned lands, removal of the diversion dam at site 981380 will provide little benefit, and could perhaps even be detrimental to salmonids utilizing upstream reaches of the canal. Since the dam at site 981380 remains impassable and fish access from the Yakima River remains blocked, screening of the diversion pump at site 931378 was not pursued.
