Cowlitz Wildlife Area Fish Retrofit

Habitat Program
Salmonid Screening, Habitat Enhancement
and Restoration (SSHEAR) Section

*Washington
Department of*
**FISH and
WILDLIFE**

December 2002

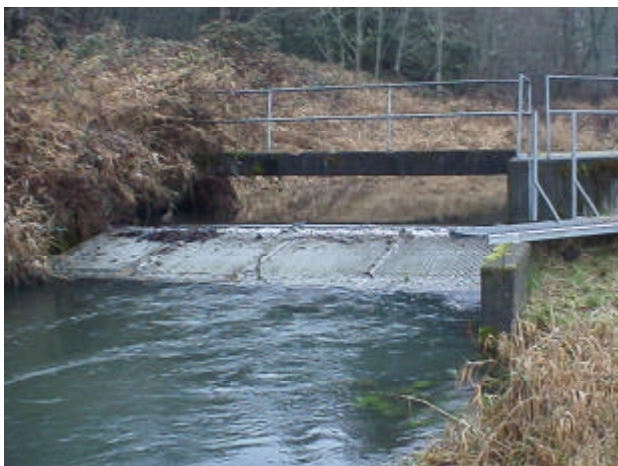
Starting the inventory of Blue Creek at site 981318, there were no features inventoried during the 1,380 meter downstream check to the confluence. Barrier dam site 981318 is equipped with a hatchery rack and a fish ladder to divert fish into the nearby hatchery (Photo 1). With the right flow the right conditions of high flows, adult Steelhead have been occasionally observed passing successfully over this barrier.

Photo 1. Site 981318, Blue Creek (26.0527) tributary to Cowlitz River. View of dam is obscured by the hatchery rack. The Fish ladder entrance is at the left bank. This site is a total barrier.

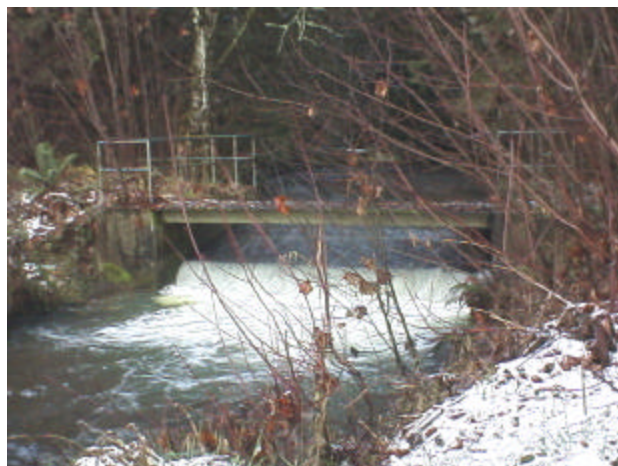
Photo 2. Site 980911, Blue Creek (26.0527) tributary to Cowlitz River. This dam is also equipped with a hatchery rack and is a total barrier to fish passage.

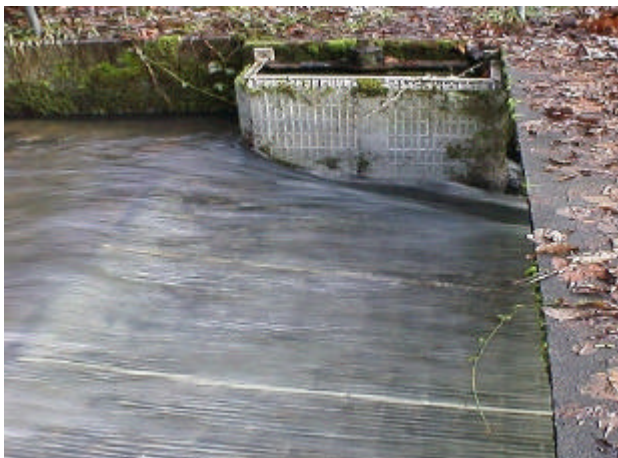
Photo 3. Site 980911 continued. Side view of this site shows the hatchery rack and the gravity diversion intake on the left bank. Because the diversion is no longer in use, the features should be removed.

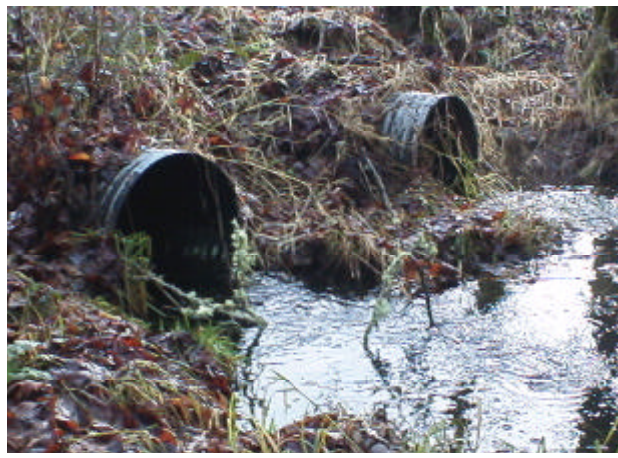
Photo 4. Site 980918, Alexander Creek (26.0528) tributary to Blue Creek. Both culverts at this site have a 3% slope and lack streambed material throughout the inside of the culverts. This site is considered a partial barrier to fish passage due to velocity.

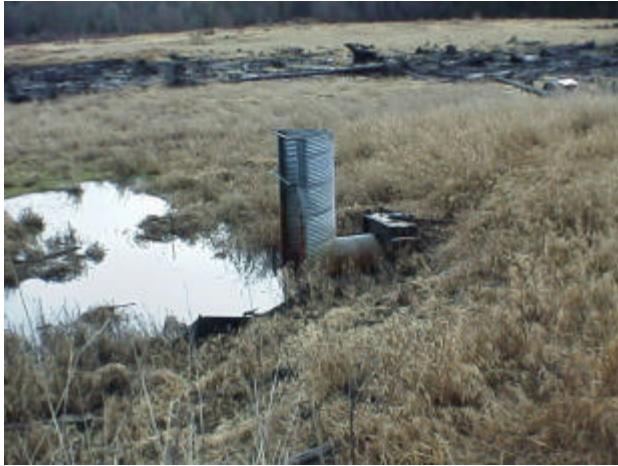
Photo 5. Site 980854, Unnamed pond to Rainey Creek. Developed to enhance waterfowl habitat, this site is influenced by the fluctuating stage of Riffe Lake and the floodplain of Rainey Creek.

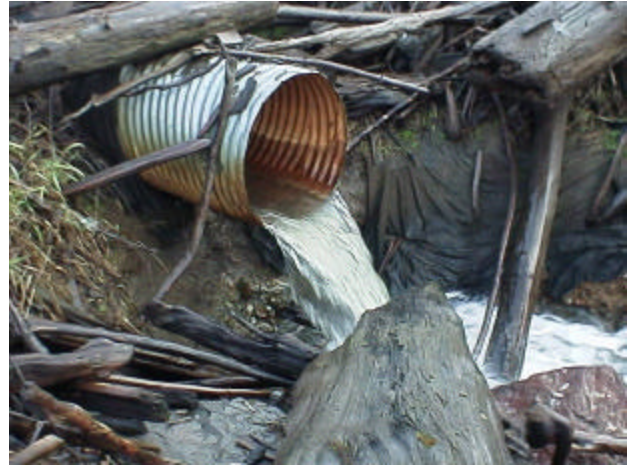
Photo 6. Site 980854 continued. Outlet of pond drains directly into Rainey Creek. No streams feed the pond and only rearing habitat exists upstream. This site is considered a total barrier to fish passage.

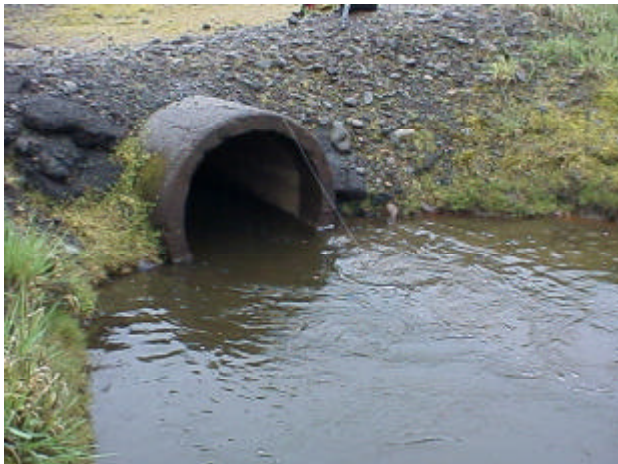
Starting the survey from the confluence with Steffen Creek and within the unit, culverts 981177 and 980852 were evaluated. Washington State Department of Transportation culvert 992113 and private culvert 981204 were identified beyond the unit. All features just described are barriers, which require repair. The potential habitat gain associated with this unnamed stream drainage amounts to 591.9 square meters and 3,135.3 square meters of spawning and rearing habitat, respectively.

Photo 7. Site 981177, Unnamed tributary to Steffen Creek. Having greater than 1% slope and no streambed material throughout the culvert, this culvert is considered a partial barrier to fish passage due to velocity. This site becomes inundated by Riffe Lake during the summer recreation season.

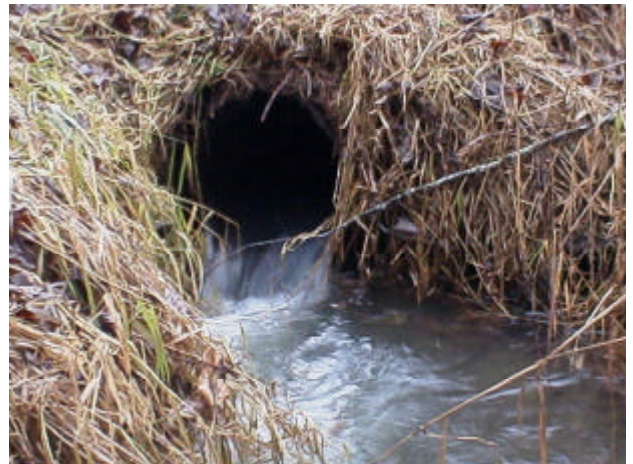
Photo 8. Site 980852, Unnamed tributary to Steffen Creek. Because this culvert is undersized and has 5 % slope, high velocities create a total barrier to fish passage.

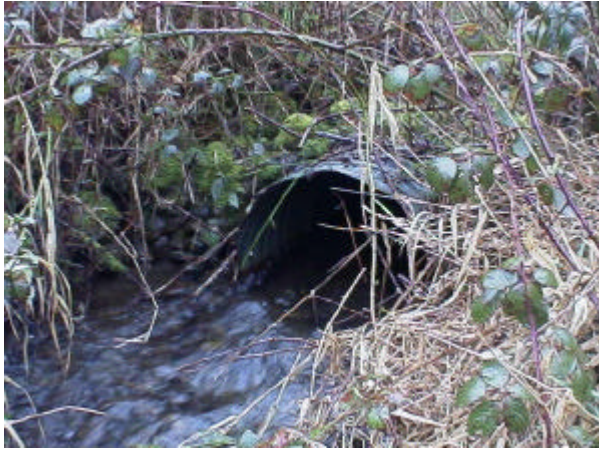
Photo 9. Site 981159, Unnamed tributary to Cowlitz River. This culvert is undersized and set at greater than 1 % slope, creating high velocity flows and a total barrier to fish passage.

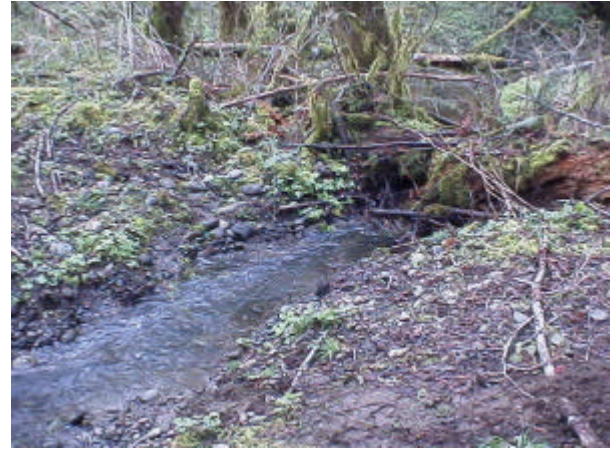
Photo 10. Site 981160, Unnamed tributary to Cowlitz River. This ford crossing creates a partial fish passage barrier due to constricted channel with a hydraulic drop of 0.30 meter at the upstream end.

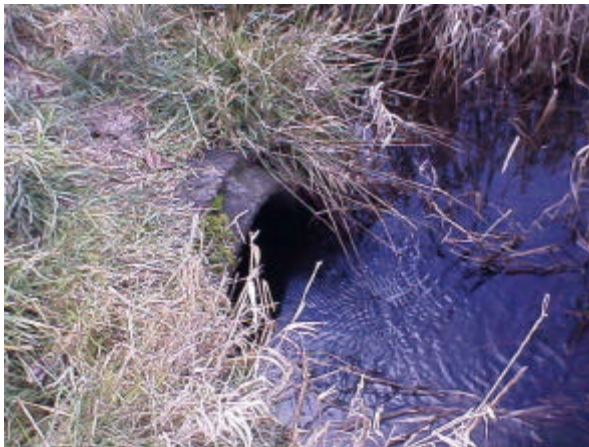
Photo 11. Site 980932, Unnamed tributary to Unnamed tributary to Cowlitz River. Having 1% slope with no streambed material throughout the inside of the culvert, this site is considered a partial barrier to fish passage.

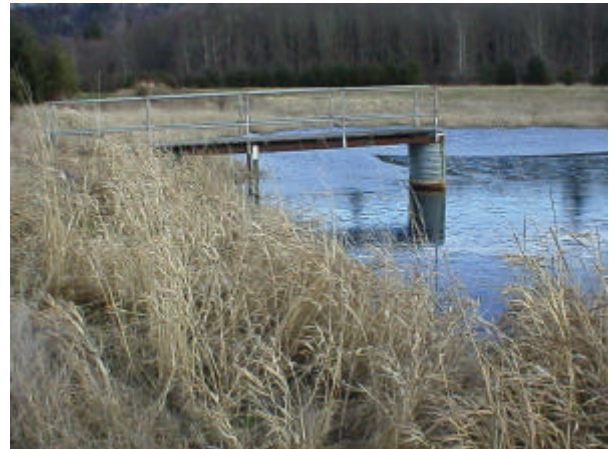
Photo 12. Site 980933, Unnamed tributary to Cowlitz River. Created for waterfowl enhancement, this dam site is a total fish passage barrier.

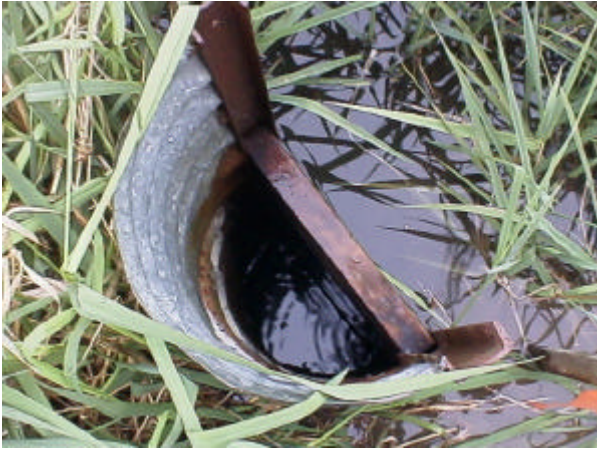
Photo 13. Site 981172, Unnamed tributary to Unnamed tributary to Cowlitz River. Created for waterfowl enhancement, this dam with a water control structure is a complete barrier to fish passage.

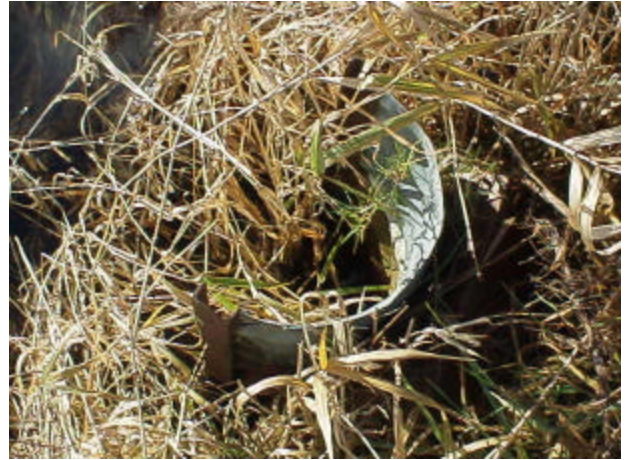
Photo 14. Site 980929, Unnamed tributary to Unnamed tributary to Cowlitz River. This barrier dam (with a water control structure) is located 107 meters upstream of site 981172.

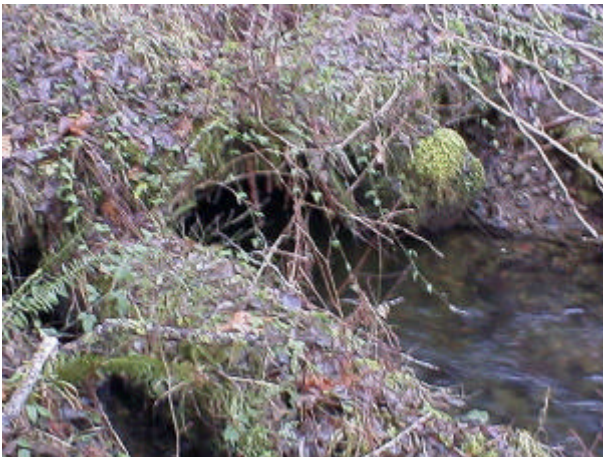
The first human-made structure, a partial barrier culvert (site 980781), was located 2,948 m upstream of the confluence with Riffe Lake. Along with partial barrier culverts 980761 and 980759 located further upstream, these three repair required sites have an overall habitat gain of 3,549.3 square meters and 17,111.3 square meters of spawning and rearing habitat, respectively (downstream).

Photo 15. Site 980781, Shelton Creek (26.0640) tributary to Riffe Lake. This timber-made culvert is considered a partial barrier and may fail over time. Several timber-made culverts within this unit have failed, resulting in flow and passage obstructions.

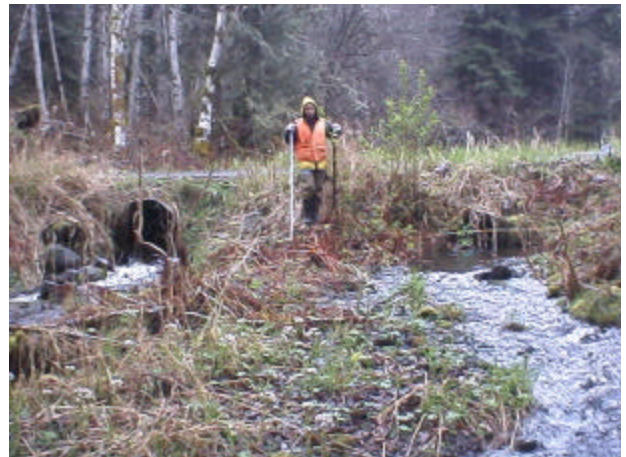
Photo 16. Site 980761, Shelton Creek (26.0640) tributary to Riffe Lake. This double culvert crossing is undersized and a partial barrier to fish passage. The right bank pipe is impassible due to velocity. The left bank pipe becomes a velocity barrier during high flows.

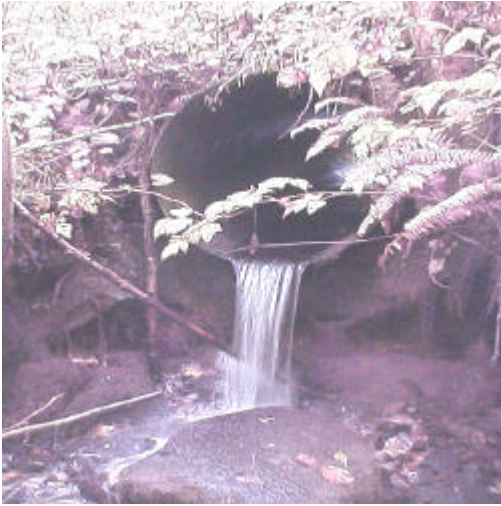
Photo 17. Site 981294, Shelton Creek (26.0640) tributary to Riffe Lake. This culvert is a total barrier due to the outfall drop and no plunge pool. Because the culvert is perched and undersize, streambed material passes through rather than settling out.

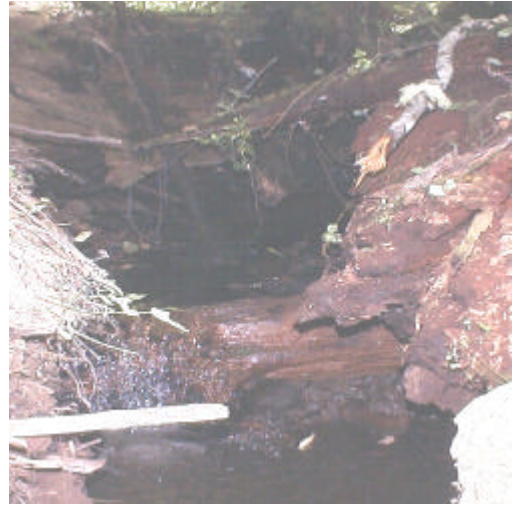
Associated with the private parcel of land described earlier in this discussion are barrier culvert sites 981295 and 981296. Along with barrier culvert 981294, these three barriers will require repair and have an overall habitat gain of 128.2 square meters and 1372.3 square meters of spawning and rearing habitat, respectively (upstream).

Photo 18. Site 981296, Shelton Creek (26.0640) tributary to Riffe Lake. This timber-made culvert has failed. The outfall drop impedes fish passage during low flow periods.

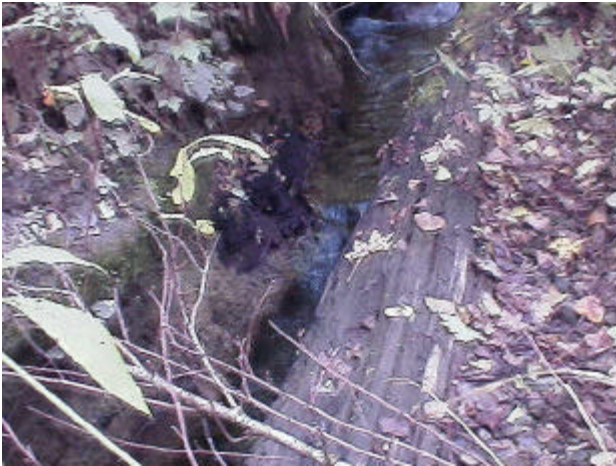
Photo 19. Site 981304, Unnamed tributary to Shelton Creek. The obstructed stream flow caused by this timber made culvert is cutting at the right bank. This is a good view of the large timbers placed parallel within the channel. This site is a partial barrier to fish passage.

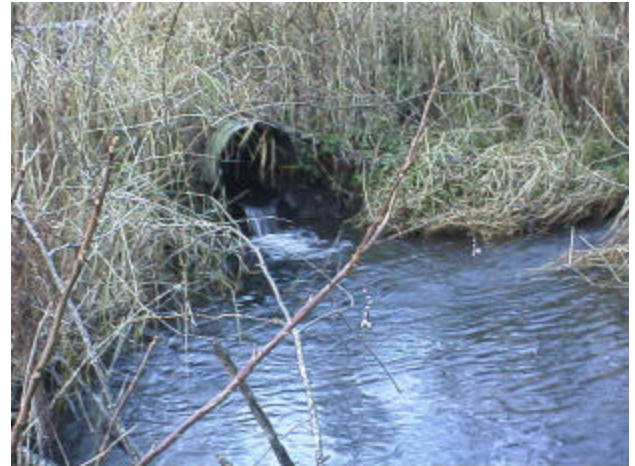
Photo 20. Site 980779, Unnamed tributary to Shelton Creek. Although this site has an overflow pipe, the culvert is undersized and has a 5% slope. This culvert is a total barrier to fish passage.

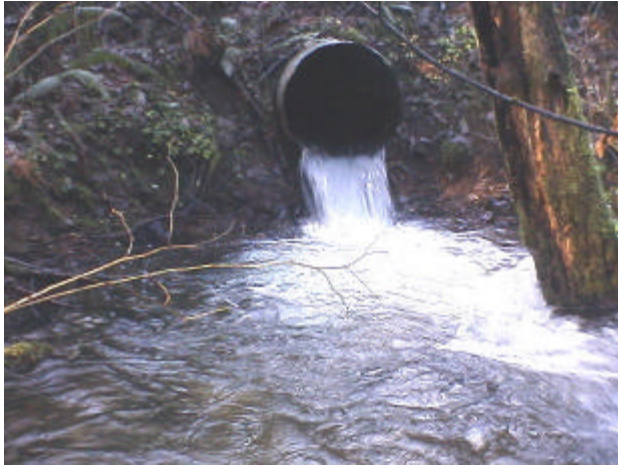
Photo 21. Site 980701, Unnamed tributary to Shelton Creek. This photo depicts two reasons why this culvert is a total fish passage barrier: (1) excessive velocity created by an undersized pipe with a 3% slope, and (2) outfall drop greater than 0.30 meter.

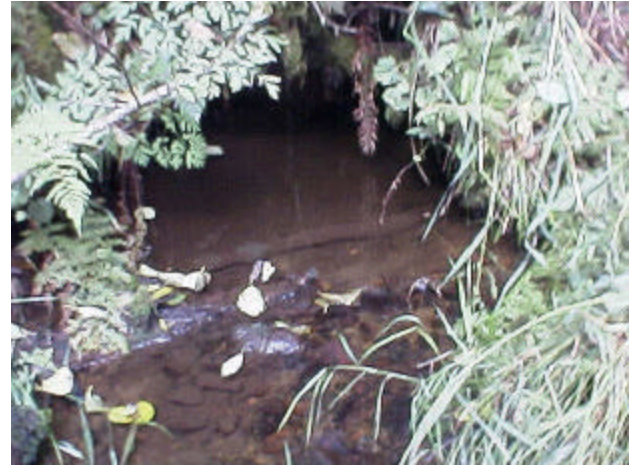
Photo 22. Site 981297, Unnamed tributary to Shelton Creek. Several sections of this timber made culvert have failed. Flow through this structure is obstructed, which partially blocks fish passage.

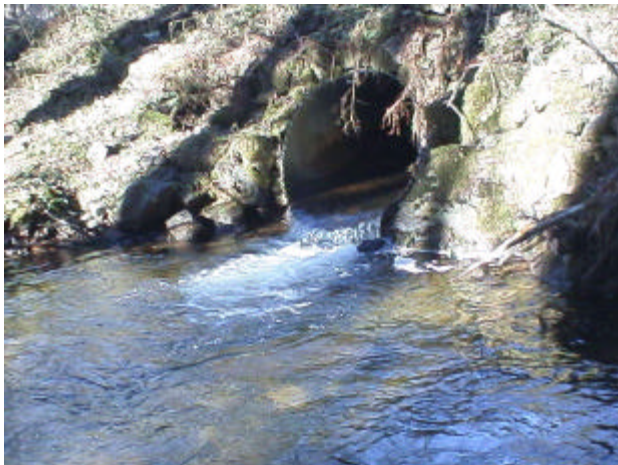
Photo 23. Site 980817, Unnamed tributary (26.0641) to Shelton Creek. This culvert is undersized with greater than 1% slope, posing a velocity barrier to adult and juvenile fish passage, depending on flow conditions.

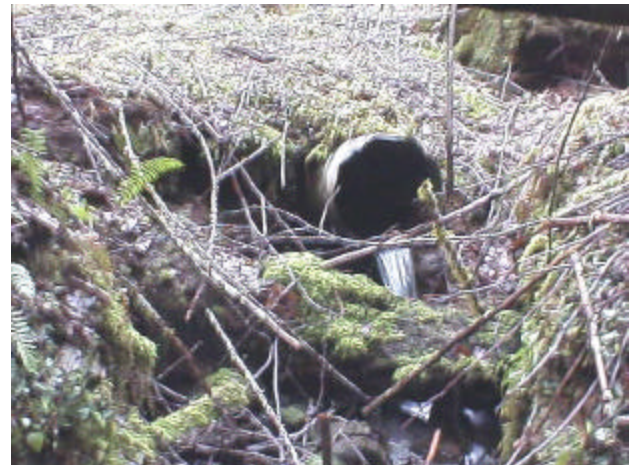
Photo 24. Site 981136, Unnamed tributary to Unnamed tributary (26.0641) to Shelton Creek. A 0.46 meter corrugated steel pipe was added to this clogged timber made culvert crossing. The road prism atop this crossing has failed and is no longer drivable. This site is a total barrier to fish passage.

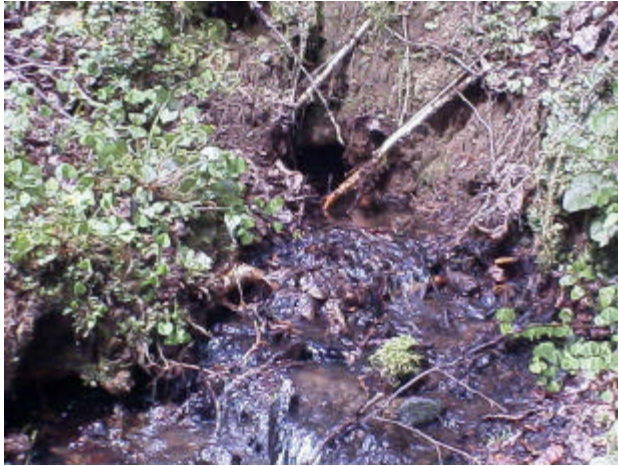
Photo 25. Site 981207. Unnamed tributary to Unnamed tributary (26.0641) to Shelton Creek. This timber-made crossing appears to be mostly clogged and the flow constricted. This site was evaluated as a partial barrier at the time of the survey.

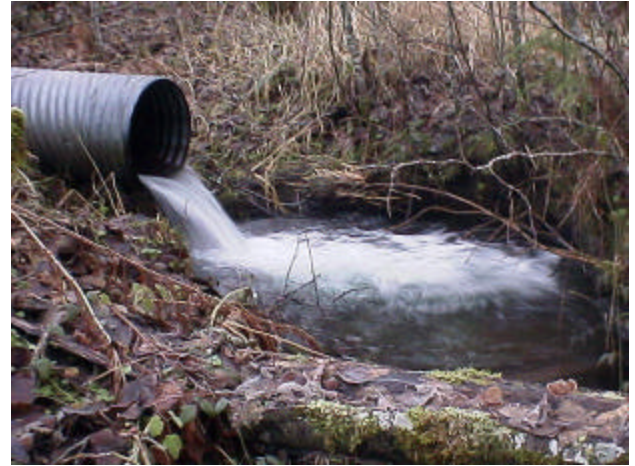
Photo 26. Site 980793, Unnamed tributary to Unnamed tributary (26.0641) to Shelton Creek. This photo illustrates how the installation of an undersized culvert can create obstacles that inhibit fish passage. The velocity and outfall drop impedes fish passage and this culvert is a total barrier.

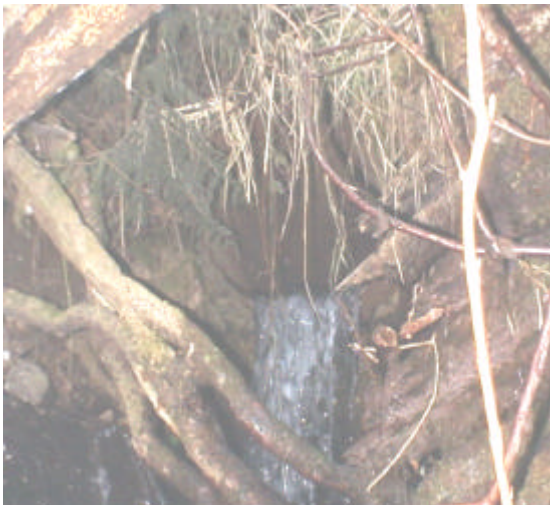
Photo 27. Site 980796, Unnamed tributary to Unnamed tributary (26.0641) to Shelton Creek. With a 1.5 meter outfall drop and a 3% slope, this culvert is a total barrier to fish passage.

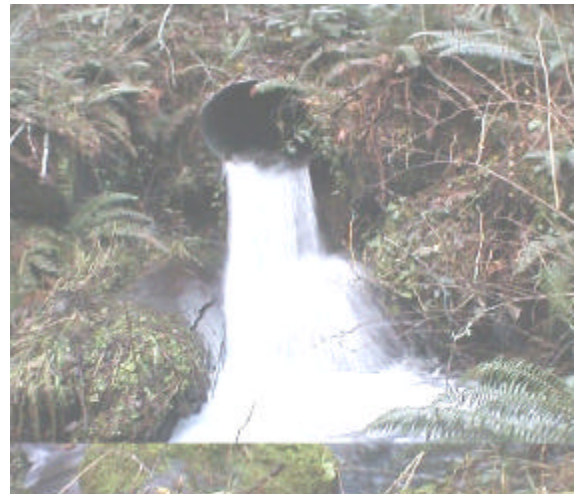
Photo 28. Site 980729, Unnamed tributary to Unnamed tributary (26.0641) to Shelton Creek. Because this culvert is undersized and has a 1.6 meter outfall drop and a 5% slope, it is a total barrier to fish passage.

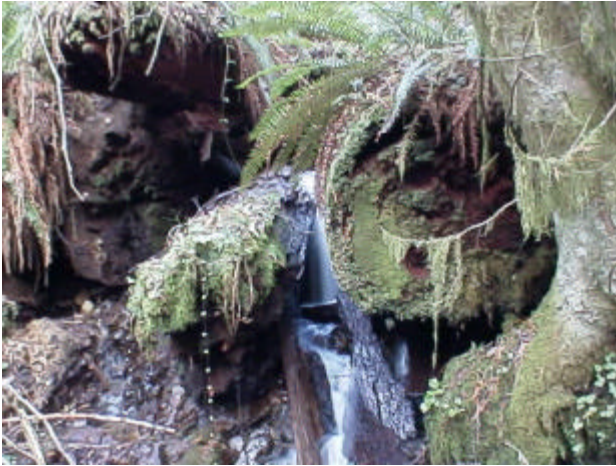
Photo 29. Site 980812. Unnamed tributary to Unnamed tributary (26.0641) to Shelton Creek. Flow and fish passage are completely obstructed through this timber made culvert.

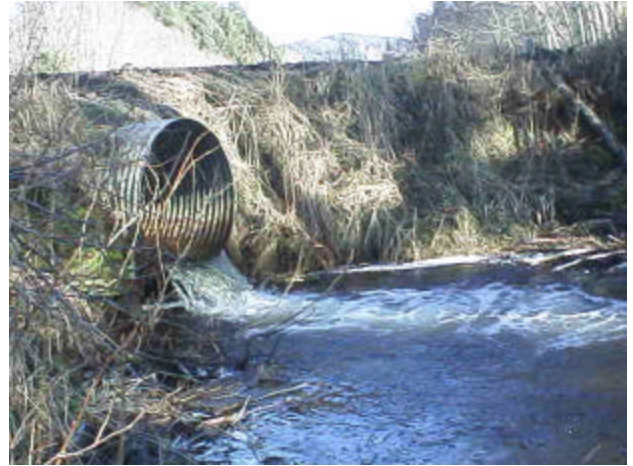
Photo 30. Site 981077, Simmons Creek (26.0631) tributary to Riffe Lake. With large headwater ponds directly upstream, this total barrier culvert blocks fish access to more than 6,300 square meters of quality rearing habitat.

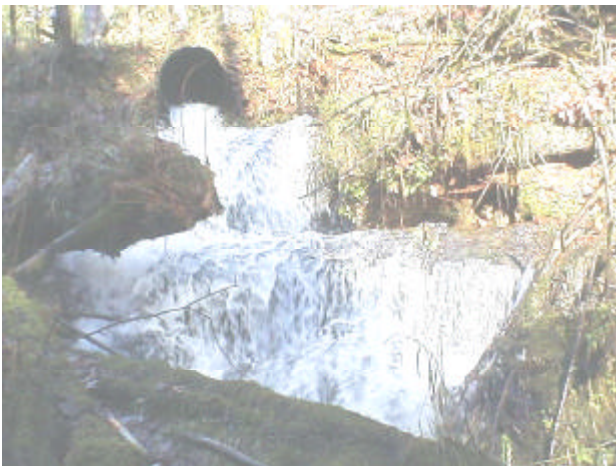
Photo 31. Site 980737, Unnamed tributary to Riffe Lake. While this high gradient stream possesses difficult obstacles for fish movement, the culvert is considered a fish passage barrier due to inadequate size and a 6% slope. There are three additional barrier culverts downstream on DNR property.

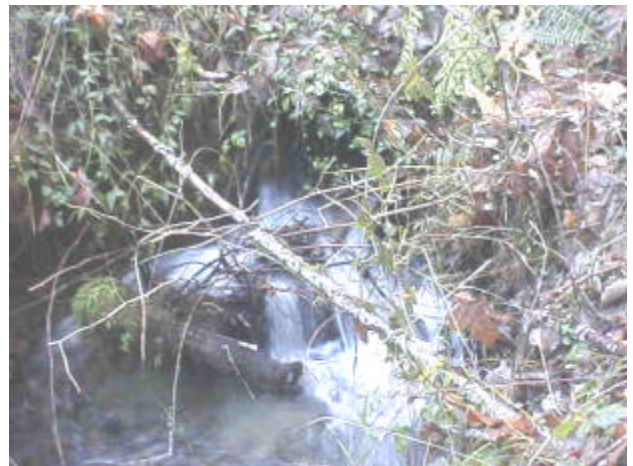
Photo 32. Site 980750, Unnamed tributary to Unnamed tributary to Riffe Lake. Several reasons why this culvert is a total barrier to fish passage include: 2% slope, 0.30 meter outfall drop, and inadequate pipe size constricting the flow causing high velocities.

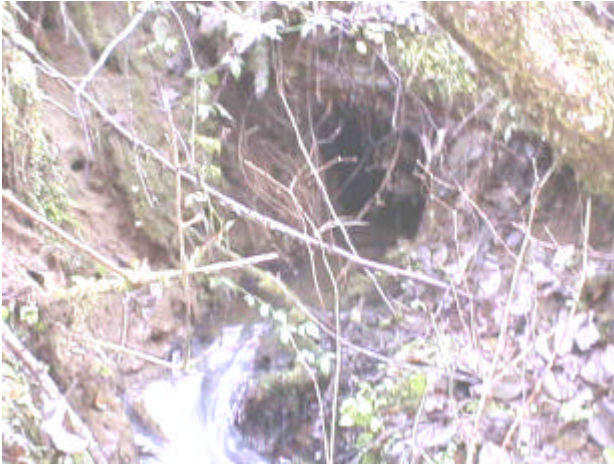
Photo 33. Site 980741. Unnamed tributary to Unnamed tributary to Riffe Lake. This timber-made culvert obstructs the flow and partially blocks fish passage.

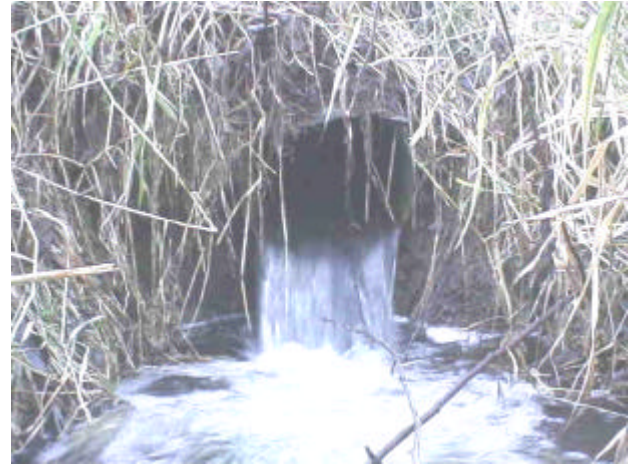
Photo 34. Site 980747, Unnamed tributary to Unnamed tributary to Riffe Lake. This photo illustrates an undersized culvert with slope greater than 1% and severe outfall drop creating a barrier to juvenile and adult salmonids.

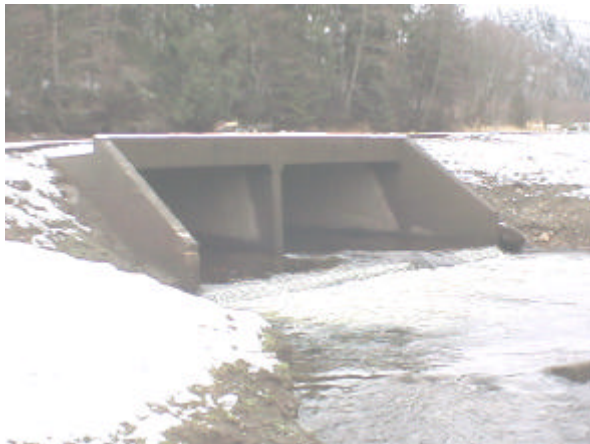
Photo 35. Site 980921, Swofford Pond outlet to Riffe Lake. This partial barrier culvert becomes backwatered and passable when the stage of Riffe Lake is raised.

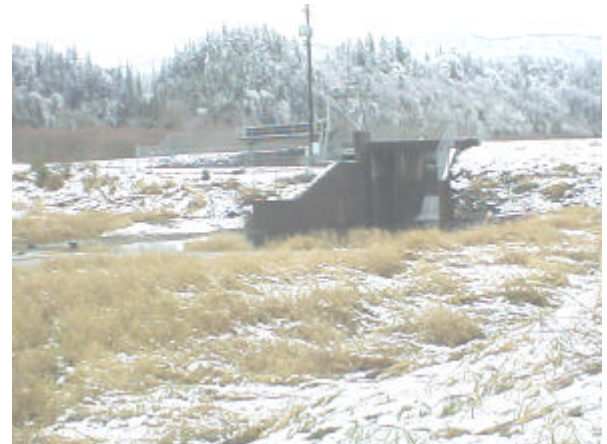
Photo 36. Site 980920, Swofford Pond (Sulphur Creek, 26.0628). Distant view of dam and lake outlet structure. Although this barrier would require repair to pass salmonids, the upstream habitat is more suitable for warm water fish. The current warm water fishery is popular and likely the best choice for this small sub-basin watershed.

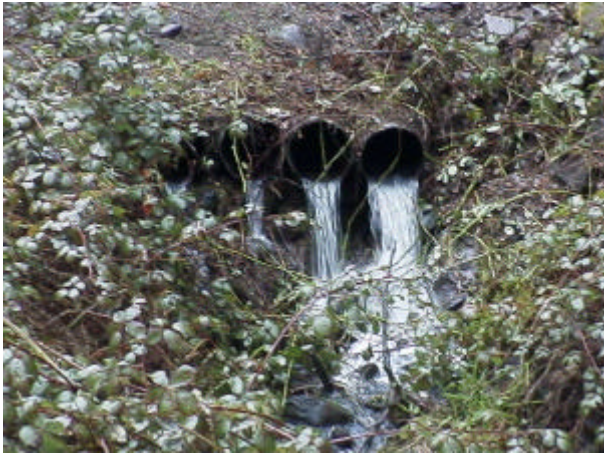
Photo 37. Site 981103, Mayfield North, Unnamed tributary to Mayfield Lake. This culvert crossing is less than 25 meters upstream of the lake. Correcting fish passage of this total barrier will allow anadromous and resident fishes upstream access to approximately 1,046 linear meters of stream.

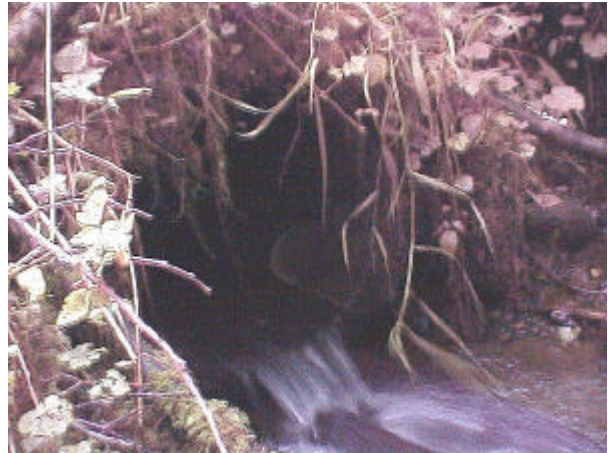
Photo 38. Site 981273, Riffe North, Unnamed tributary to Riffe Lake. Located under an abandoned black top road, this partial barrier culvert is undersized and has a 2% slope.

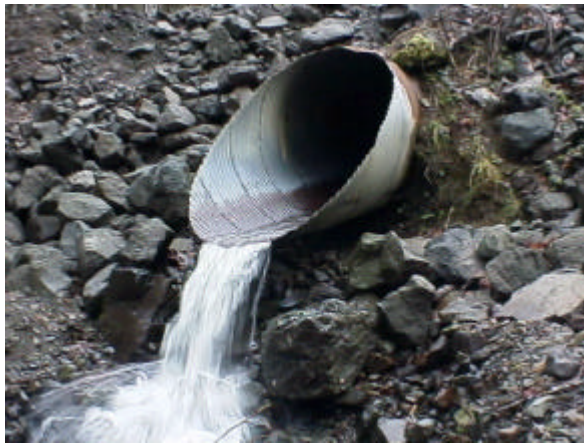
Photo 39. Site 980888, Riffe South, Unnamed tributary to Cowlitz River. This total barrier culvert is the only feature on this fish bearing stream and blocks access to approximately 736 linear meters of stream.

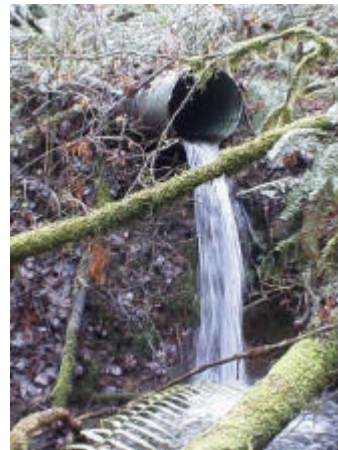
Photo 40. Site 980871, Riffe Lake South, Unnamed tributary to Cowlitz River. This site is a total barrier to fish passage.

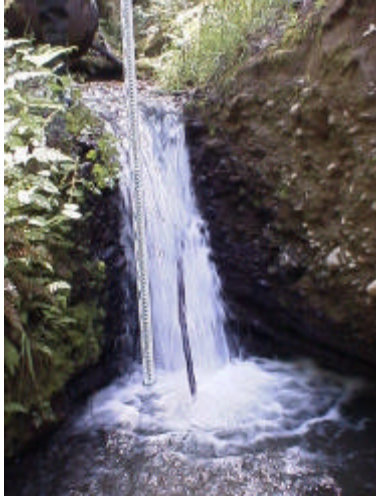
Photo 41. Site 981233, Riffe South, Unnamed tributary to Riffe Lake. This barrier outfall drop is likely the result of the undersized culvert that washed out sometime in the past.

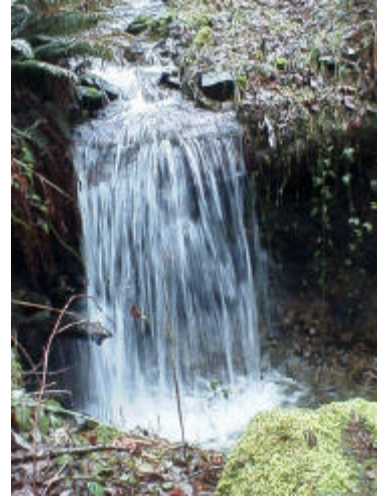
Photo 42. Site 980962, Riffe South, Unnamed tributary to Riffe Lake. This 'Other' site is on an abandoned logging road. Logs were placed across the stream and backfilled with crushed rock to create ford crossing. This is a total barrier due to a 1.9 meter drop.
