Lake Terrell and Tennant Lake Wildlife Area Fish Passage and Diversion Screening Prioritization Inventory

Habitat Program
Technical Applications Division
Habitat and Passage Projects Section

Washington
Department of
Fish and Wildlife

July 2003

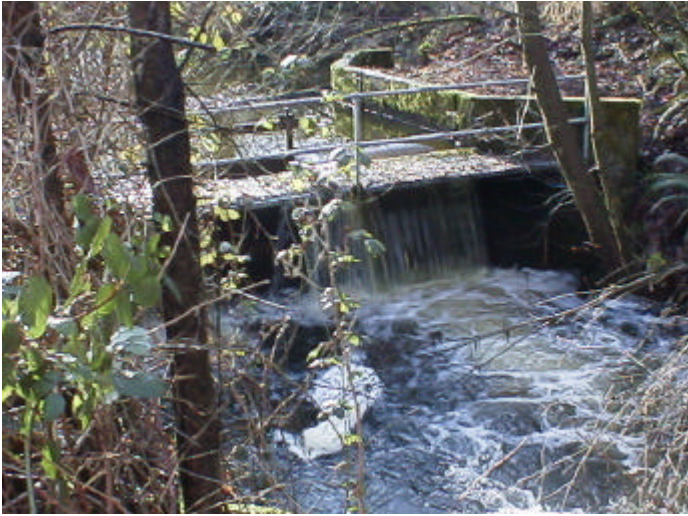
Figure 3. Site 01.0089 8.70, Lake Terrell Dam, is a total barrier to fish passage. Within the WLA, this is the only barrier on Terrell Creek. This dam blocks access to 8.3 km (5.2 miles) of stream habitat. The PI value for this barrier is 43.97.

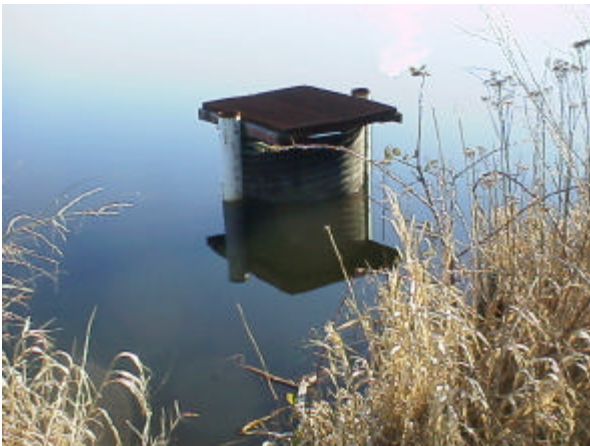
Figure 4. Site 981798 features an earthen dam with a vertical standpipe. This total barrier to fish passage blocks access to 2.0 km (1.23 miles) of stream containing 0 square meters of spawning habitat and 16,841 square meters of rearing habitat. The PI for this barrier is 23.65.

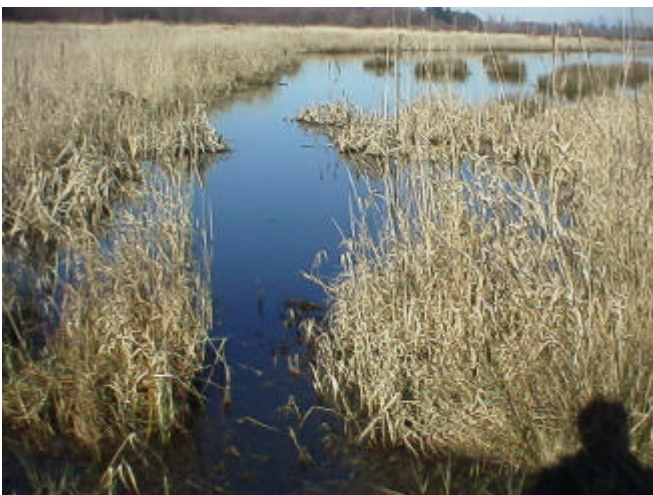
Figure 5. This photo shows a portion of the pond created by the previous feature, site 981798, and is typical of all the waterfowl ponds created. The photo, taken from site 981797 at Mt View Road, is owned by Whatcom County. It consists of a totally submerged culvert that is a partial barrier due to a 1.16% slope. The PI value for this barrier is 16.68.

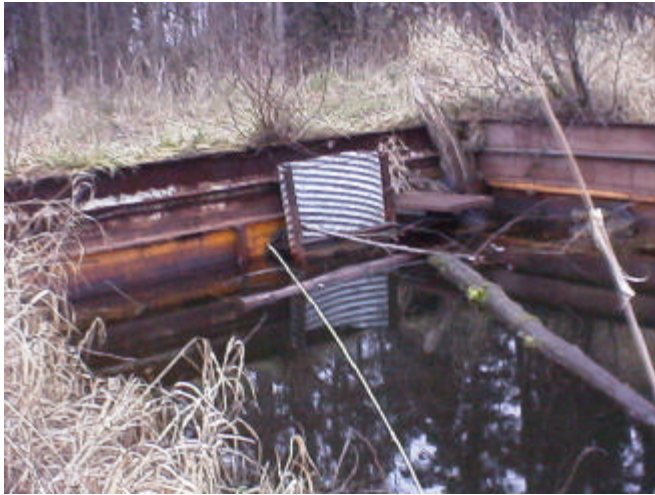
Figure 7. Site 981786 features an earthen dam with a headgate on a culvert. This total barrier to fish passage blocks access to 1.14 km (0.71 miles) of stream containing 12,396 square meters of rearing habitat. The PI value for this barrier is 21.91.

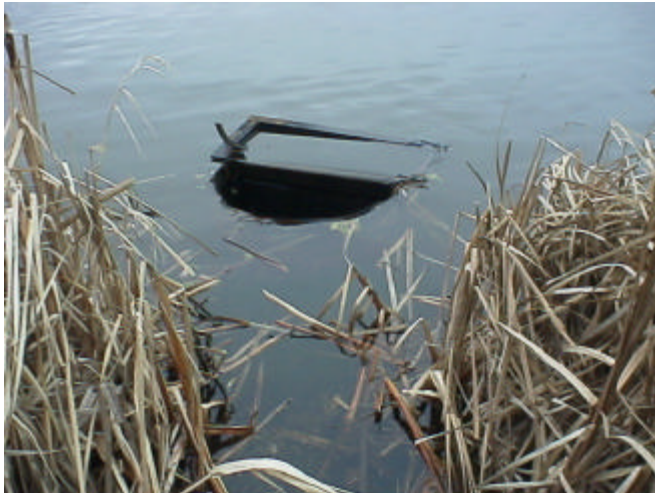
Figure 8. Site 981785 consists of an earthen dam with a standpipe. This total barrier to fish passage blocks access to 0.50 km (0.31 miles) of stream containing 6,081 square meters of rearing habitat. The PI value for this barrier is 18.33.

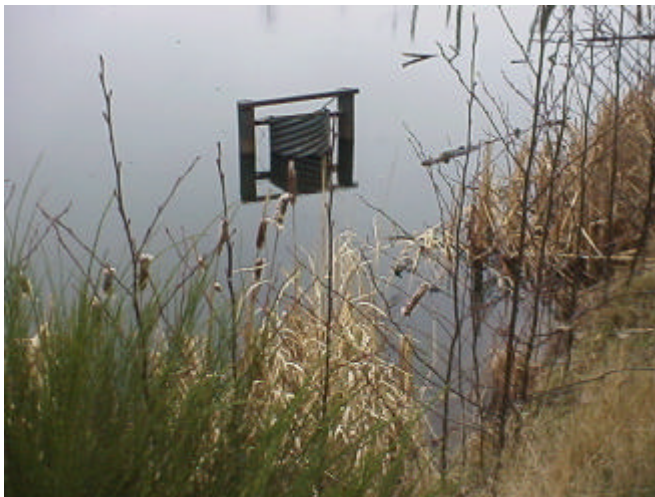
Figure 9. Site 981780, features an earthen dam with a vertical standpipe. This total barrier to fish passage blocks access to 0.26 km (0.16 miles) of stream containing 2,893 square meters of rearing habitat. The PI value for this barrier is 15.23.

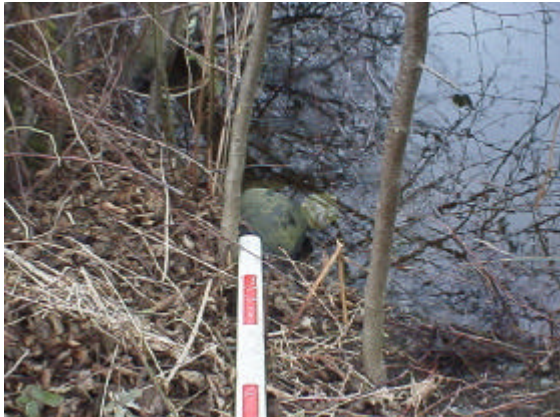
Figure 10. Site 981781. An earthen dam with a 0.21 meter overflow culvert creates a small pond. The pond has 1,219 square meters of potential rearing habitat. The PI value for this barrier is 3.48. The tip of the meter rod points to the overflow culvert.

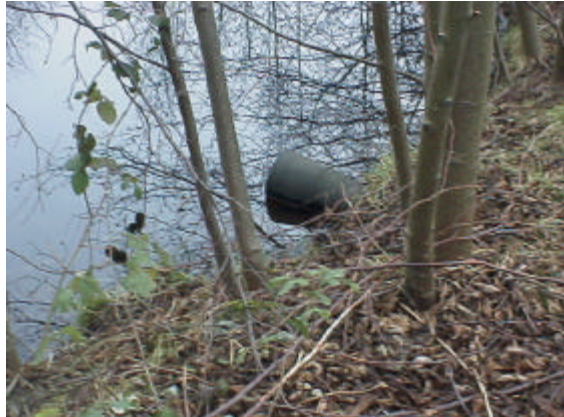
Figure 11. Site 981783. An earthen dam with a 0.21 meter overflow culvert creates a small isolated pond. The pond has 788 square meters of potential rearing habitat. The PI value for this total barrier is 3.12.

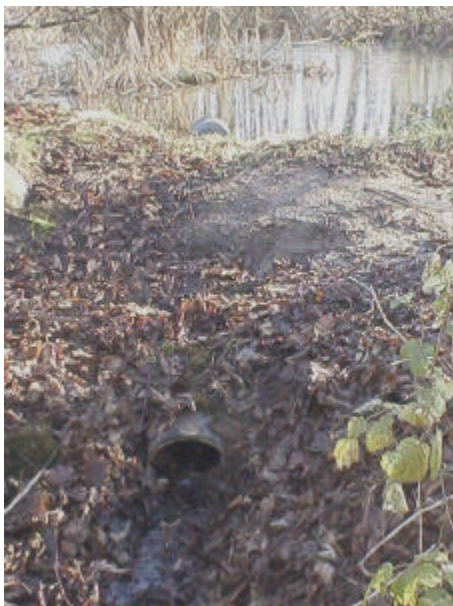
Figure 12. Site 981787. An earthen dam with a small (0.21m) overflow culvert creates a small isolated pond. The pond has 1,126 square meters of potential rearing habitat. The PI value for this total barrier is 3.41.

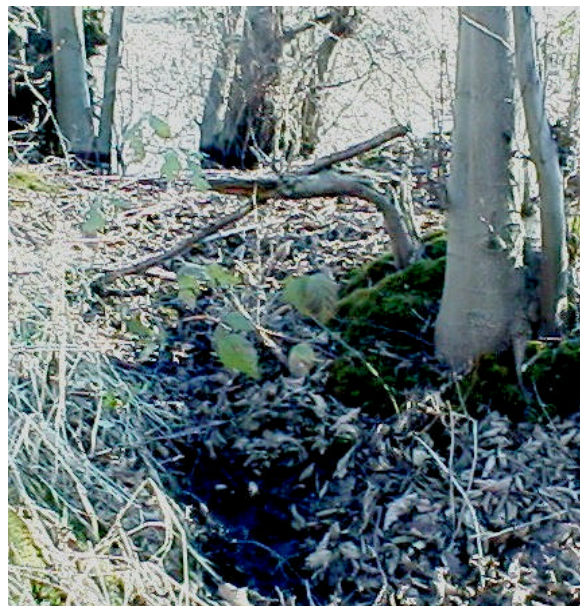
Figure 13. Site 981796. An earthen dam with a spillway. Pond water spills over the top of the earth dam into an overflow channel. Rarely, if ever, is there enough flow for fish to use the channel. The pond has 1,407 square meters of potential rearing habitat. The PI for this total barrier is 3.61.

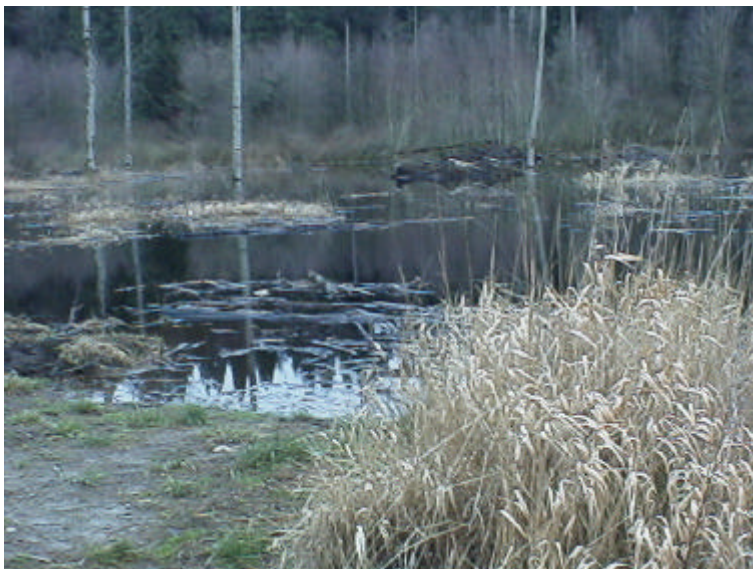
Figure 14. Site 981779 features an earth dam with a vertical standpipe to control water level. The photo shows a small portion of the earth dam at the bottom left and the pond created by the dam. The dam is a total barrier to fish passage. Fish use of the pond is likely limited to winter rearing due to high water temperature in summer. The pond has 3,364 square meters of potential rearing habitat. The PI value is 15.82.

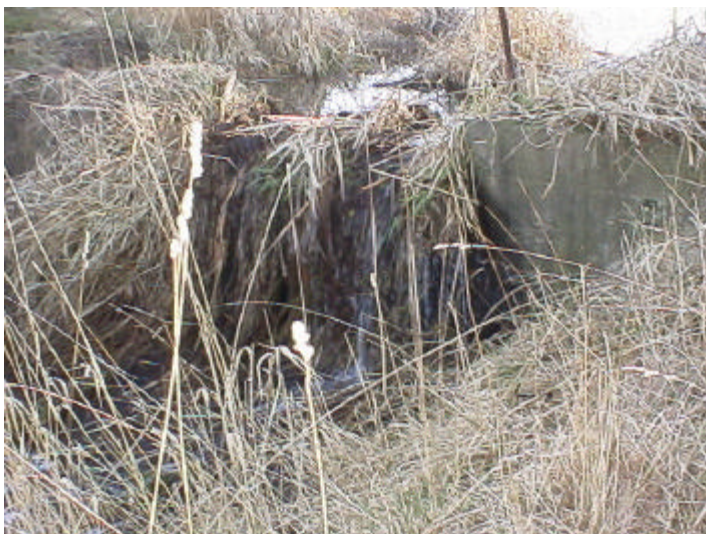
Figure 15. Site 981792. This concrete dam is just upstream of the confluence with Terrell Cr. Water spilling over the dam falls 0.90 meters onto a concrete apron. There is 4,084 square meters of potential rearing habitat upstream. This barrier has a PI value of 16.60.

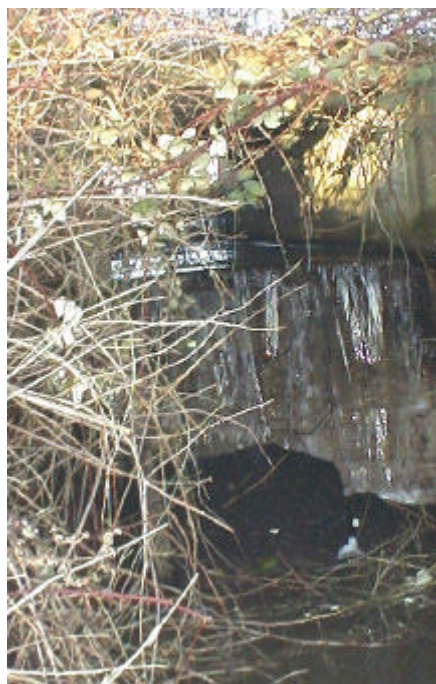
Figure 16. Site 981793. This site has an earthen dam with a concrete spillway and slots for stop boards. The spillway has a 1.54 meter outfall drop. There is 2,613 square meters of potential rearing habitat upstream. The PI value is 14.85.

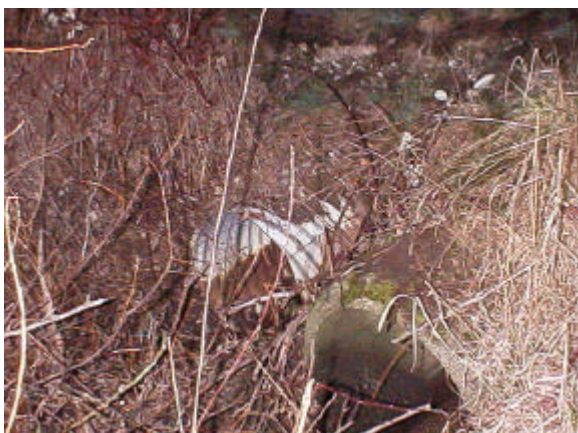
Figure 18. Site 981794. The two culverts at this site, a corrugated steel and a concrete pipe are a barrier to fish passage. This limited habitat gain site has only 179m of fish bearing stream upstream of this barrier. At 179 meters upstream, the stream flows through reed canary grass with no defined channel. The PI value is 6.85.

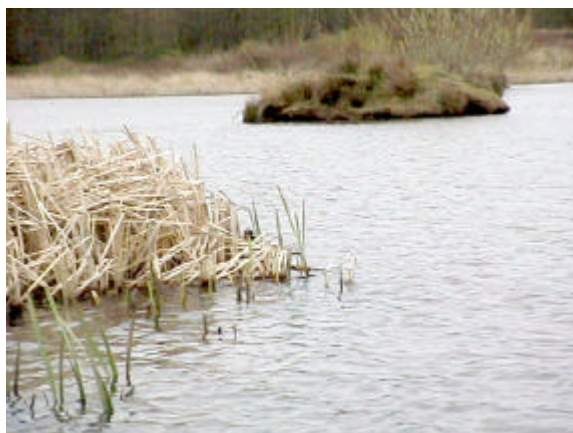
Figure 19. Site 981821 features an earth dam with a vertical standpipe (hidden behind cattails). This pond could provide 5,368 square meters of rearing habitat. The PI value is 4.56.

Sites 981821, 981822 and 981823 are upstream of the previous sites but are inaccessible due to a lack of a defined channel that could be utilized by fish. The flow spreads out and trickles through dense reed canary grass. BP is currently trying to control the reed canary grass. Dams further upstream prevent sufficient flow to maintain a channel. Should a channel be restored, substantial pond habitat exists upstream.

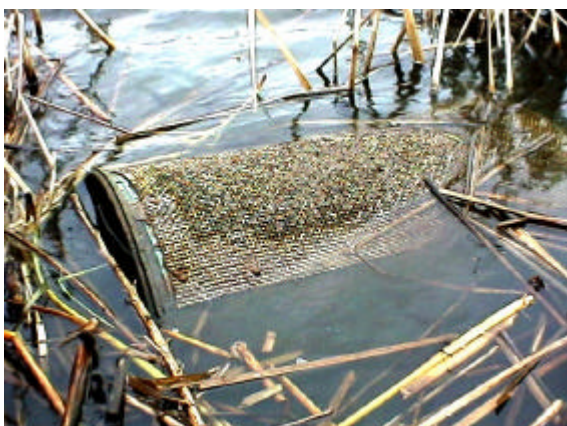
Figure 20. Site 981822 has a screened pump diversion, located in the pond created by site 981821. The screen is not compliant due to the size of the screen openings. This pump diversion supplies water during summer and fall to newly planted trees on the BP mitigation project about 250 meters to the north. No PI value could be generated because the pump was not present at the time of the evaluation.

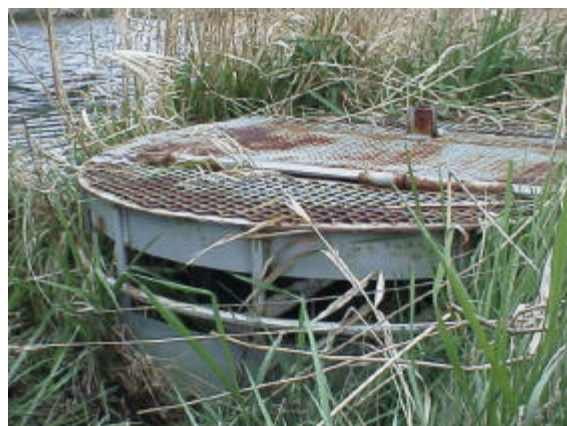
Figure 21. Site 981823 is an earth dam with a flow control structure in the dam. This pond could provide 2,392 square meters of rearing habitat. The PI value is 4.12.

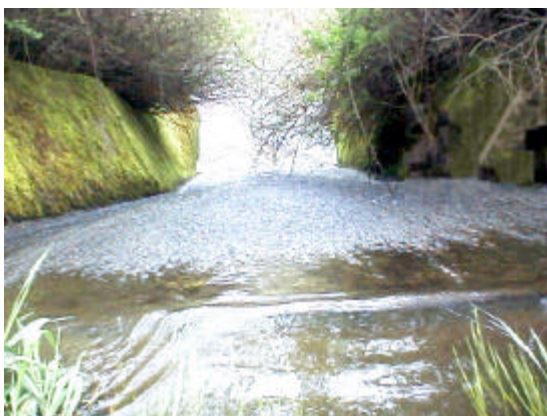
Figure 22. Site 981825 features an earthen dam with a concrete spillway at a 30% slope. This total barrier to fish passage blocks access to 2.5 km (1.57 miles) of stream containing 355 square meters of spawning habitat and 18,203 square meters of rearing habitat. The PI for this barrier is 30.61. This site is on BP land.

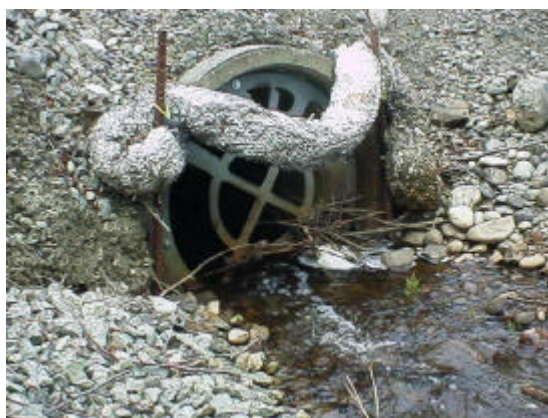
Figure 23. Site 981830, on Jackson Road, is a 0.76 m (2.50 ft) culvert. Because the upstream end is inside a high security area of the BP refinery there is a security grate installed. The worm-like mesh bag is a pollution control device. This culvert is a partial barrier due to a 2.26% slope and the PI value is 11.98. This site is owned by Whatcom County.

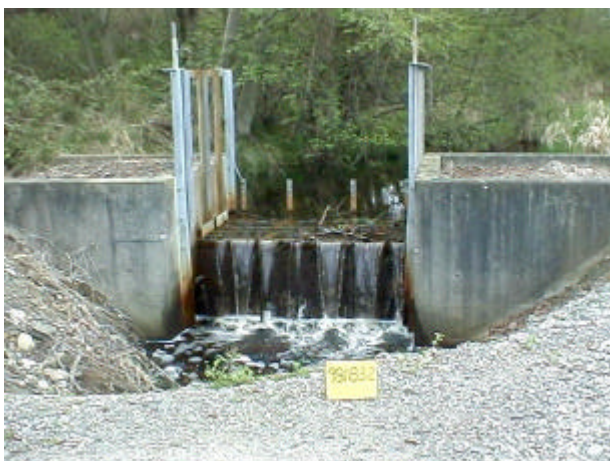
Figure 24. Immediately upstream of site 981830 is site 981832, which is a pollution control device consisting of hay bales inside of an expanded wire mesh cage. This feature acts as a dam blocking access to 0.66 km of stream and pond habitat. There is no spawning habitat upstream but there is 3,370 square meters of rearing habitat in beaver ponds and wetlands. The PI for this barrier is 15.82. This site is on BP land.

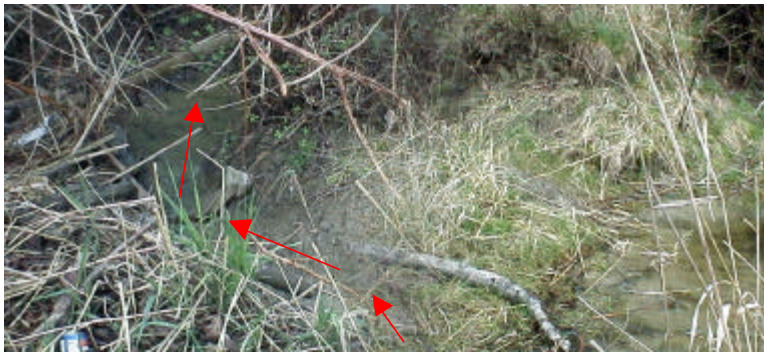
Figure 26. Site 981814 at Claypit Pond. This earthen dam has an overflow channel that empties into Tennant Creek. The photo shows the dam spillway and the direction of the overflow channel. At the outlet of the channel is a culvert that carries some flow but has no apparent function. Claypit pond provides 9,033 square meters of potential rearing habitat. The PI value is 15.33.

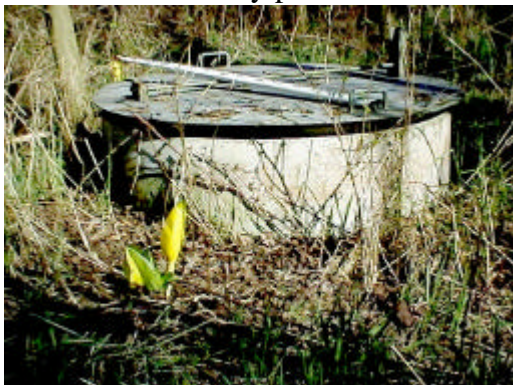
Figure 27. Site 981811. This vertical concrete culvert set in an earthen dam has slots for stop boards inside. Submerged corrugated culverts extend into and out of the vertical culvert up and downstream. There is no discernible flow going through the structure. Beaver dams divert flow around this dam making it passable during high flows. This dam partially blocks access to 14,677 square meters of rearing habitat. The PI value is 17.32.
