**Shillapoo Wildlife Area and Mt. St. Helens Wildlife Area  
Fish Passage and Diversion Screening Prioritization  
Inventory**

Habitat Program  
Technical Applications Division  
Habitat and Passage Projects Section

**June 2003**

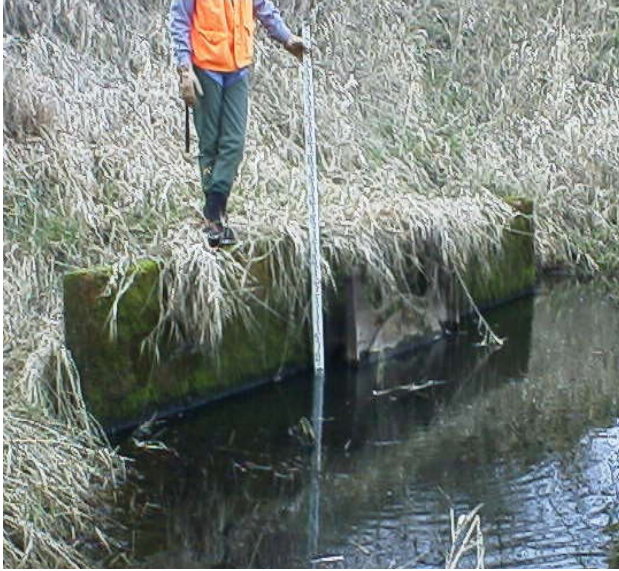
**Figure 6.** Site 981451, Shillapoo Lake to Lake River. This barrier culvert is fitted with a tide gate and has a 2.64% slope. Photo shows inundation from Lake River at high tide.

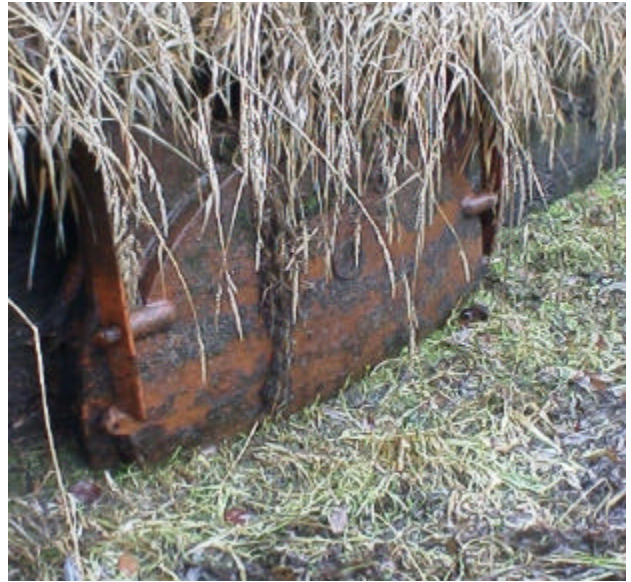
**Figure 7.** Site 981451 continued. Taken at low tide, this photo shows the sedimentation of the tide gate.

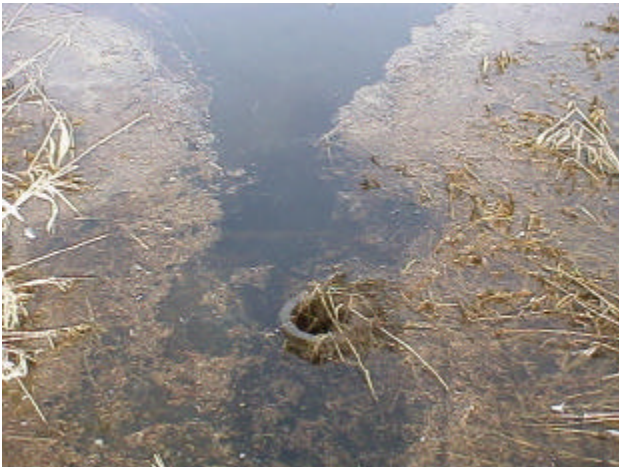
Dam site 981452 was identified about 580 meters due south of 981451 (figure 3). This feature is located at a low point where a natural drainage begins to flow south, through a meandering draw towards the lake bottom. The purpose of the dam is to retain standing water that collects to the north to attract waterfowl. A 0.25 meter culvert, blocked off at the upstream end, and a 0.15 meter standpipe are used as the spillway (figures 8 and 9) and create a total barrier.

**Figure 8.** Site 981452, Shillapoo Lake to Lake River. Upstream view of dam spillway. Plywood is used to block inlet and a small standpipe is used to maintain the level of standing rainwater.

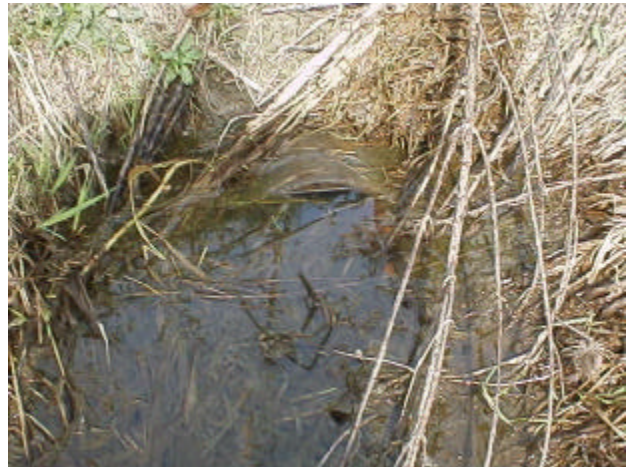
**Figure 9.** Site 981452 continued. Downstream view of spillway. This site is a total barrier.

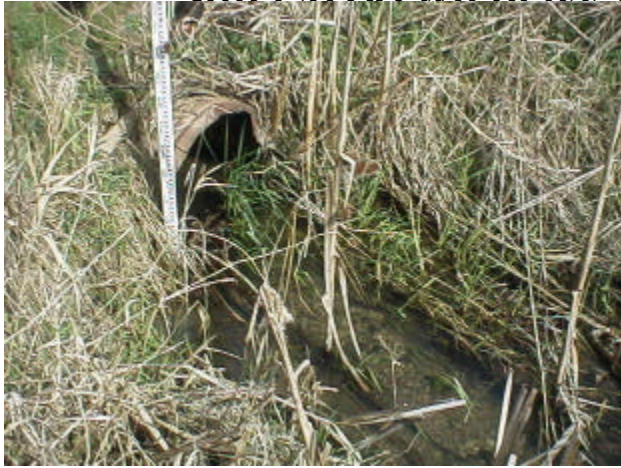
**Figure 10.** Site 981453, Shillapoo Lake to Lake River. This undersized culvert creates a velocity barrier. The culvert is rusted out and the upper section of the pipe is disconnected.

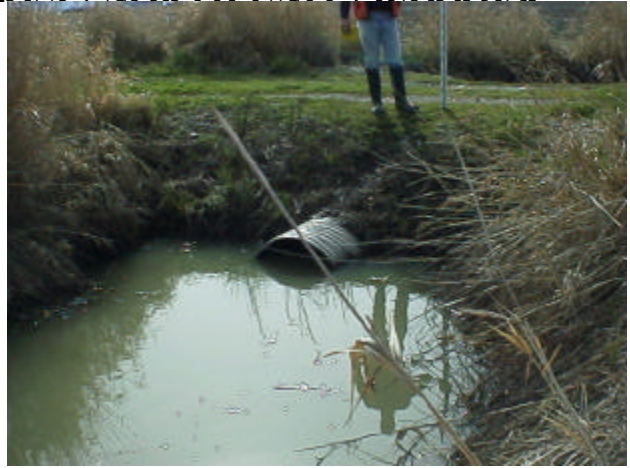
**Figure 11.** Site 981454, Shillapoo Lake to Lake River. Located in a drain canal, this culvert has a 2.39% slope and is a partial barrier.

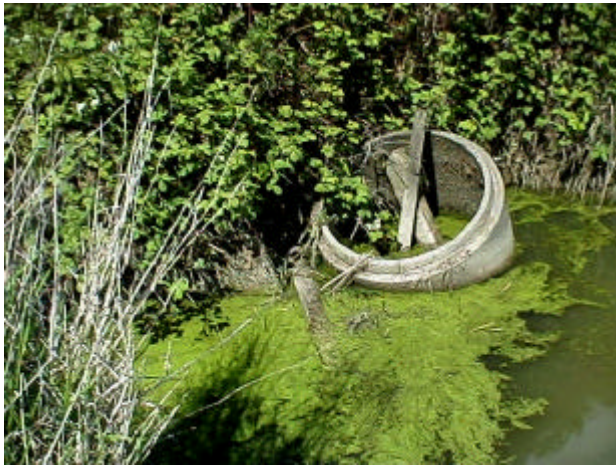
**Figure 12.** Site 981864, Shillapoo Lake to Lake River. Looking at the upstream end, this metal culvert is rusted out, undersized and a partial barrier due to velocity. The larger concrete round may have been dumped there.

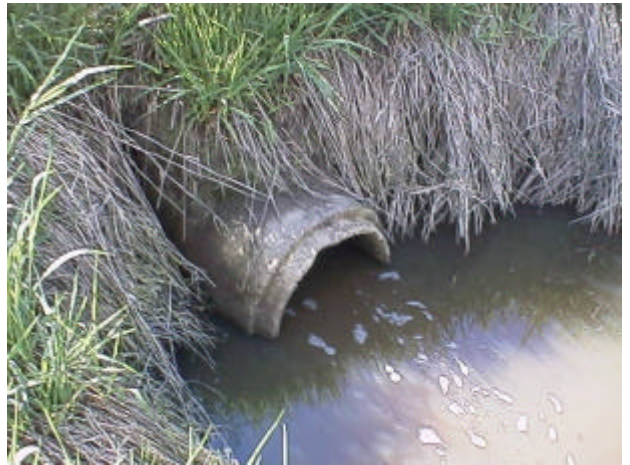
**Figure 13.** Site 981865, Shillapoo Lake to Lake River. This culvert has a 2.67% slope and is a total barrier.

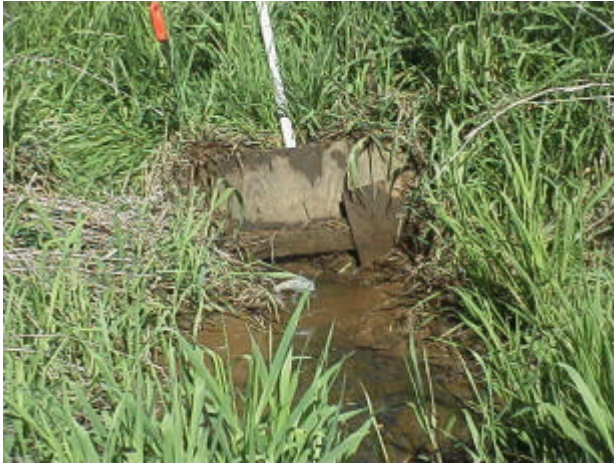
**Figure 14.** Site 981865 continued. View of culvert inlet, which has been boarded off.

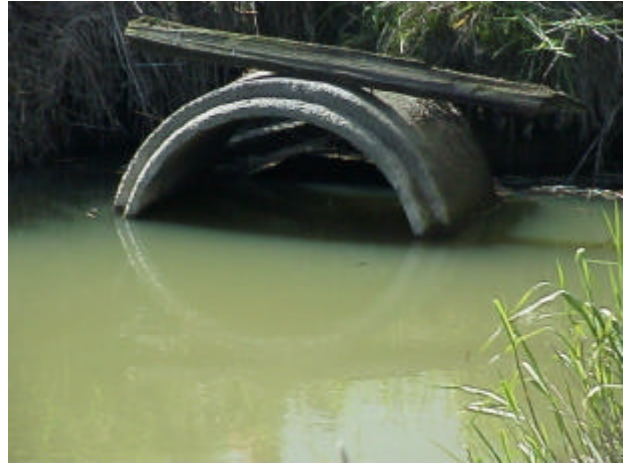
**Figure 15.** Site 981866, Shillapoo Lake to Lake River. This undersized (0.80 meter round metal) culvert has a larger concrete round placed at the outlet and is a partial barrier due to velocity. Scoured fill was observed at the upstream side and on top of the crossing.

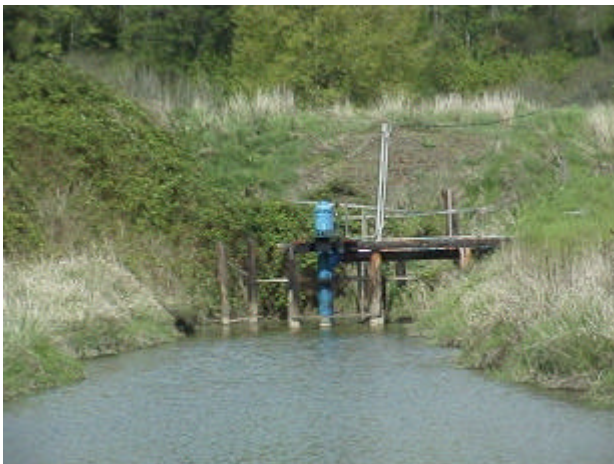
The pump and culvert at site 981457 (figure 16 and 17, respectively) are used to expel surface water from the lake into Lake River at approximately river mile 10.5. The pump is unscreened and the culvert is fitted with a tide gate. The purpose of this culvert is to provide gravity discharge from Shillapoo Lake. However, the active management of the pump and the high water levels of Lake River typically prevent actual discharge from this culvert.

When the pump is inactive during the fall and winter, the accumulation of surface runoff reportedly reaches four to five feet. As a result, the culvert at this site becomes inundated and a physical connection between Lake River and Shillapoo Lake exists. Fish passage and fish safety issues will need to be considered at this site.

**Figure 16.** Site 981457, Shillapoo Lake to Lake River. View of 'expulsion' pump and sump area. The pump is unscreened and there is wire fencing being used as a trash rack.

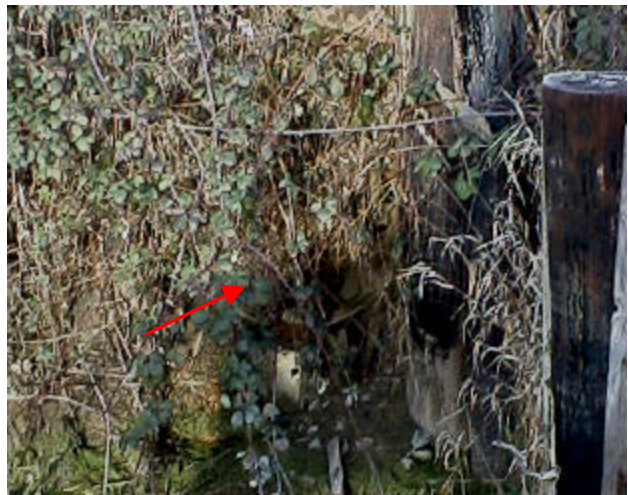
**Figure 17.** Site 981457 continued. Upstream view of tide-gated discharge pipe. Flow and fish access through this pipe is unknown. This location is a human made outlet for Shillapoo Lake.

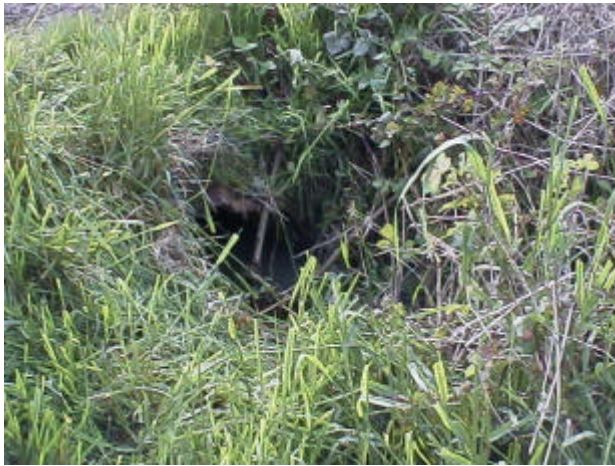
**Figure 18.** Site 981861, Shillapoo Lake to Lake River. Located on a ditch that is fed by a natural spring, this undersized culvert is a partial barrier due to velocity.

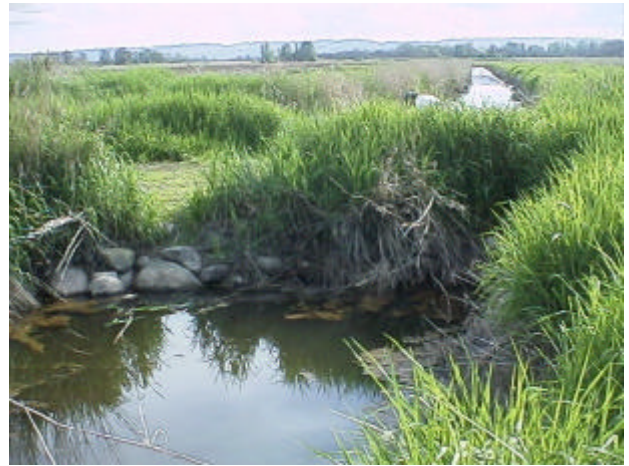
**Figure 19.** Site 981862, Shillapoo Lake to Lake River. This undersized culvert is a partial barrier due to velocity. The upstream end of the pipe was partially clogged when surveyed. Grazing livestock have also created water quality issues.

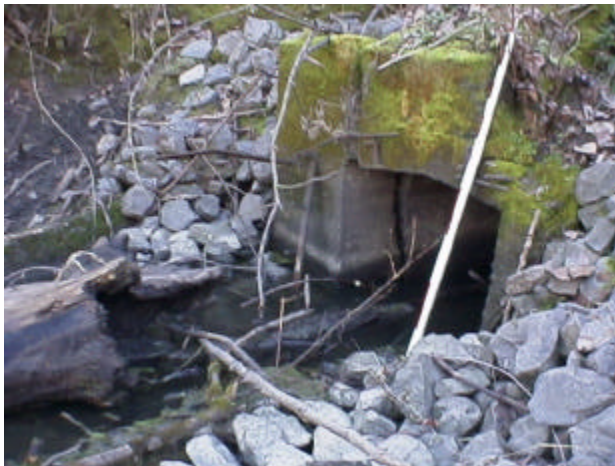
Matthews Slough and Buckmire Slough are connected via a connection channel. This connection channel appears to be human-made. Barrier site 981459 was identified at an abandoned road that crosses this channel (figure 4). Treated as an “other” feature, this structure is a large 1.14 meter span by 1.02 meter rise concrete box culvert with a water control structure (figures 20 and 21). Placing dam boards in the water control structure to hold back the water creates an outfall barrier. During both site visits the water control structure was not in use and fish passage was possible.

**Figure 20.** Site 981459, Buckmire Slough (28.0136) to Lake River. Downstream view of site. Evidence of a pre-existing tide gate was observed. The crushed rock and water control structure were recently added to this site.

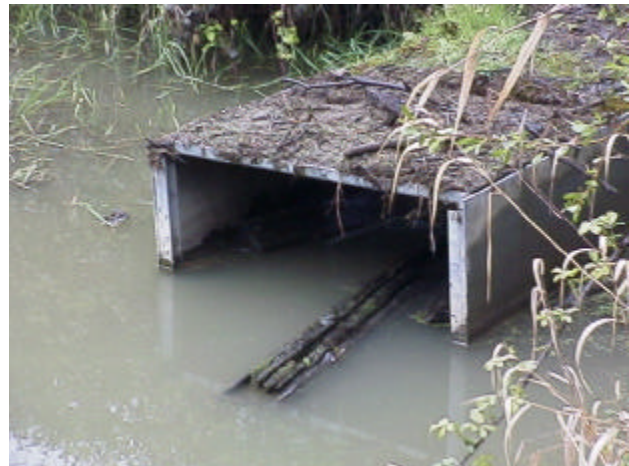
**Figure 21.** Site 981459 continued. View of water control structure upstream. With no dam boards installed and a water depth of 0.51 meter, the culvert is passable under these conditions. When water is held back, a barrier outfall drop is created.

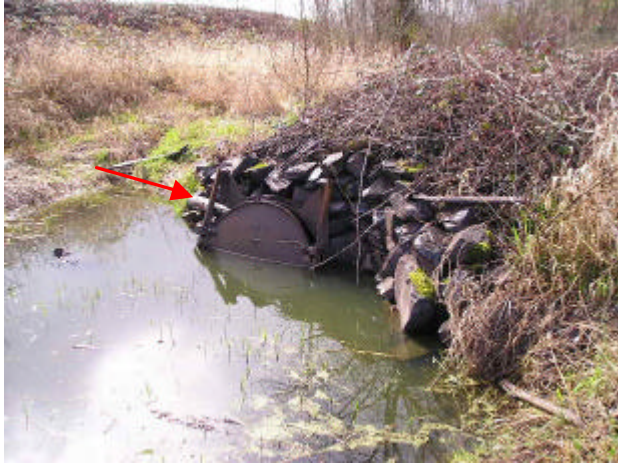
**Figure 22.** Site 981853, Buckmire Slough (28.0136) to Lake River. Under State Route 501, this crossing is a barrier culvert due to the tide gate. The flap style tide gate is currently propped open with LWD.

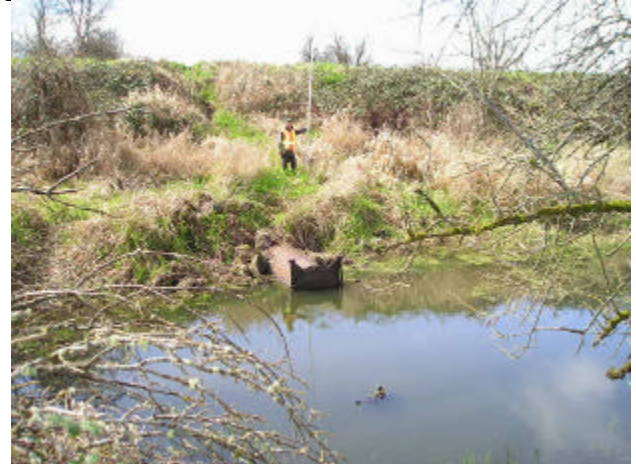
**Figure 23.** Site 981854, Buckmire Slough (28.0136) to Lake River. This site is a barrier culvert due to the tide gate. The hinges on the tide gate are rusted, but appear operable.

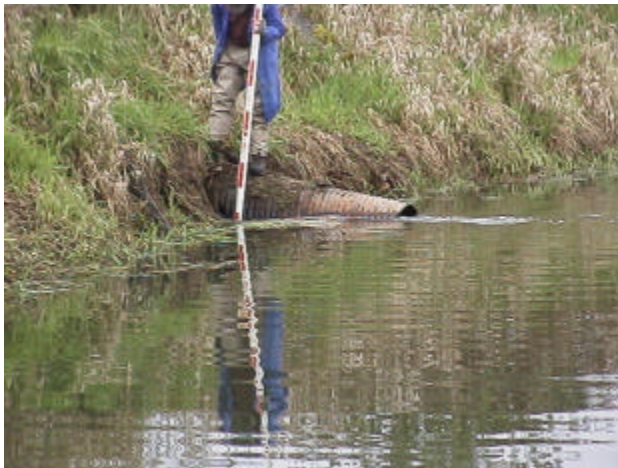
During the downstream survey for site 981459, four culvert sites were identified outside the SWA (figure 4). Sites 981853 and 981854 each have a barrier tide gate (figure 22 & 23, respectively). Site 981855 has two culverts, which become inundated during high tide. The larger mid-channel pipe (0.76 meters round corrugated steel, figure 24) is rusted out and both protruding ends have collapsed. The condition of this pipe can be attributed to the fact that it receives the majority of the cross flow during the out-going tide, which creates a velocity problem. This culvert also has a 1.16% slope and is velocity barrier.

**Figure 24.** Site 981855, Buckmire Slough (28.0136) to Lake River. Downstream view of the mid-channel culvert at this crossing. With a slope of 1.16% and receiving the majority of the flow, this undersized culvert is a partial barrier. The sides and bottom of the culvert are rusted out. Both ends of pipe are collapsed as well.

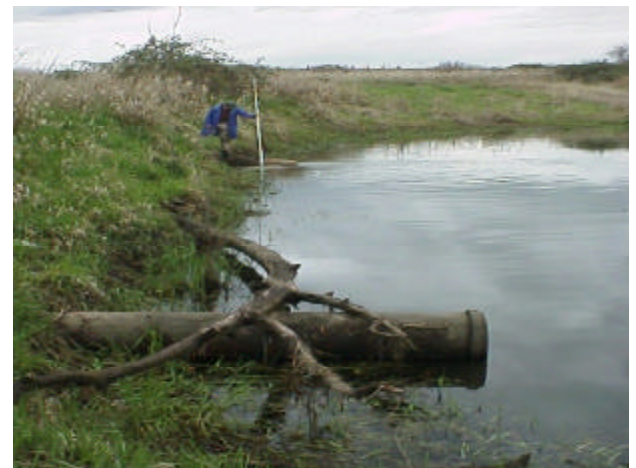
The second pipe (0.55 meter round smooth steel, figure 25), located near the right bank, becomes dry and impassible during the lower tidal stages.

**Figure 25.** Site 981855 continued. Downstream view of smaller sequencer pipe near the right bank. No flow was observed during the outgoing tide. While both pipes become inundated during high tide, this smaller pipe is set at a higher elevation and becomes dry during low tides.

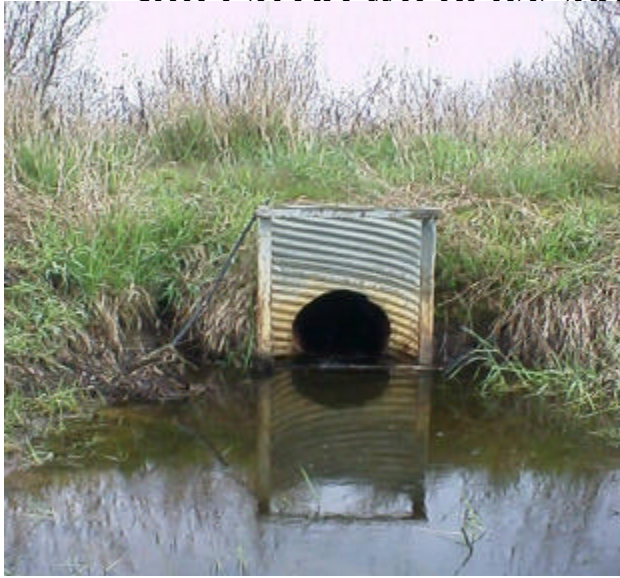
Correcting sites 981470 and 981471 would allow fish access to approximately 62,000 square meters (15.32 acres) of winter rearing habitat. This amount of habitat gain reflects the current conditions. If controlled inundation and unimpeded fish passage (at all four sites) can be managed, the amount of available habitat would be approximately 263,043.60 square meters (65 acres).

**Figure 26.** Site 981471, Mulligan Slough to Vancouver Lake. View of the inlet and water control structure. Placement of dam boards to impound water creates an outfall barrier. This site is the principal location of tidal influence.

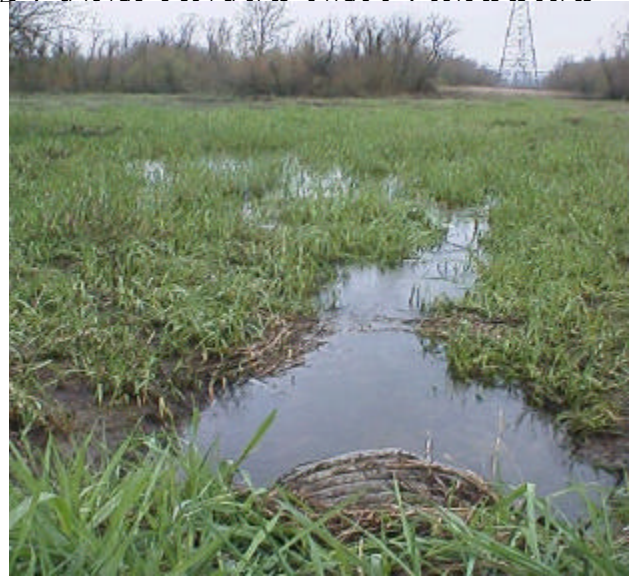
**Figure 27.** Site 981471 continued. View looking downstream.

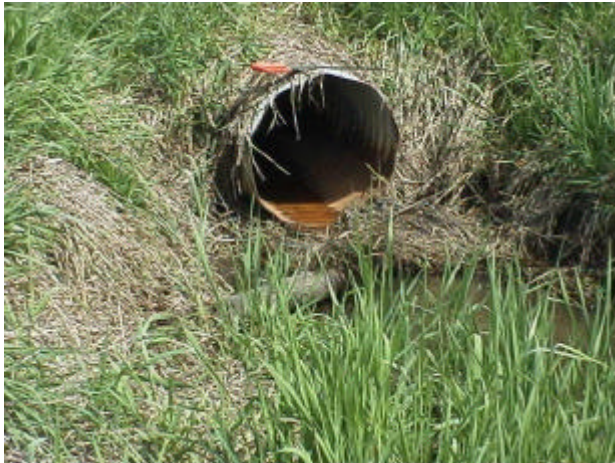
**Figure 28.** Site 981470, Mulligan Slough to Vancouver Lake. Set a foot higher than 981471, this site has a barrier water control structure too. This site is also a location where Mulligan Slough inundates the flood plain regularly.

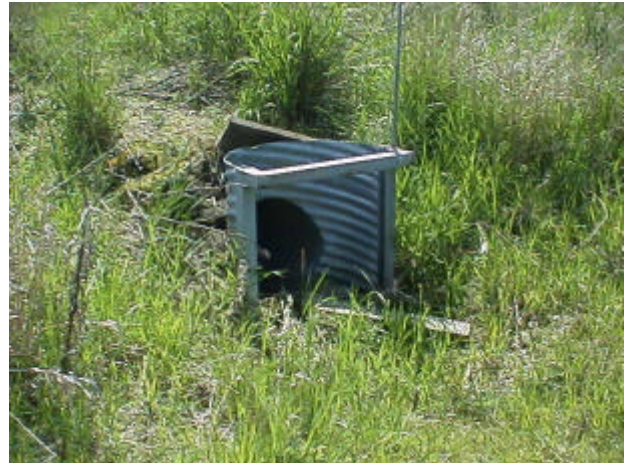
**Figure 29.** Site 981469, Unnamed to Mulligan Slough. View of inlet and barrier water control structure.

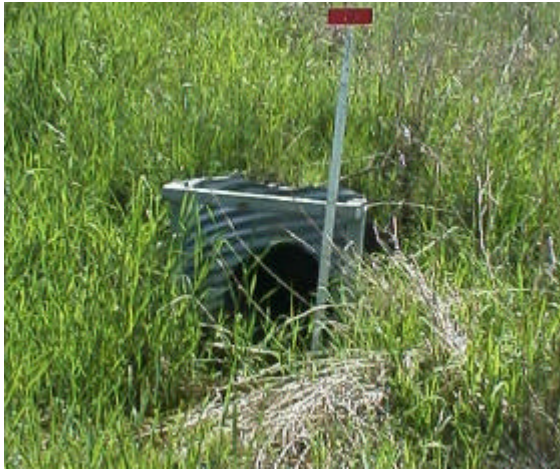
**Figure 30.** Site 981472, Unnamed to Mulligan Slough. View of inlet and barrier water control structure.

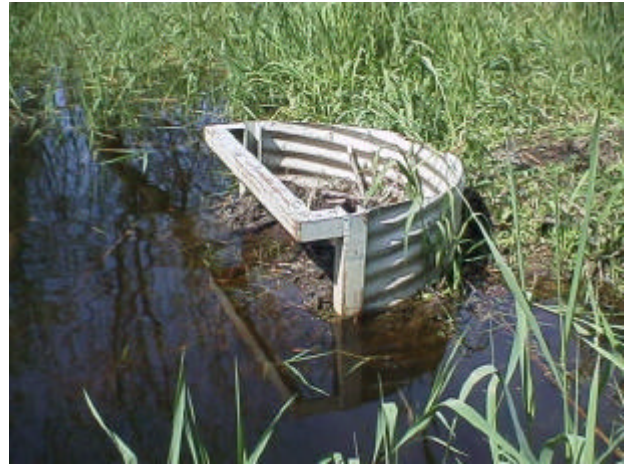
On the northeast portion of the unit, site 981473 is approximately 125 meters inland from the low water shoreline of Vancouver Lake, but well within the extent of tidal influence (figure 5). During the evaluation of this barrier site the water control structure was completely clogged by beaver activity (figures 31 and 32) and a 15 meter section of the overflow levee was breached. Upstream of both locations, unidentified juvenile fish were observed.

**Figure 31.** Site 981473, Vancouver Lake to Lake River. Beaver routinely plug this structure. The overflow levee associated with this site has a 15m wide breach that also impedes fish passage.

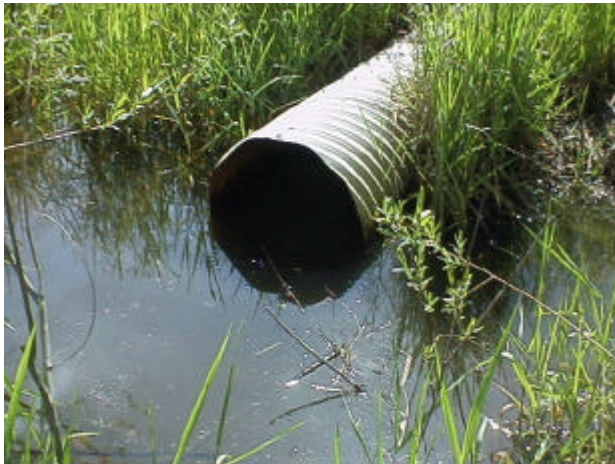
**Figure 32.** Site 981473 continued. Downstream view of site shows daily inundation from the tidally influenced Vancouver Lake.
