**Skagit Wildlife Area
Fish Passage and Diversion Screening
Prioritization Inventory**

Habitat Program
Technical Applications Division
Habitat and Passage Projects Section

October 2003

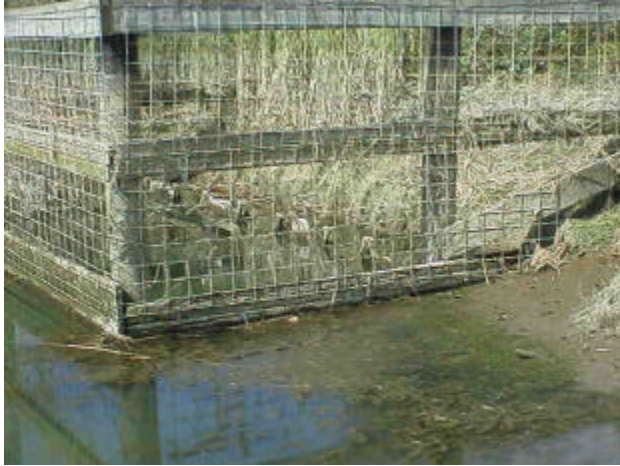
A total of seven features were evaluated within the Wylie Slough area (figure 3). Site FI 15, the drainage structure of Wylie Slough to Skagit Bay, is a series of six culverts, each with a tide gate at the downstream end, which impede fish passage (fig. 6 and 7). Approximately 1,235 and 1,300 meters upstream are culvert sites FI 32 and FI 31, respectively. While both sites were evaluated as non-barriers, fish passage at Site FI 31 is considered unknown due to collapsing fill and the potential failure of the crossing. The repair of this site is in the permitting stage and will occur in the near future. Approximately 300 meters further upstream and located on the left bank is pump diversion site FI 29. Used for flood control, the pump intake is unscreened and requires correction. Fish can physically reach the site of this pump, which presents a fish safety risk. This site has an SPI of 69.62. Although the only mapped fish use consists of bull trout/dolly varden, the screening priority index must take into account the physical (hydraulic) connection and possibility of restored fish use, which would include all anadromous salmonid species (see table 3.).

Figure 6. Site FI 15. Wylie Slough to Skagit Bay. Right bank picture shows 4 of 6 culverts with tide gates. All 6 gates are of the flap style.

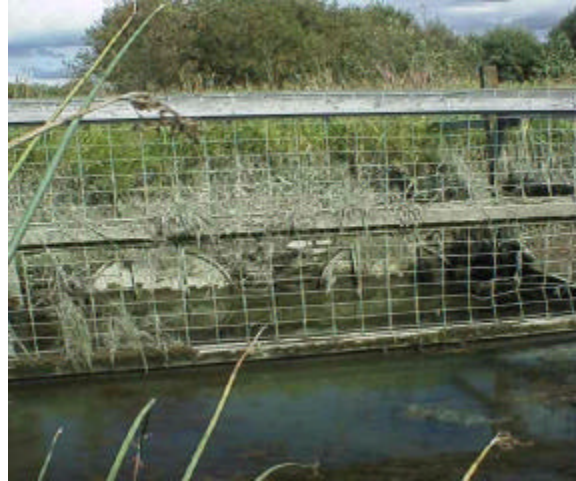
Figure 7. Site FI 15 continued. Left bank picture shows 2 of 6 culverts with tide gates. This site is a partial barrier.

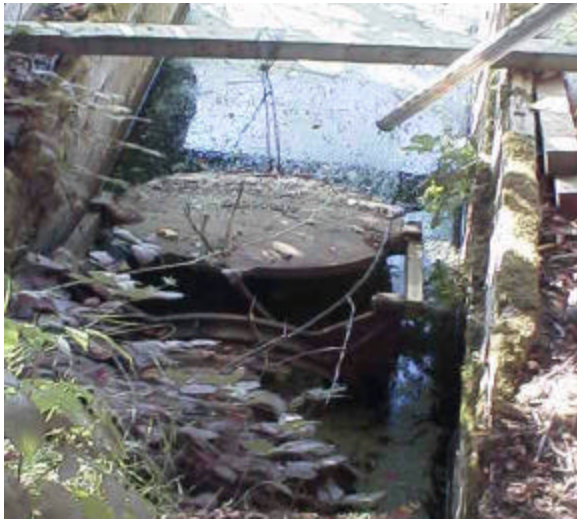
Approximately 435 meters upstream of FI 15 and located on the left bank is barrier ‘other’ site FI 19 (figure 8). Consisting of a culvert with a flap-style tide gate at the downstream end and a screw gate near the upstream end, this site is for the ditch that drains the upper portion of Teal Slough. When utilized for wetland management this feature becomes impassible. The lower portion of Teal Slough is cut off by dike and no longer drains to Skagit Bay.

Figure 8. Site FI 19. Teal Slough to Wylie Slough. Downstream view of wired open tide gate. Upstream screw gate for wetland enhancement not shown. Currently, several metal fence posts are positioned in the channel at the inlet to prevent beavers from clogging the structure.

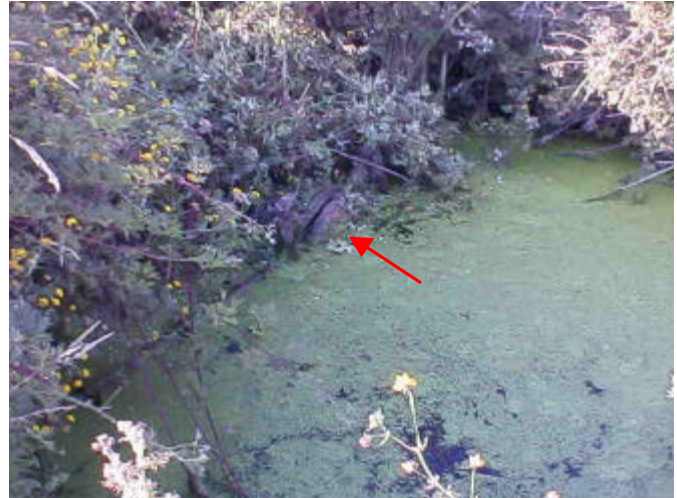
On a small right bank tributary that enters the slough approximately 880 meters upstream of FI 15 is culvert site 981897 (figure 9). The wildlife area property boundary is not clearly known here, but the feature is located about 12 meters above the confluence. The culvert has a flap gate on the downstream end and drains a small pond upstream. This site is a partial barrier. Associated with this drainage further upstream is culvert site 981891. This site is for ditched run-off that passes under the easement road to the SWA. An unidentified fish (30-35mm fry) was observed in the plunge pool of this culvert. This demonstrates that the physical connection of water allows for fish movement into artificial drainage ditches that are often presumed and managed as non-fish bearing.

Figure 9. Site 981897. Unnamed to Wylie Slough. Located close to the confluence, juvenile fish can negotiate this partial barrier.

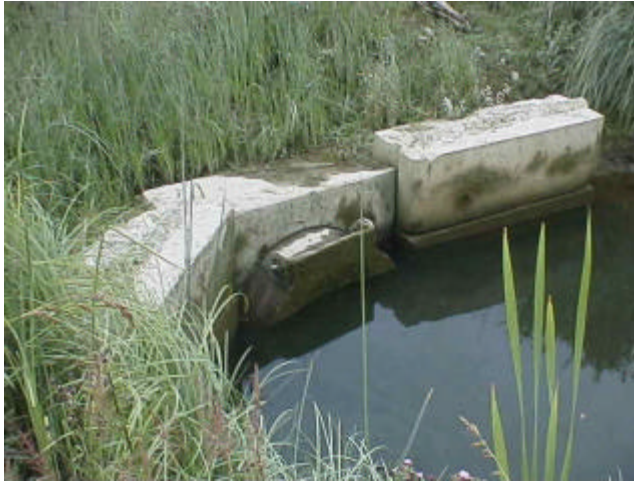
Figure 10. Site FI 9. Dry Slough to Skagit Bay. View of right bank tide gate. This site is a partial barrier.

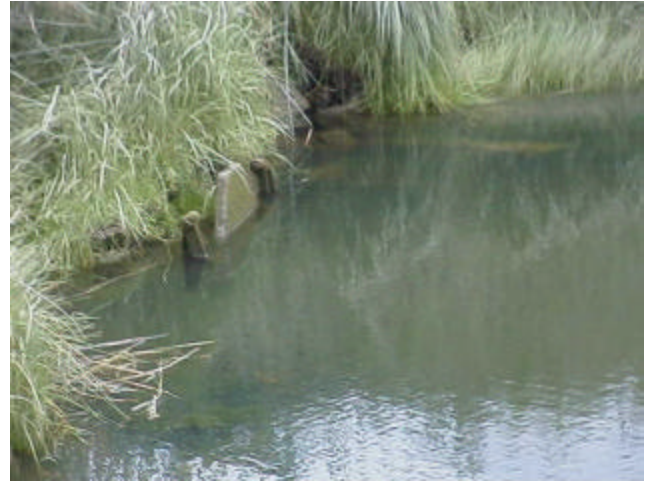
Figure 11. Site FI 9 continued. View of left bank tide gate.

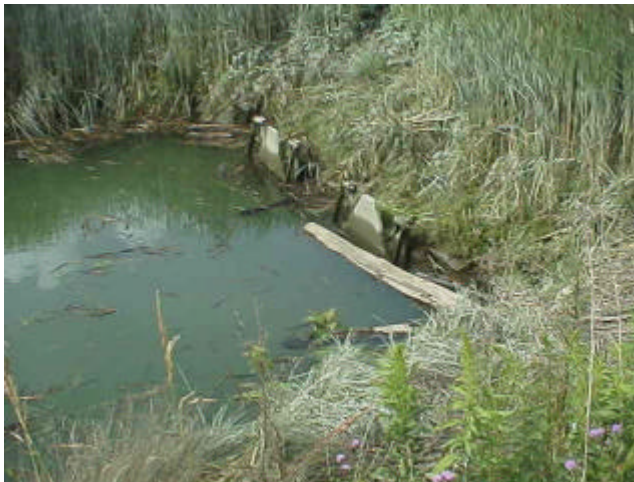
Figure 12. Site FI 41, Unnamed slough to Skagit Bay. View of partial barrier flap-style tide gates.

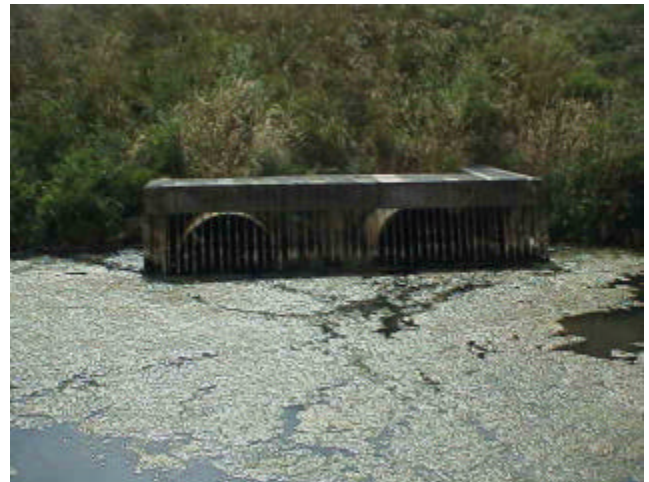
Figure 13. Site FI 41 continued. Upstream view shows trash rack structure and stagnant water.

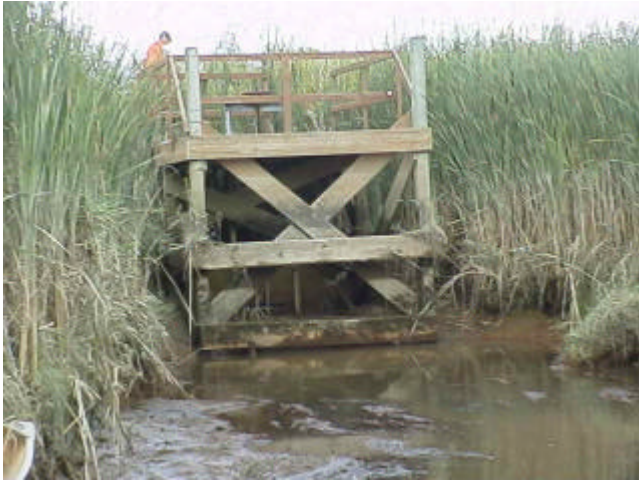
Figure 14. Site 981874. View of combination drainage and canal gate with platform to access the handwheel for raising the gate to allow backflow. Fish passage is dependent on management activities.

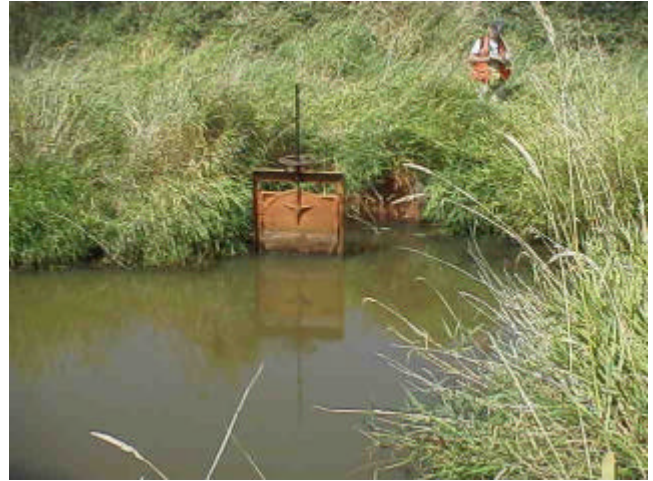
Figure 15. Site 981876, Unnamed to Deepwater Slough. This feature could be shut and potentially strand fish upstream. The artificial drainage upstream is a borrow ditch that follows the perimeter of the dike system. Site 981923, not shown, is upstream of this potential barrier.

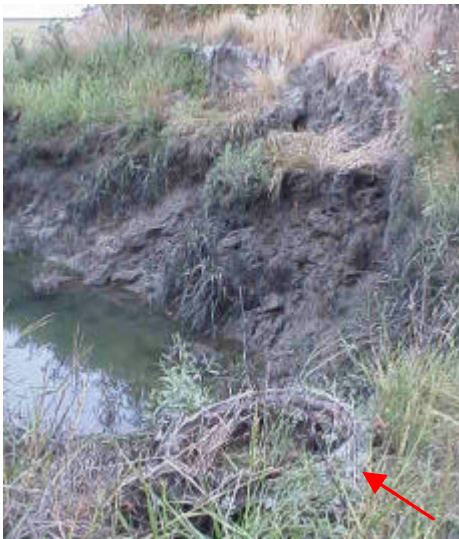
A total of 16 culverts were identified during the inventory of this unit (figure 4). Four culverts are drainage structures through the dike. Located on the northwest side of the island and connected to Davis Slough are sites 981916 (figures 16 and 17) and 981912. Both of these culverts are impaired and the dike at each site is failing. The tide gates are no

longer attached to these culverts and the pipes are intentionally plugged until repairs can occur. Site 981908 has a functioning tide gate that drains into the West Pass of the Stillaguamish River and site 981904 has a functioning tide gate that drains into the South Pass of the Stillaguamish River. The additional 12 culverts are for interior drainage. Two of these culverts are under State Route 532 (figure 4). Considered Washington State Department of Transportation ownership, these features are not include in Table 1, but are in Appendix A.

Figure 16. Site 981916, Unnamed to Davis Slough. Downstream view of eroding dike and remnant tide gate in the bank.

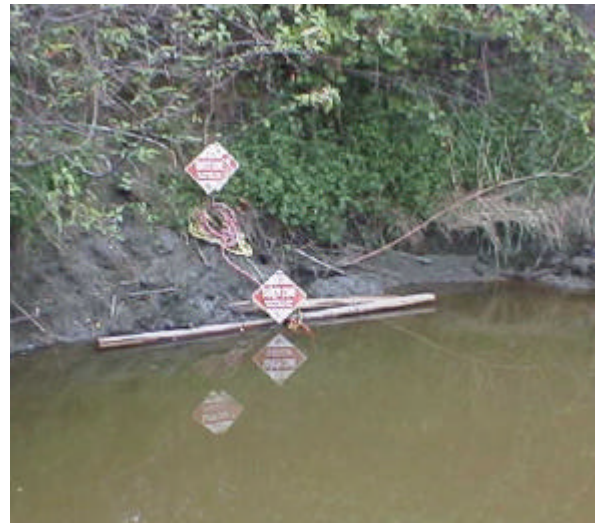
Figure 17. Site 981916 continued. Upstream view shows the orange tube for the air bladder apparatus used to plug the culvert until repairs can be made.
