# SKAGIT WILDLIFE AREA FISH PASSAGE AND DIVERSION SCREENING SCOPING REPORT

HABITAT PROGRAM  
TECHNICAL APPLICATIONS DIVISION (TAPPS)

BY  
CHRIS DETRICK

**WASHINGTON DEPARTMENT OF FISH AND WILDLIFE  
SKAGIT WILDLIFE AREA  
FISH PASSAGE AND DIVERSION SCREENING SCOPING REPORT  
TECHNICAL APPLICATIONS DIVISION (TAPPS)-HABITAT PROGRAM  
JANUARY 2007**

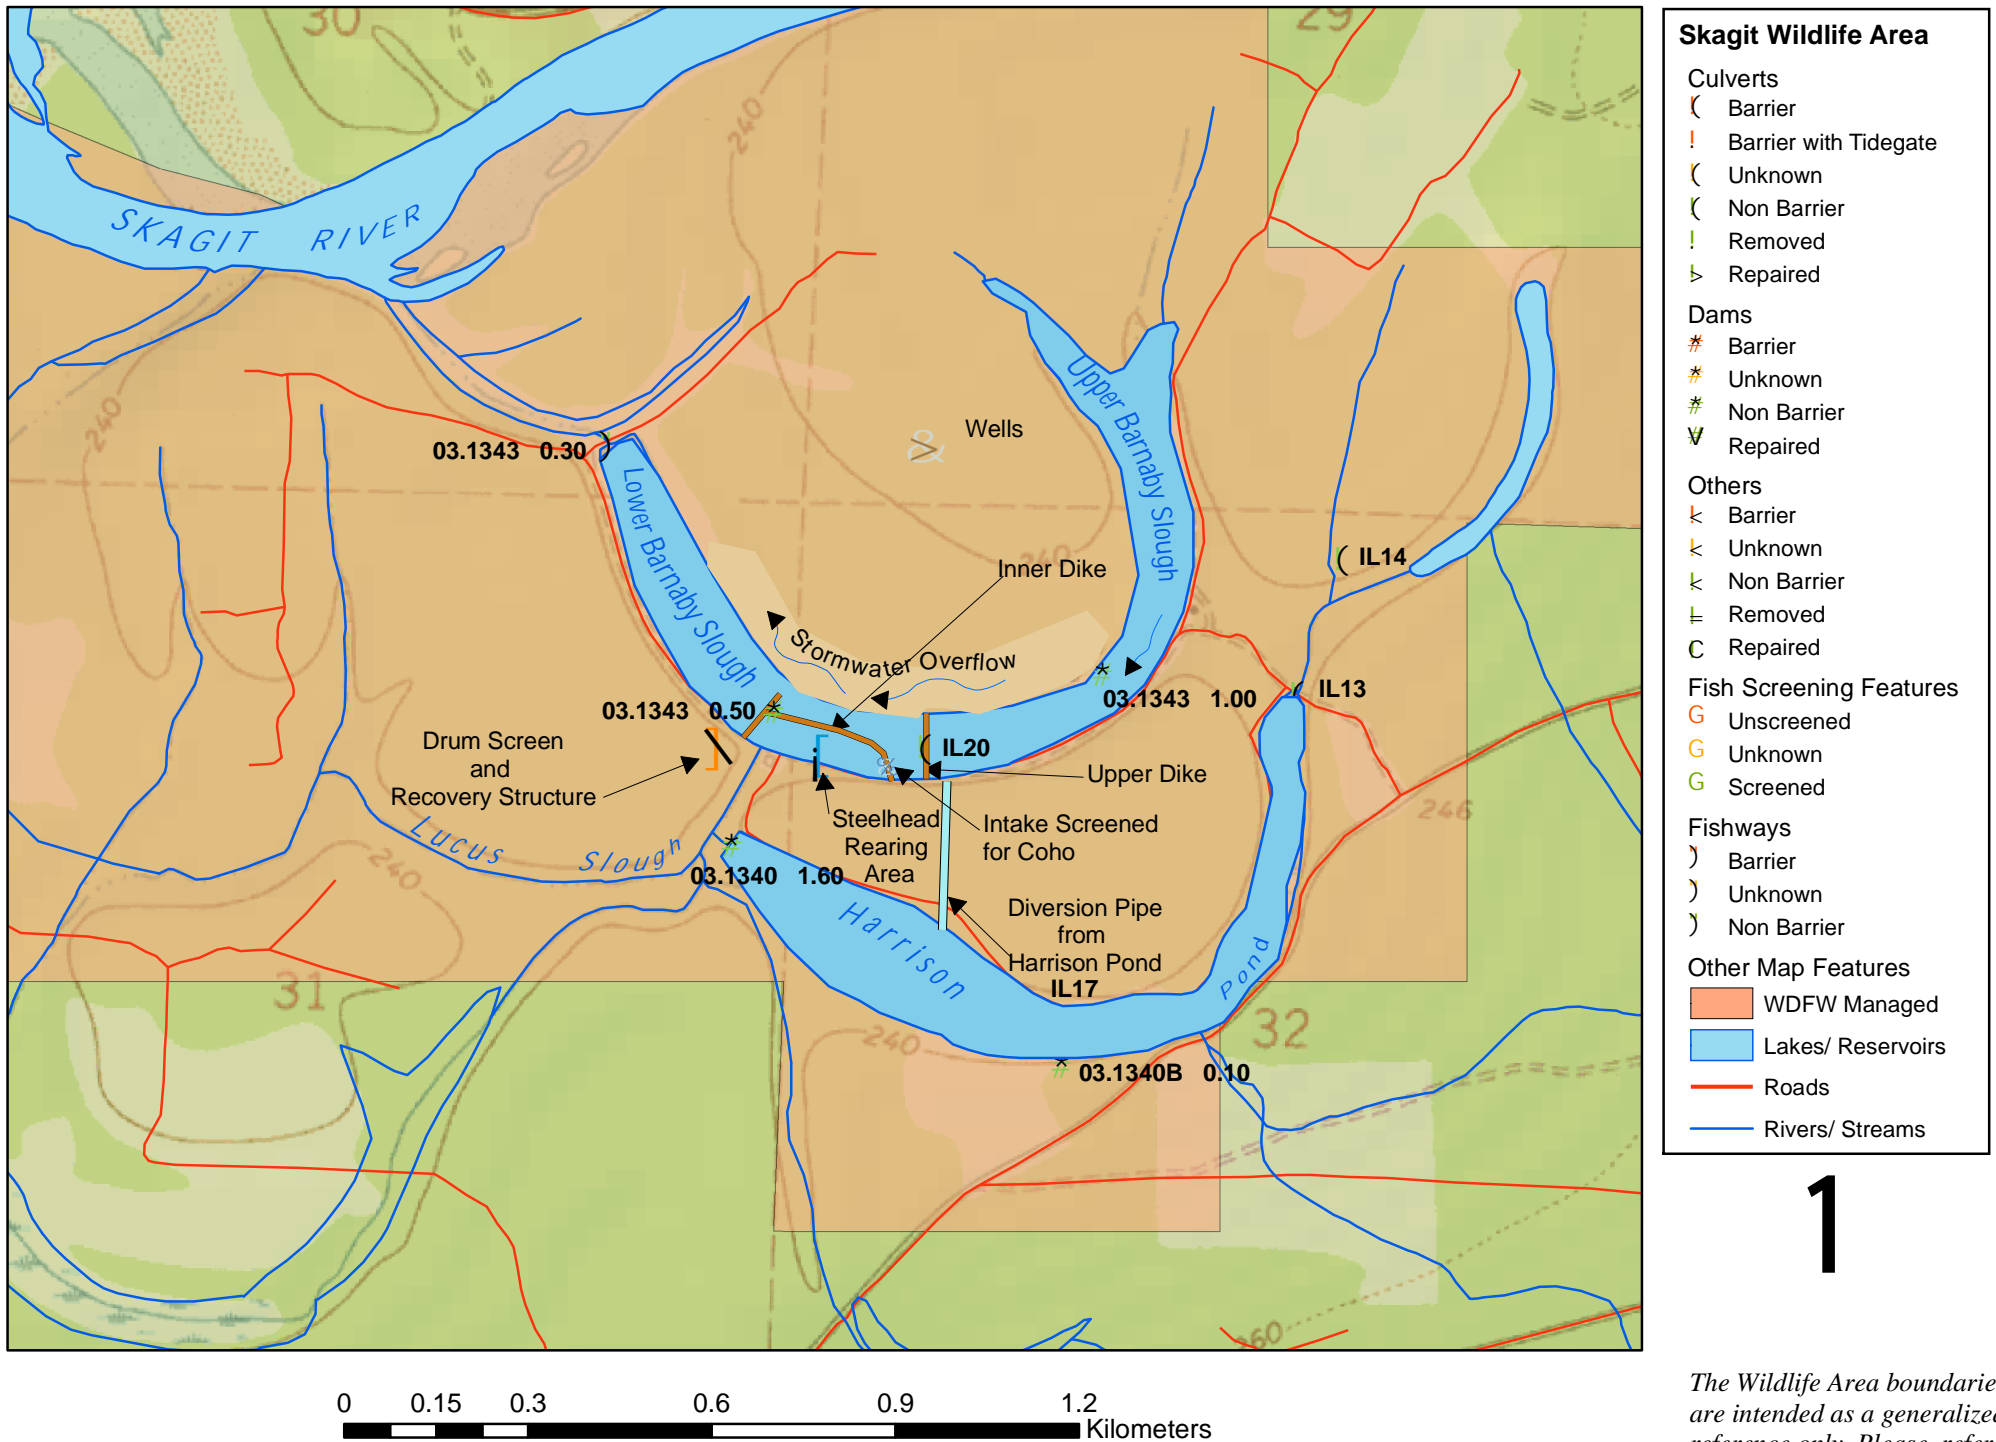
Figure 2. Skagit Wildlife Area, Bald Eagle Natural Area, Barnaby Slough Subunit showing physical infrastructure elements.

In working with the Fish Program that manages this unit, TAPPS has constructed fishways in all three cross dikes of Barnaby Slough and at the outlet of Harrison Slough. Formally, all these sites were barriers. All four of these fishways have been durable and efficient and only need to be adequately maintained to ensure free and unobstructed use by native salmonids.

The standpipe riser diversion from Harrison Slough to Barnaby Slough (IL20) may divert fish to Barnaby Slough but this is not likely a problem. (Fish migration is probably only one way because the fall of water into the vertical riser from Harrison Slough is probably impassable to upstream migrants) The diversion outlet into Barnaby Slough is outside the steelhead rearing area.

The culvert at the upper end of Harrison Slough (IL13) is an old concrete box structure originally built for a drum screen but is large and durable creating no problems for fish passage. It supports the road crossing into the Barnaby Slough residence and complex.

The old fishway into Harrison from the adjacent un-named tributary (13.1340B 0.10) built prior to the outlet fishway (03.1340 1.60) is now inoperable and no longer needed for fish use of the pond.

There has been a deliberate effort to exclude native salmonids, especially rearing coho, from the steelhead rearing area when it is watered. Many of the coho parr that could be diverted would likely be lost to predation and also be at risk of disease. Additionally, they would add to the loading rate for the pond area and required flow that is already maximized. The small amount of flow from Barnaby Slough and occasionally Harrison Slough diverted through this sub-area does not diminish habitat quality elsewhere in either slough. Nearby wells are also used to supplement water when extra flow is needed.

The amount of habitat restoration possible in this unit has been done. Removal or reactivation of the old Harrison Slough fishway (13.1340B 0.10) would not provide any further benefit. Reactivation would necessitate constant maintenance that is not available and only duplicate the function the newer more efficient outlet fishway (03.1340 1.60) that has been generally maintenance free. Restoring heavy equipment access across the newer concrete fishway and brushing the old road along Harrison Slough to the site would now cause more damage to the recovered riparian zone along the slough than is probably justified.

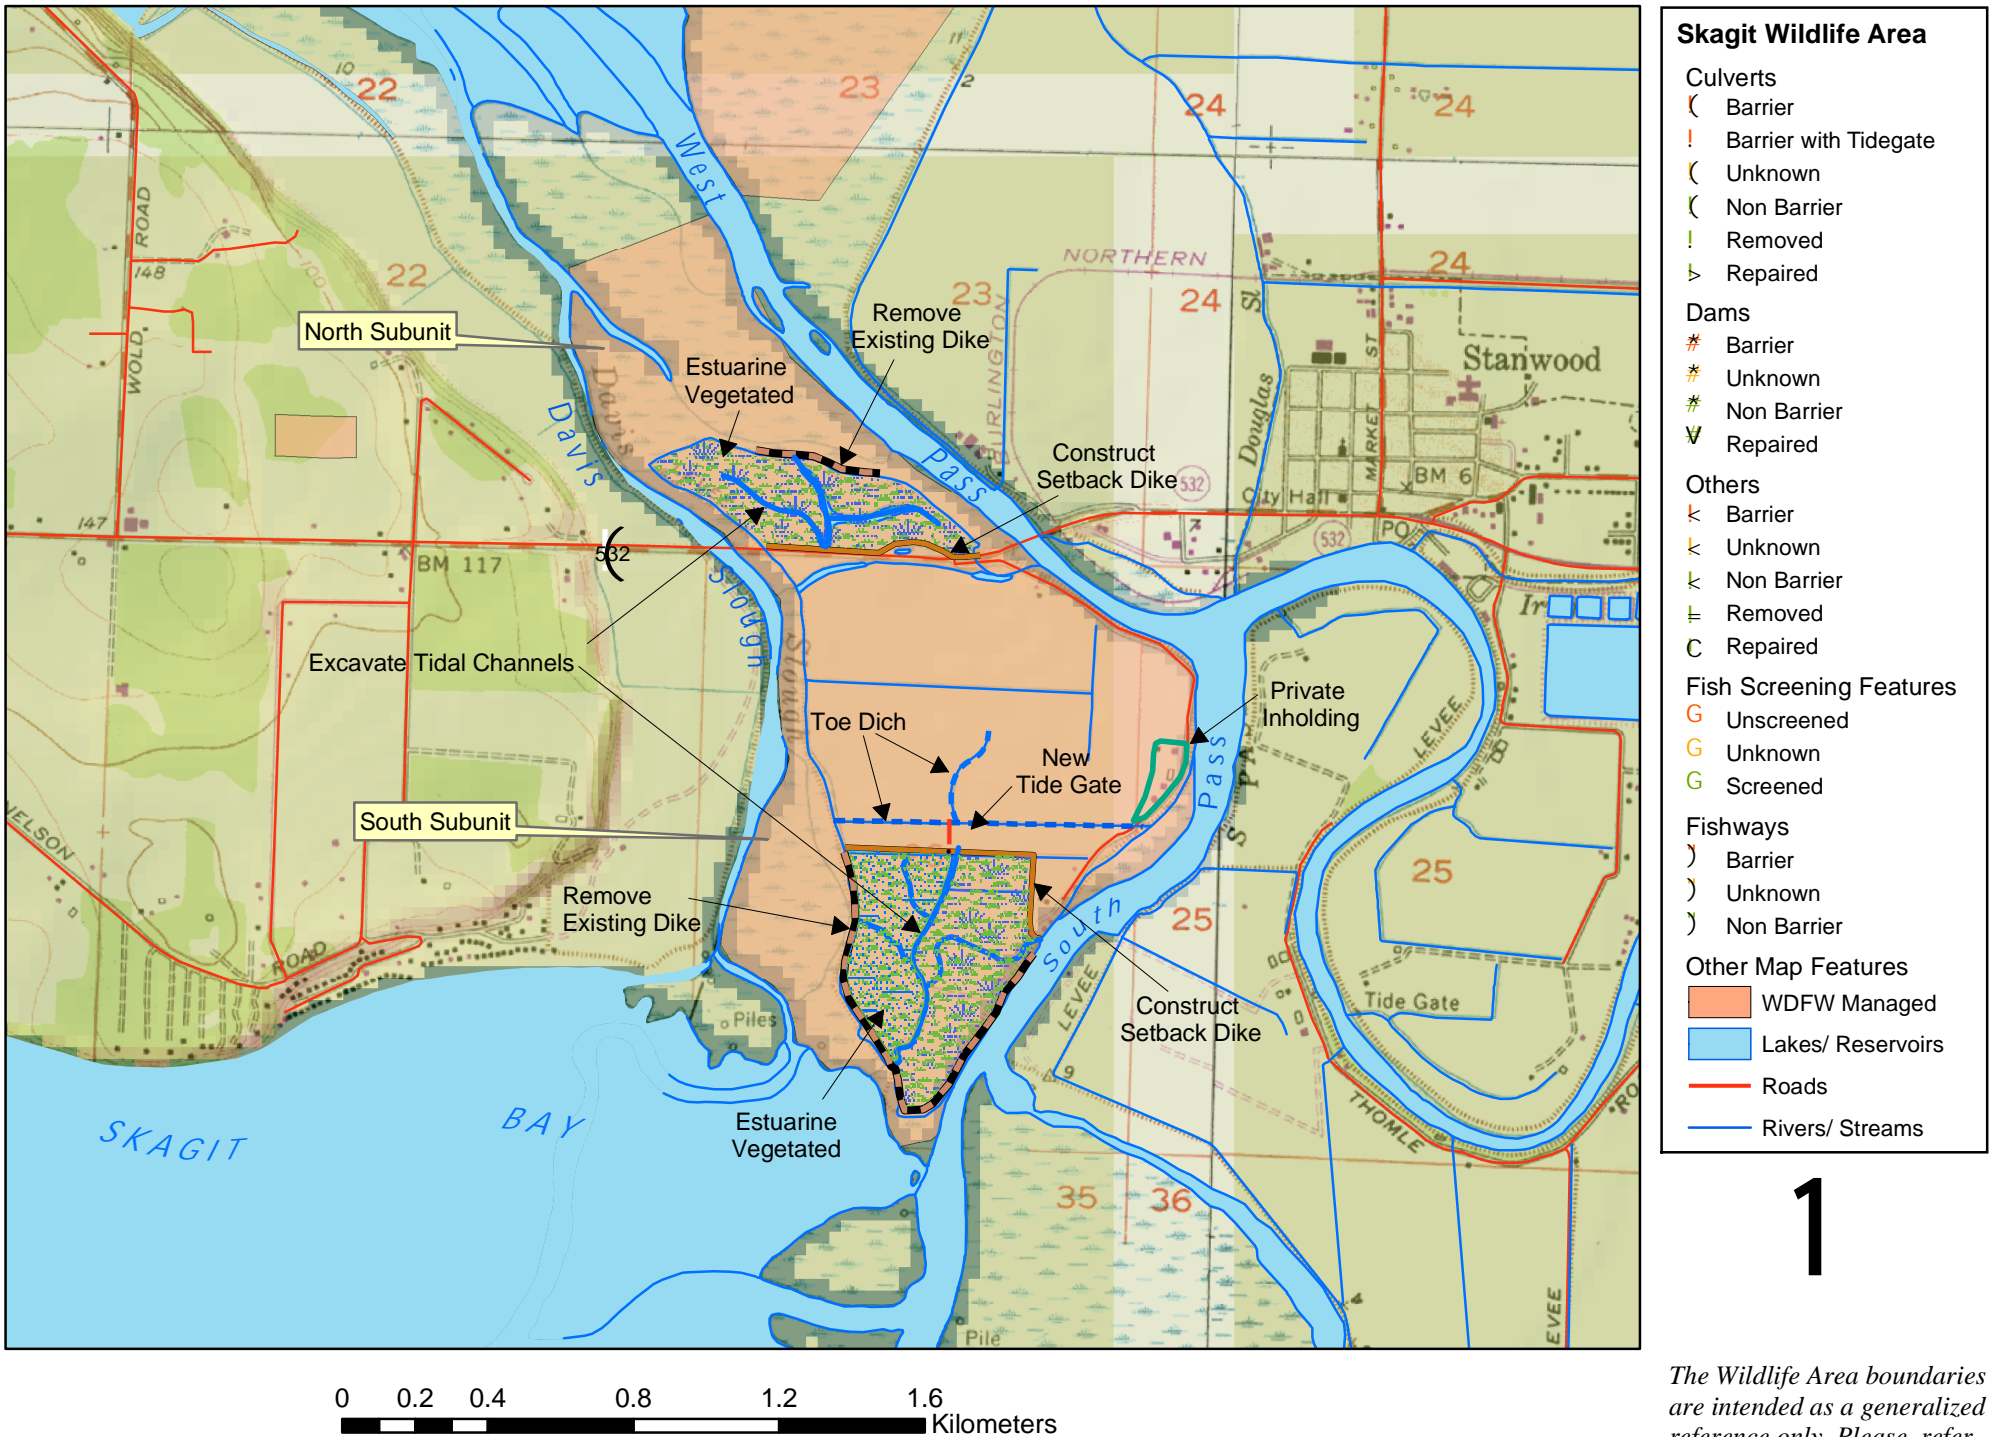
Figure 4. Skagit Wildlife Area, Leque Island Estuary Restoration.

The dike on the north segment is beginning to fail in several places and without maintenance will soon allow tidal inundation. The tide gate is also in need of replacement. The dike on the south side is generally secure but has one weak location and 2 of the 3 tide gates need replacement. WDFW has responsibility for management and maintenance of the tide gates and both dikes except the short section along the inholding.

This plan eliminates the need to replace tide gates 981915 & 981916, repair of the dike on the north segment and repair of the weak dike section on the south segment (located in the dike section to be removed). It protects the highway on the north side with a new levee and avoids the immediate expense of acquiring the inholding. The two old remaining tide gates (981912 & 981908) on the south segment were not part of the DU plan and will still need replacement by WDFW. At this time, Habitat Engineering Technical Assistance staff is evaluating the potential to replace these with SRT's. Culvert sites 981913, 981902, 981903, 981905 and 981906 will be eliminated in the dike

setback. The remaining culvert sites 981907, 981909, 981911 and 981910 will be retained as interior drainage crossings.

The new tide gate shown in Figure 4 (replacing 981904) may be a self-regulating tide gate to better accommodate fish access to the interior drainage ditches. A SRT could provide opportunity to further study their value in passing fish. Any study would necessarily involve seasonal and tidal sampling of fish on both the inside and outside and effects on the soils inside. The baseline for inside soils would need to be established immediately if implementation of the project were to occur in 2007. Soil assessment would be an important part of the study since this diked area, like most of the Skagit delta, has subsided (Hood, pers. comm.) and reduced drainage could worsen already increasing salinities that are slowly making these diked agricultural lands less productive restricting species that can be planted. Additionally, there needs to be a review of the fish benefits by allowing increased access to the remaining interior diked area. The available habitat inside is only a series of shallow drainage ditches with little flow most of the year. Water temperatures are excessive much of the time for salmonids and can be silt laden when farming is underway. Only rearing area could be provided, there is insufficient flow to maintain or promote use of spawning gravel. Reducing the area available for farming by providing buffers along the ditches would probably be less valuable than setting the dike back further and recovering more natural estuary marsh.

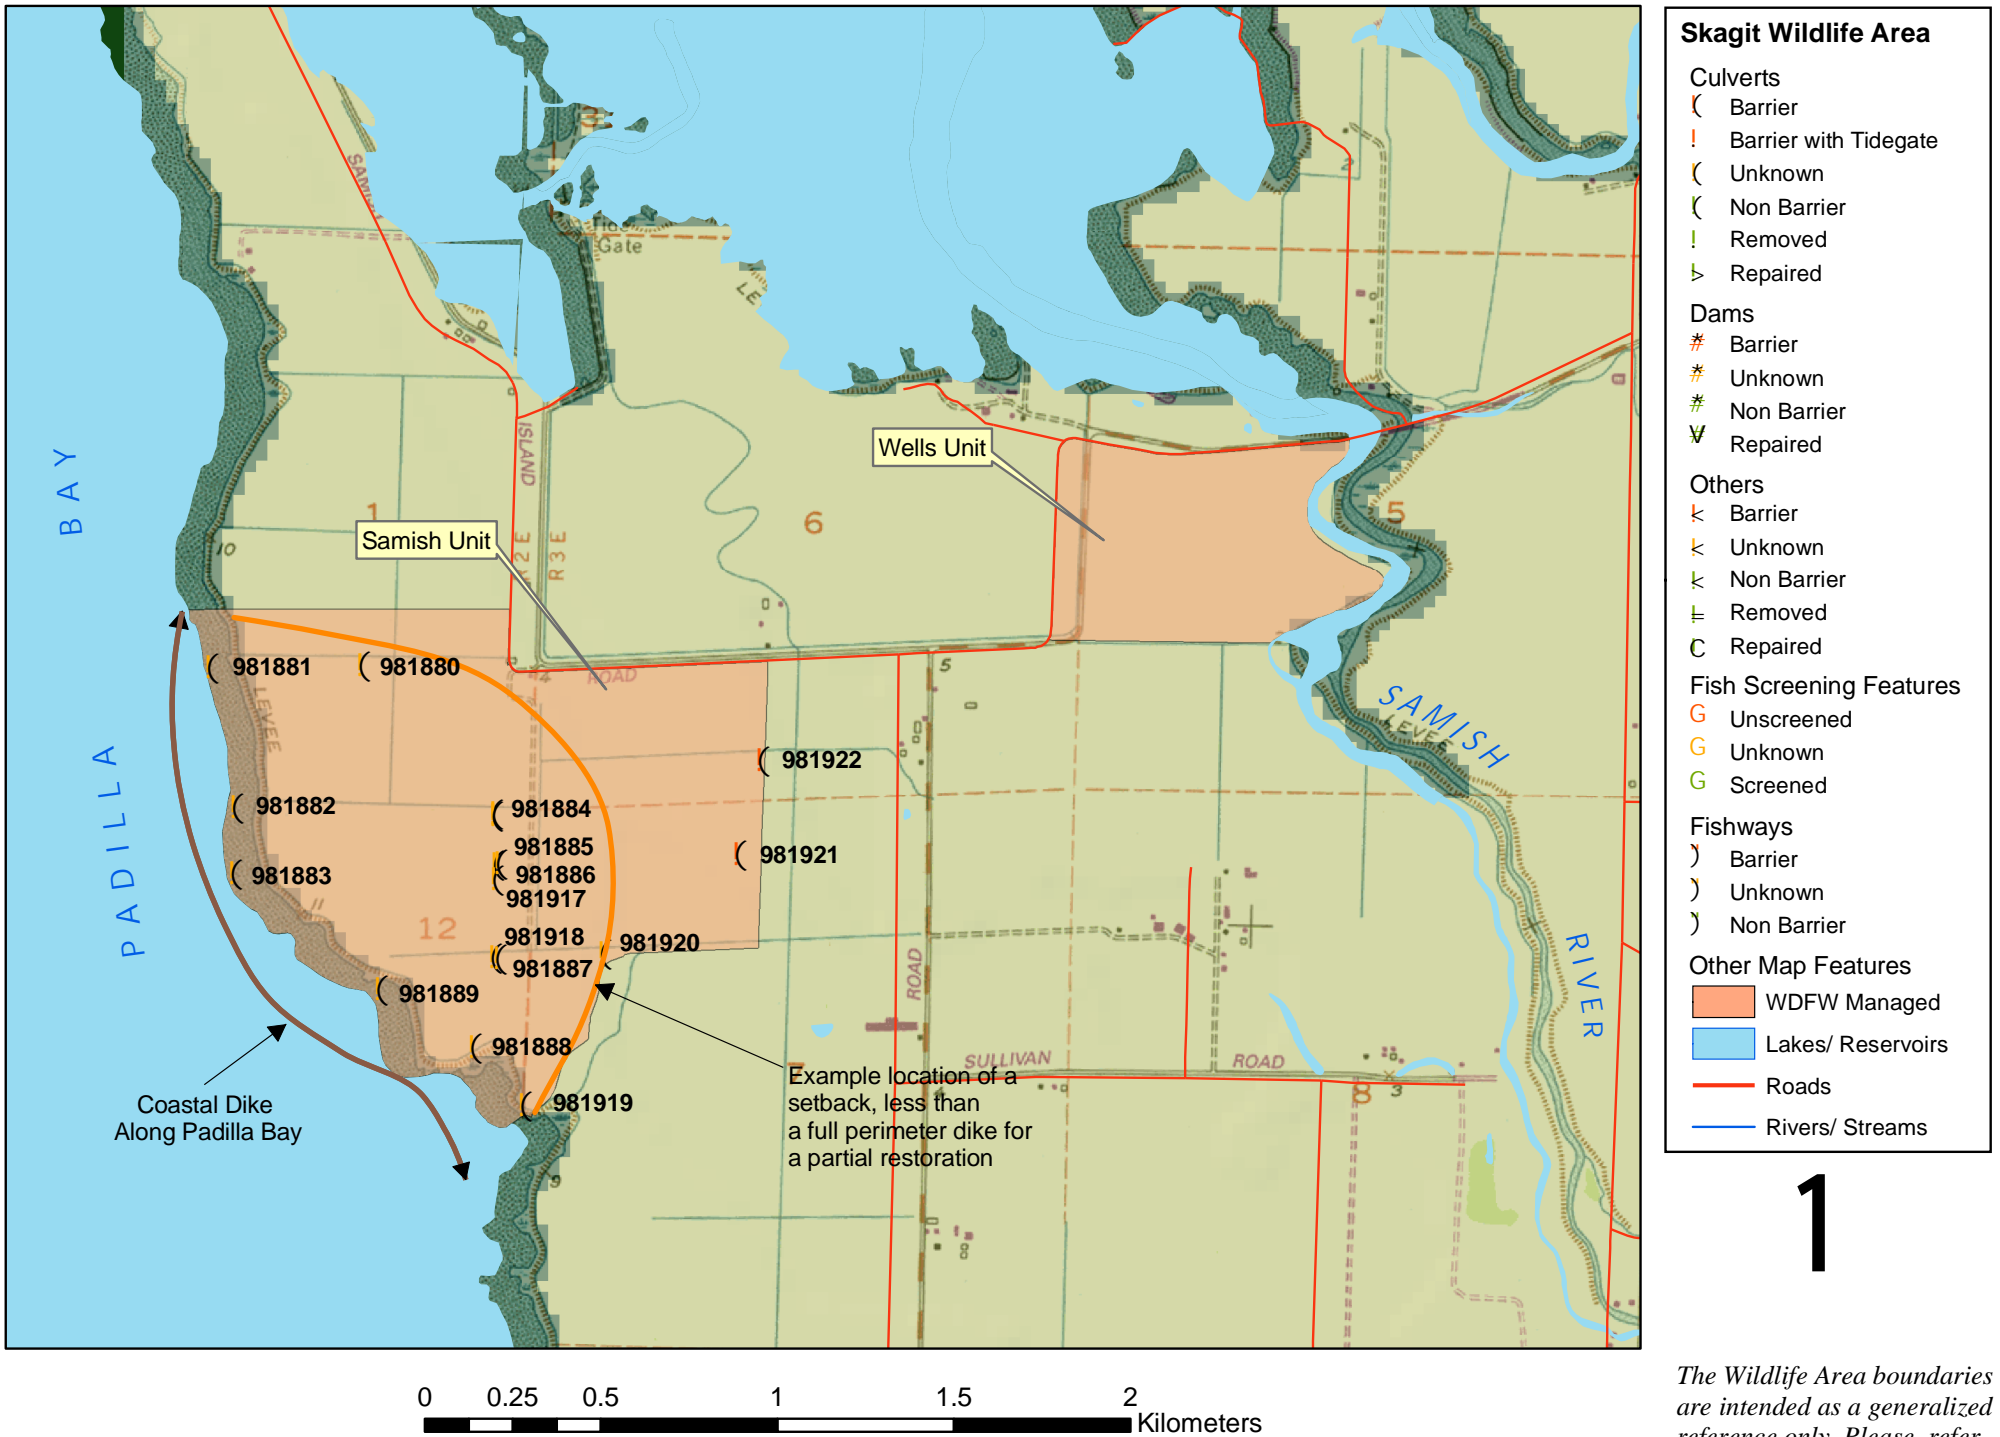
Figure 5. Skagit Wildlife Area, Samish and Welts Units.

The Welts Unit on the lower Samish River (Figure 5) was recently acquired from the Natural Resources Conservation Service (NRCS). It is currently isolated from the river and Samish Bay by the Samish River and coastal dikes (continuous). No part of the area is currently aquatic habitat.

Removal of the riverside dike will necessitate construction of a new perimeter dike around the south, west and north sides to protect the county road and adjacent private property. As Hood suggests, if the riverside dike was removed, pilot channels may have to be excavated from the remnant distributaries to direct drainage east to the river. Flow cannot likely be returned north to the bay as originally occurred because the parcel north of the property between the county road and the bay is privately owned and used for a residence.

WDFW is currently working with NRCS to develop a restoration plan and secure funding for implementation. Both agencies would like to begin constructing a project by 2007-08.

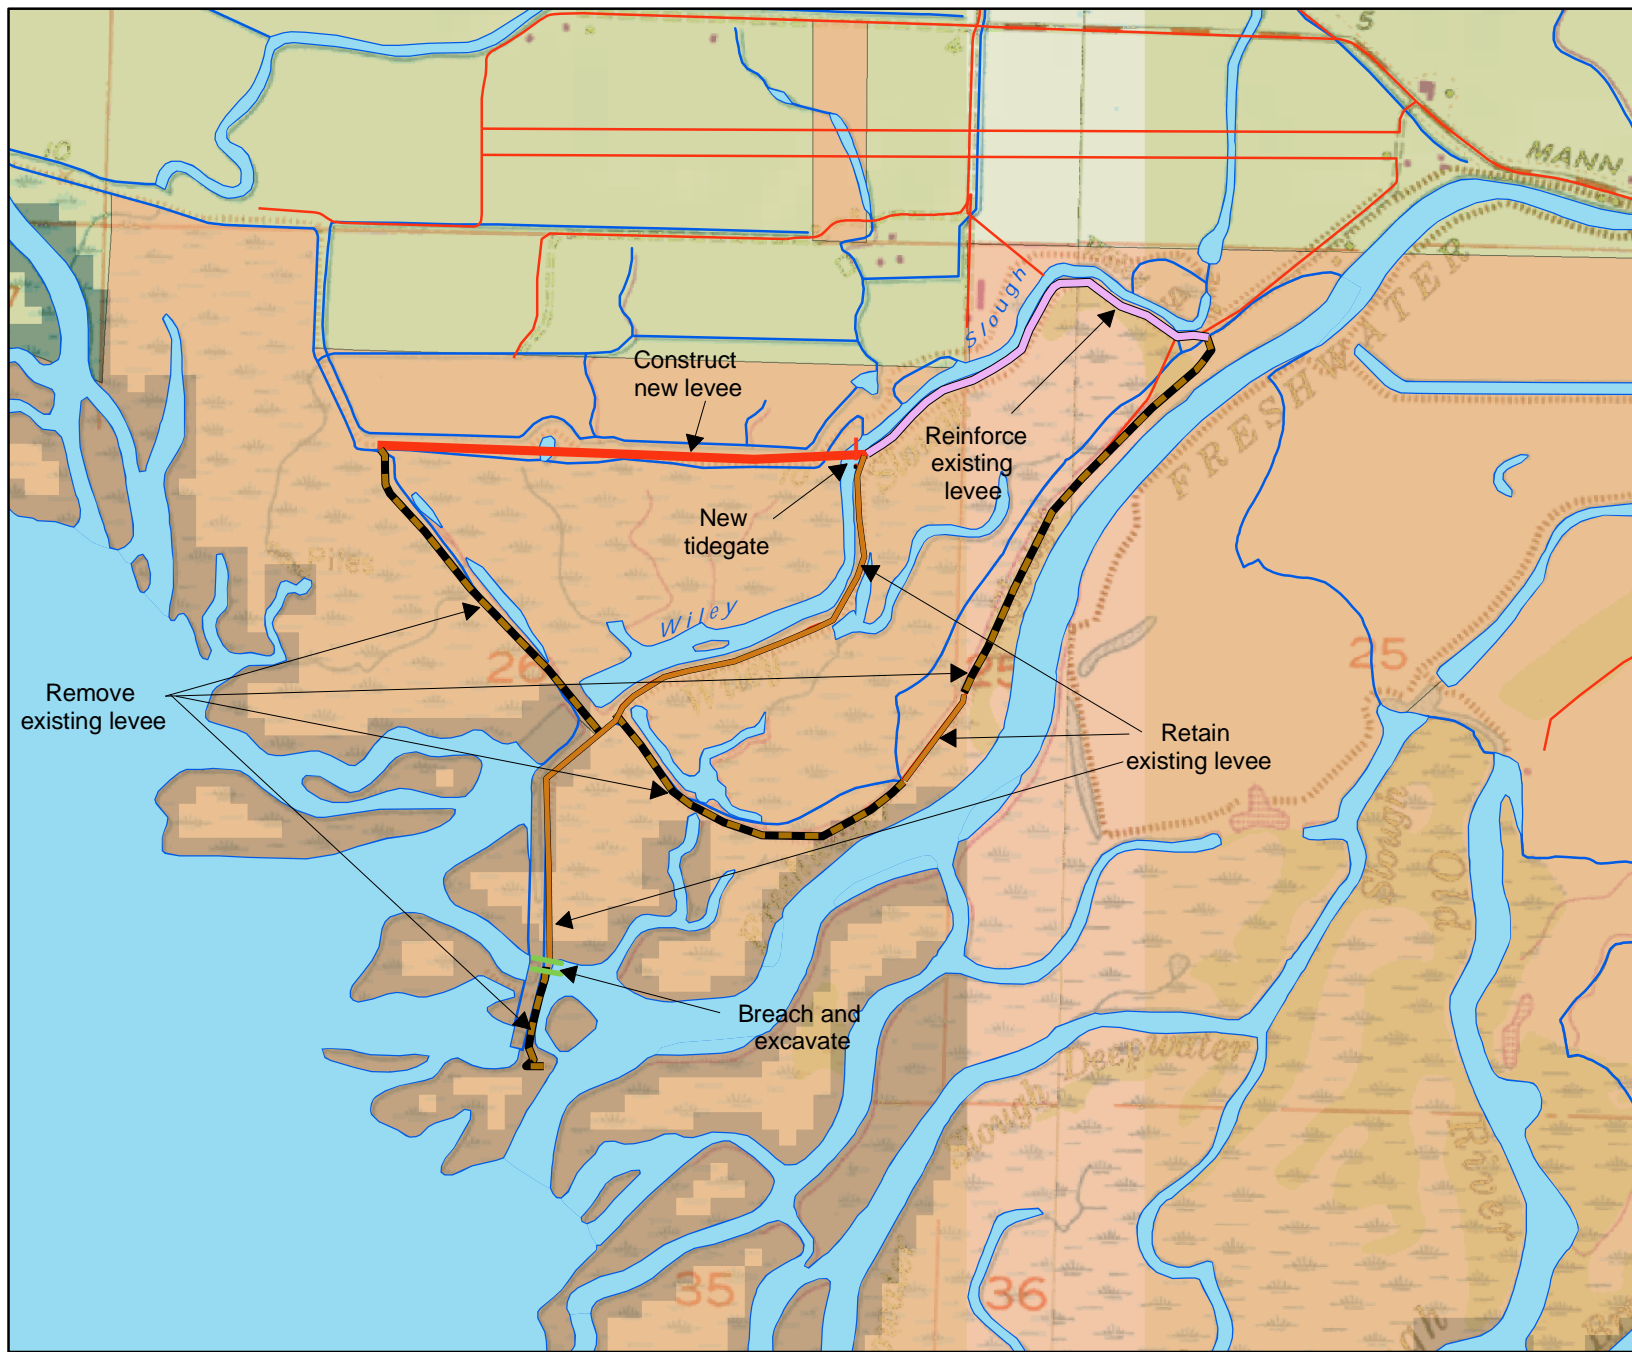
Figure 10. Skagit Wildlife Area, Fir Island Unit, Wiley Slough Subunit Restoration Draft Design.

Version 3.1 of the design report was approved by WDFW in July 2005 and that approval enabled the Team to pursue construction money immediately. Key elements of the draft and now final plan are shown in Figure 10. Since it is unlikely the total proposed cost of \$3.8 million can be obtained at one time, the construction will probably be staged over several years. The tide gate F115 will be moved up to where Figure 10 shows the new tide gate location. It will not be a SRT by agreement between the Department and the local drainage district. F119 will be eliminated and the other culverts retained since they are inside what will become the coastal dike (shown as levee to be reinforced in Figure 10). Work is scheduled to begin in 2007.

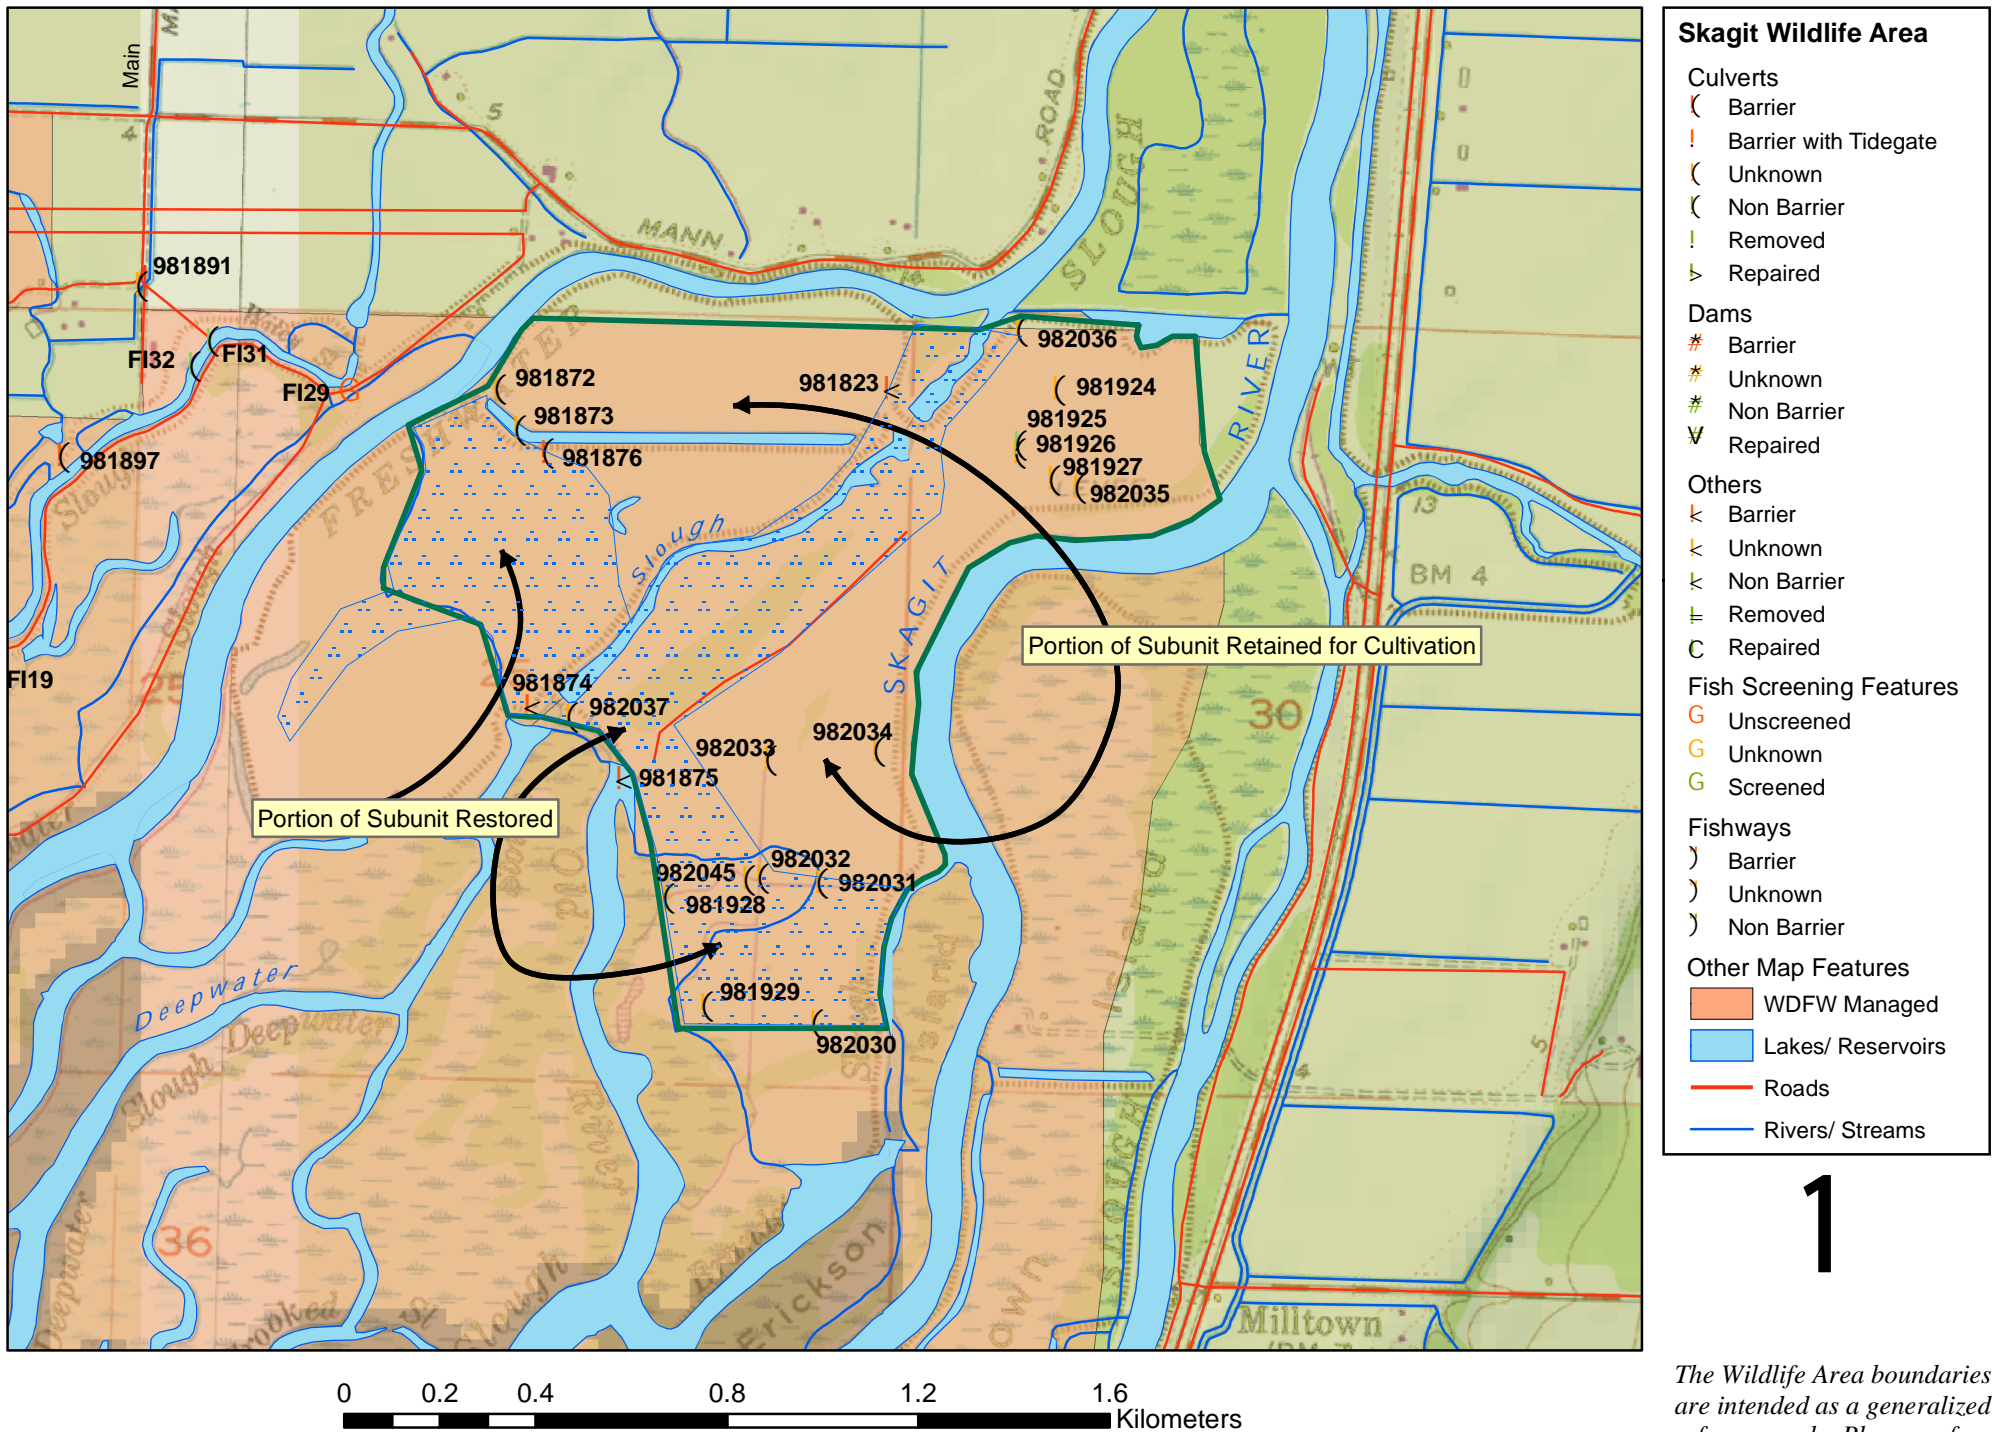
Figure 11. Skagit Wildlife Area, Fir Island Unit, Deepwater Slough Subunit - Restored and Unrestored Areas.

in two sections as shown in Figure 11. The remaining area continues to be farmed for waterfowl.

Currently, with completion of the recent restoration effort, there is little interest or support in the near-term for additional work at Deepwater. However, the department recognizes that salmon habitat recovery effort, especially for threatened Chinook, will focus on public lands first in the greater Skagit delta and eventually this site may be completely restored to provide the maximum estuary area obtainable.

Full restoration would breach the recently rebuilt and new dikes to allow the river to develop/restore a distributary network channel complex as originally existed or would occur under current hydrology and sediment processes. Grain production for waterfowl would either have to cease or be moved to an undetermined upland site. Culverts and other structures would be removed as part of the restoration.

Partial recovery would probably breach the dikes on one of the remaining sections. This option would likely be much less expensive than constructing new dikes to further reduce the size of one section or the other or both. It would also be easier to manage grain production on only one larger section than two smaller ones. Again, on whichever segment was abandoned, culverts and any infrastructure would be eliminated as part of the restoration. Refer to the inventory report for specific culvert identities that would be affected with a specific plan.

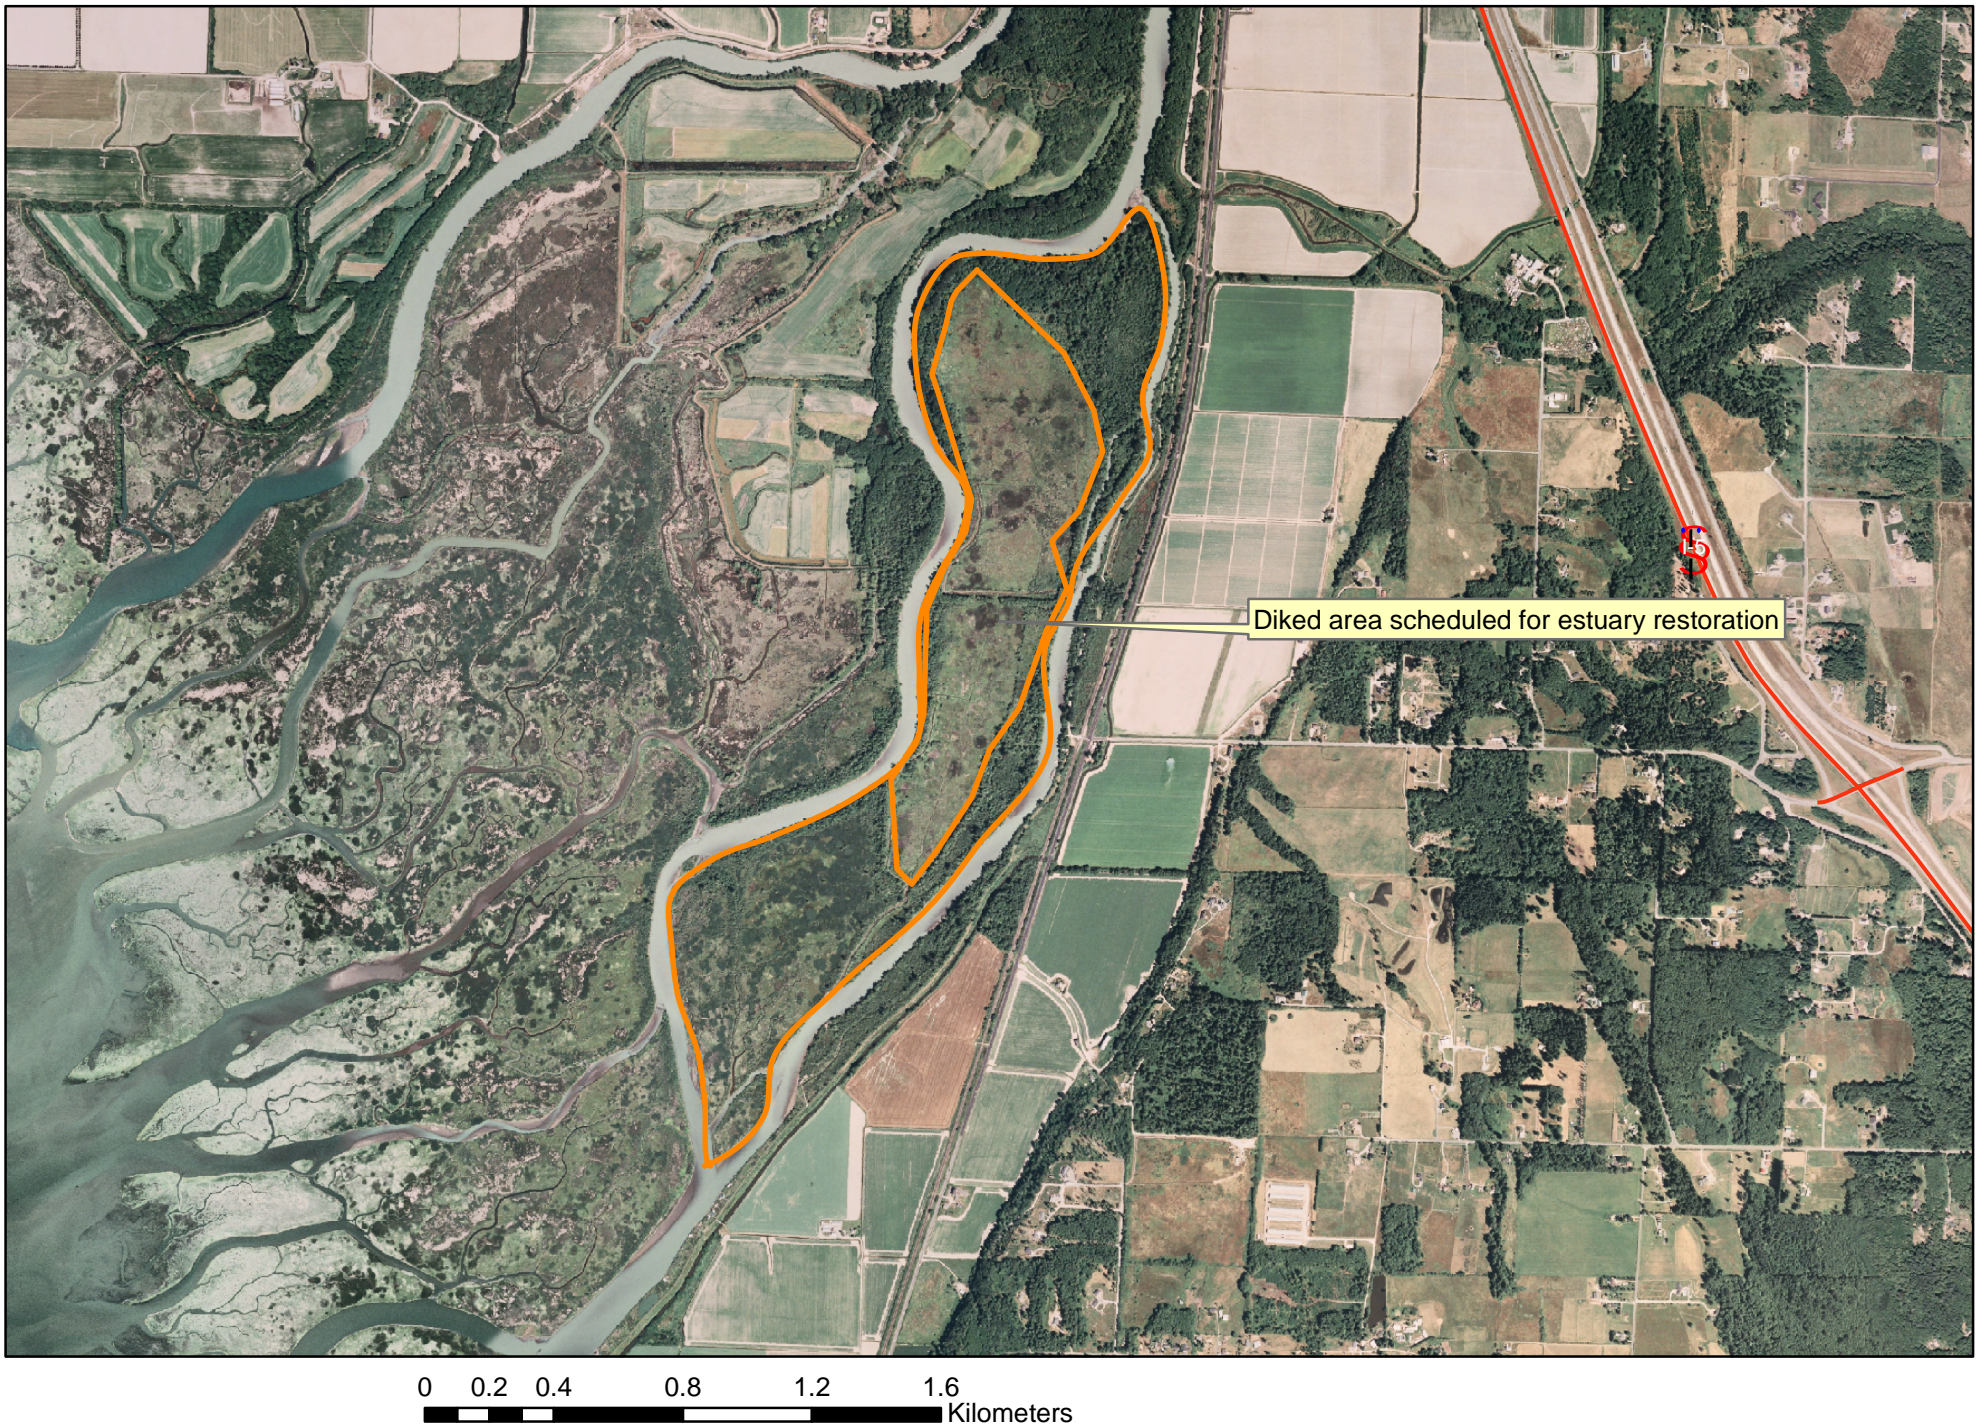
Figure 12. Skagit Wildlife Area, Fir Island Unit, Milltown Island Subunit.

The perimeter dikes were partially breached during floods in the 1970's and the department has done no active management since that time. Those breaches, however, did little to restore natural tidal channels and much of the diked area remained fallow, dominated by reed canary grass. Several *ad hoc* breaches were done after work at Deepwater Slough in 2000 but they made little improvement in restoration processes. About 212 acres of the island remain within the diked area. (see Figure 12)

In the fifth round of SRFB grants (2004), the Skagit River System Cooperative (SRSC) obtained funding to investigate and implement full restoration of the diked area to

estuary habitat. Planning is complete and they will be removing significant sections of the remaining dikes with blasting. They will also be implementing a vegetation management plan including mowing and planting to eliminate extensive stands of reed canary grass to hasten recovery of native marsh shrubs and emergent vegetation. They predict a minimum of 19 tidal channels can be recreated totaling about 15 acres of wetted slough. Work is to be completed in 2006/2007. Total cost of the restoration is \$455,000. (Skagit River System Cooperative 2004)
