September 2019 WDFW Gear Test and Results

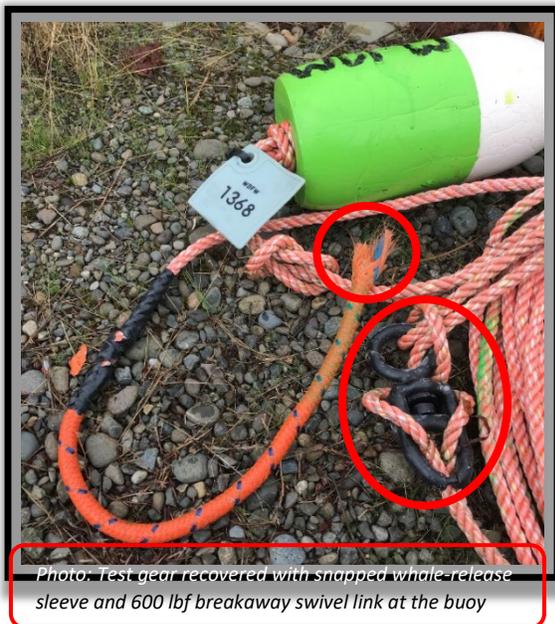
A total of five of twenty pots were lost during this study period, two of which were likely lost when the buoys were cut off by vessel traffic. The other three lost pots were tacked down in mud after initial deployment in places where pots are known to become stuck during normal fishing operations. When force was applied to line attached to each of the three stuck pots, the whale-release sleeve broke as designed. Two of these three had portions of the line that were returned to WDFW and our examination confirmed that that had occurred. See photo below.
