Site A just above Eldorado parking area December 2017  
View downstream

Cascade River Road near Eldorado Trailhead  
Site A Plan View  
Existing January 31, 2018

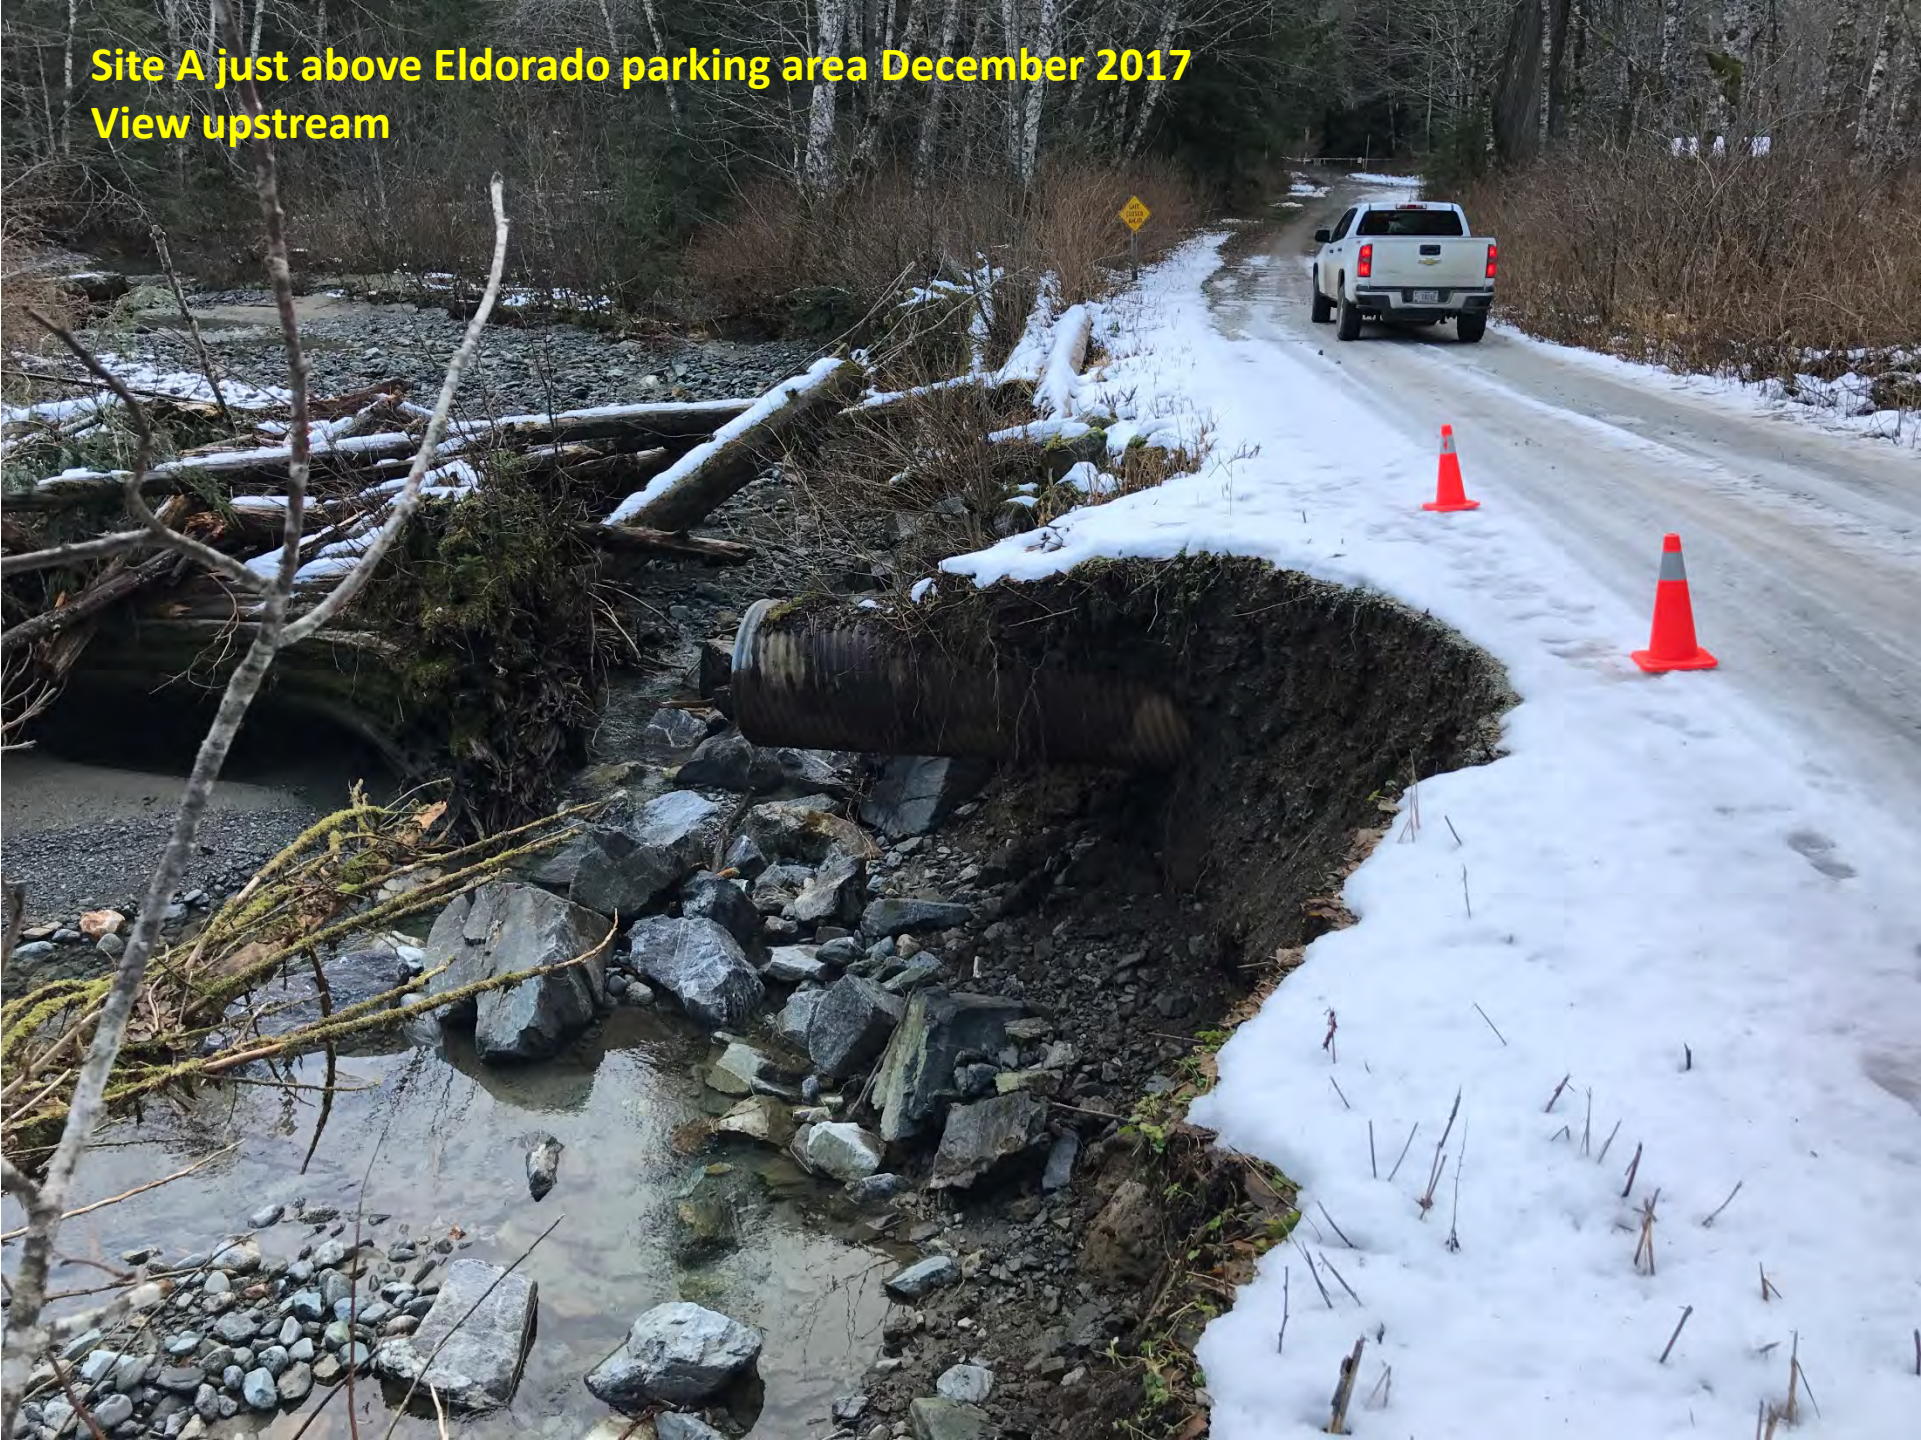
**Site A just above Eldorado parking area December 2017**  
**View upstream**

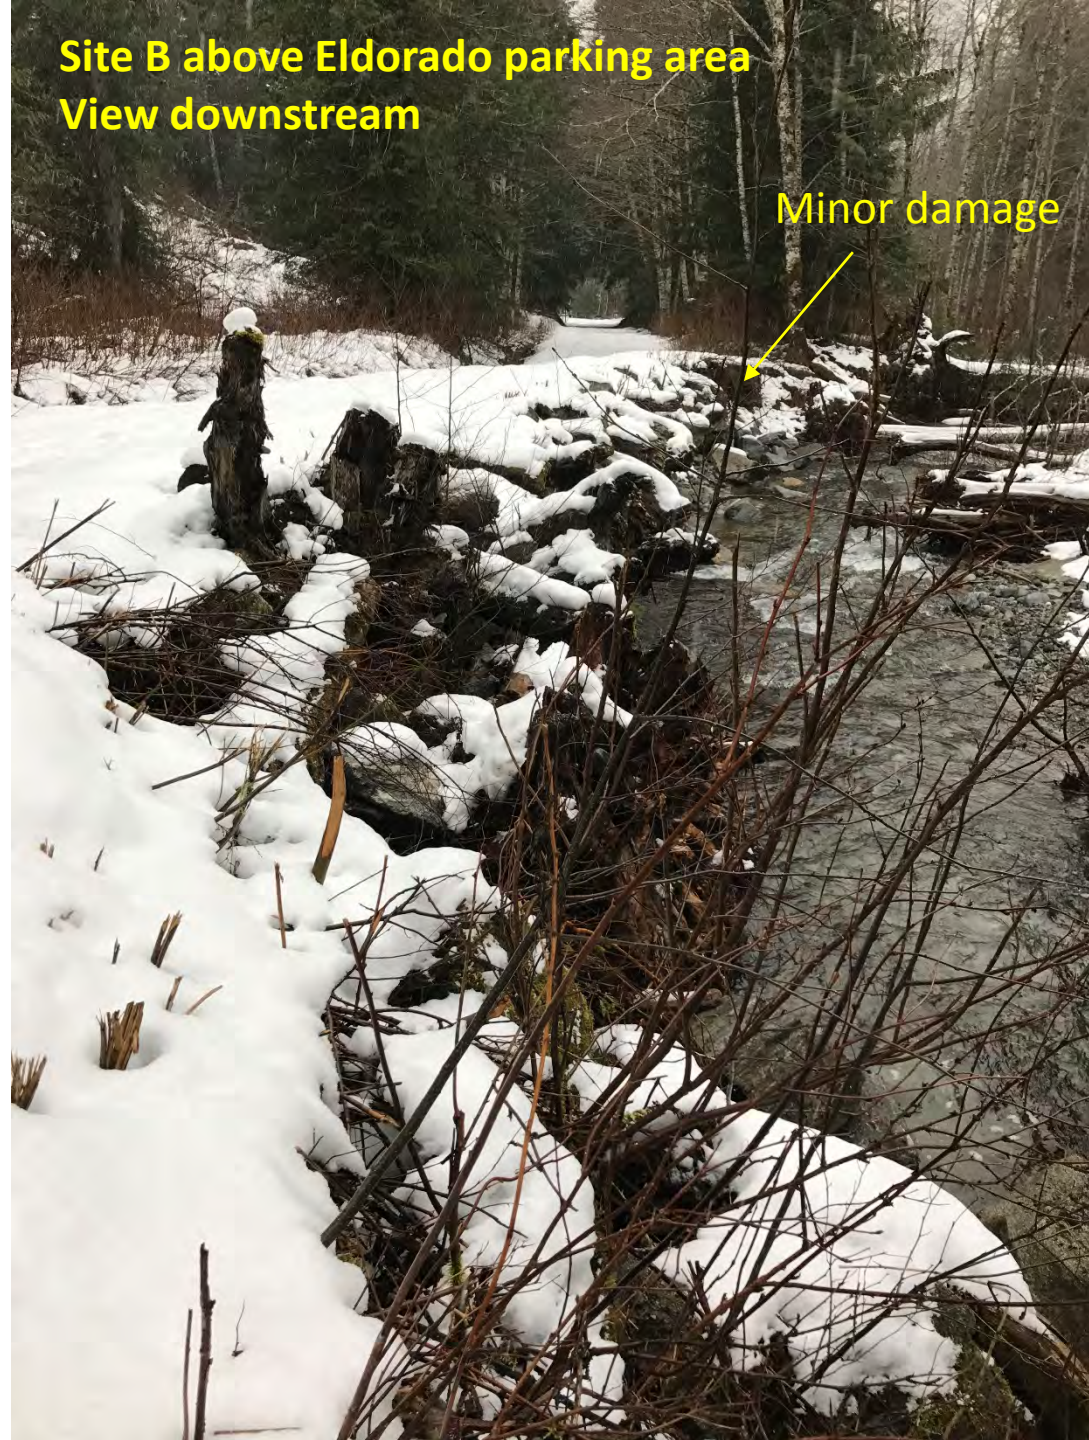
**Site B above Eldorado parking area  
View downstream**

**Minor damage**

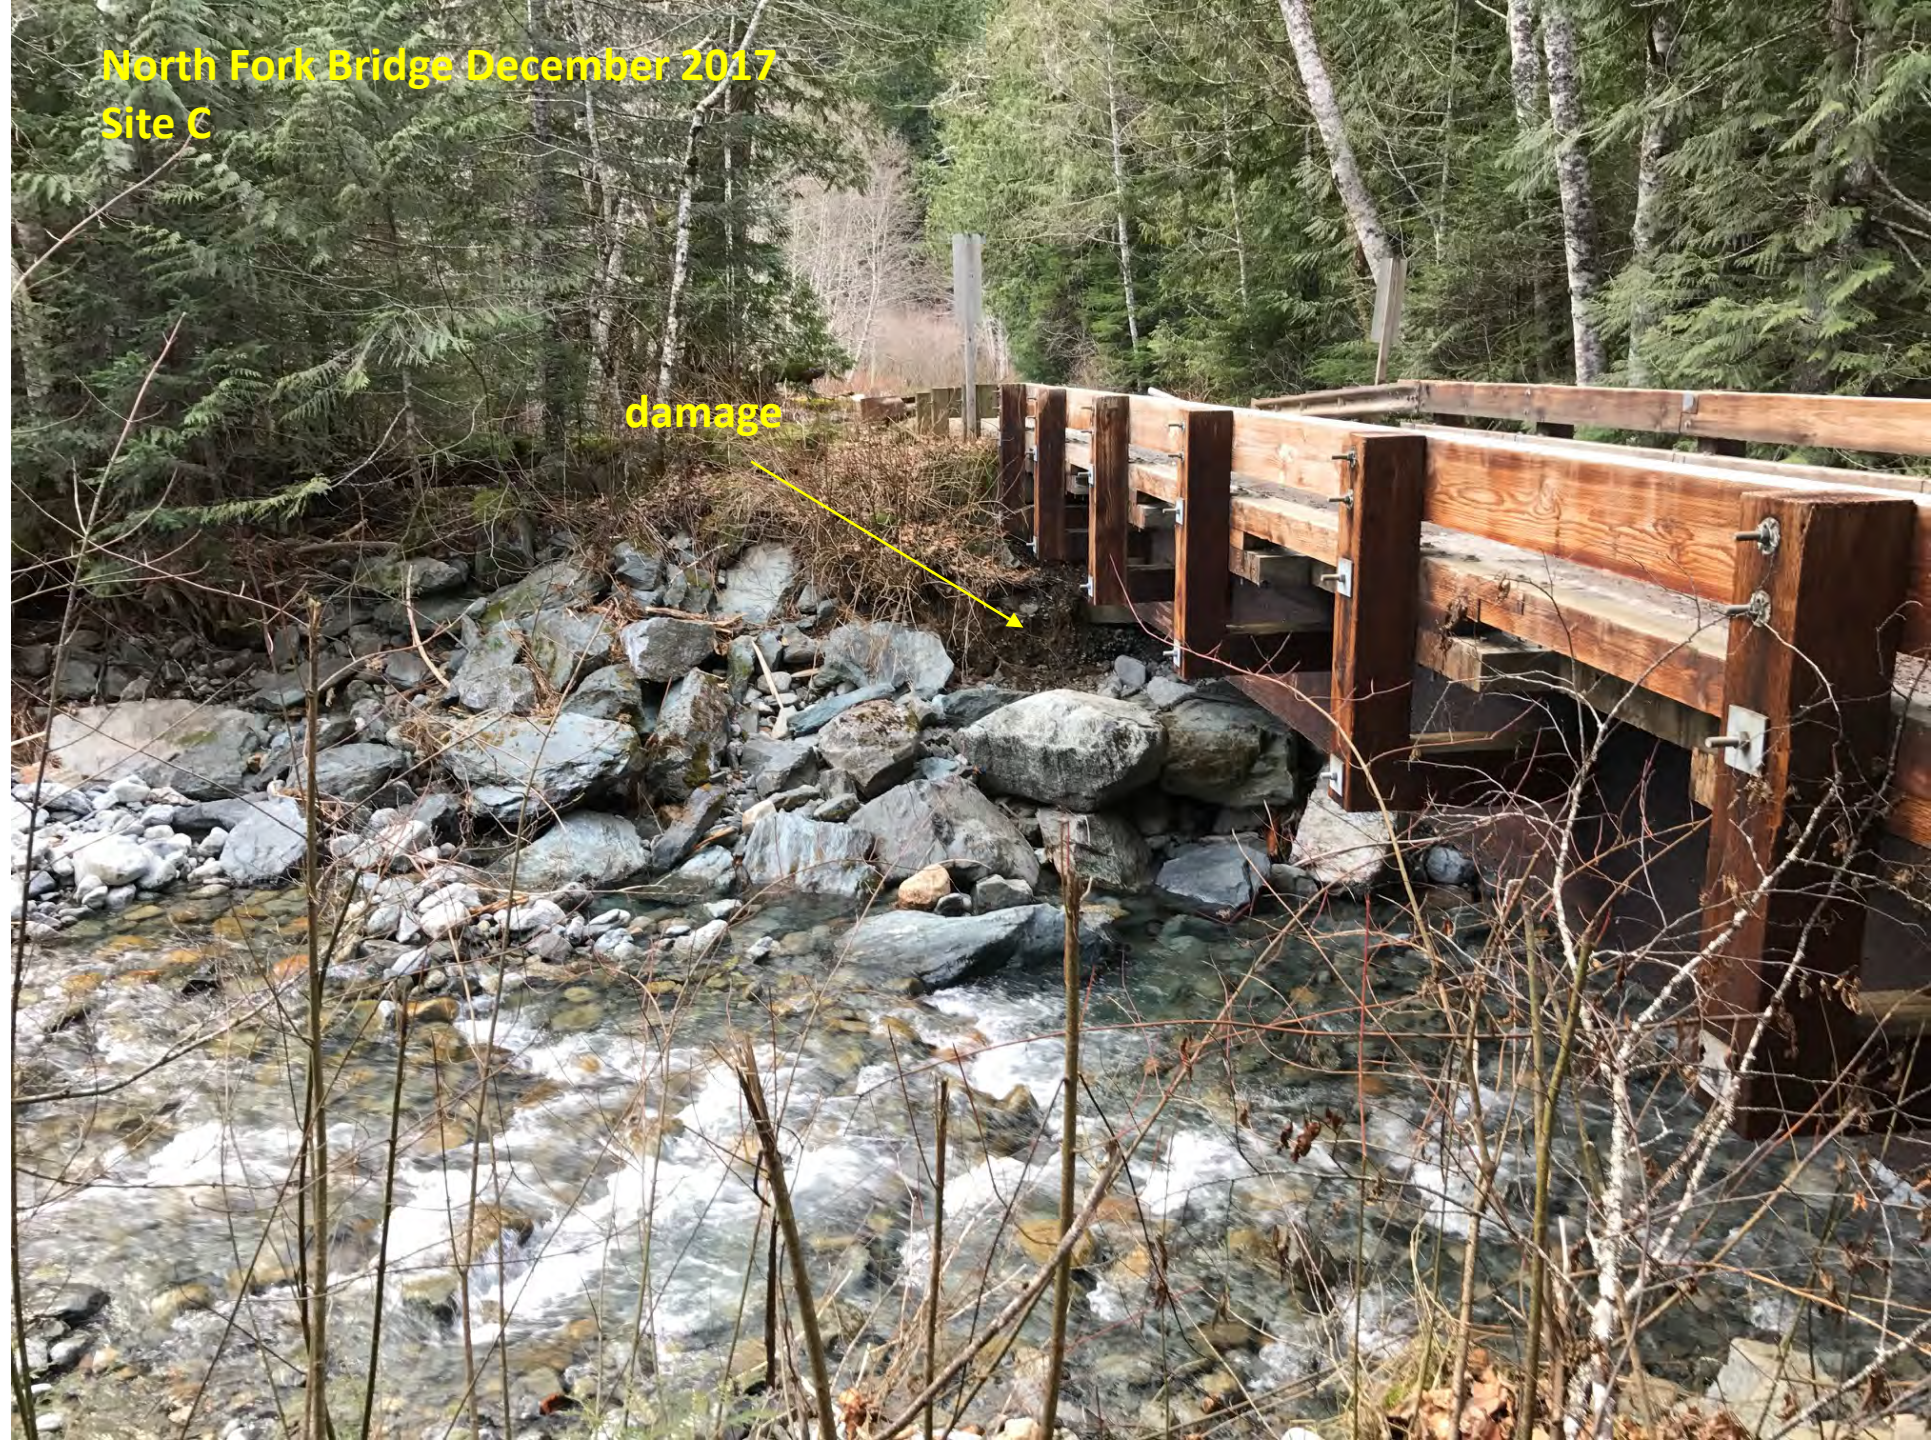
North Fork Bridge December 2017  
Site C

damage

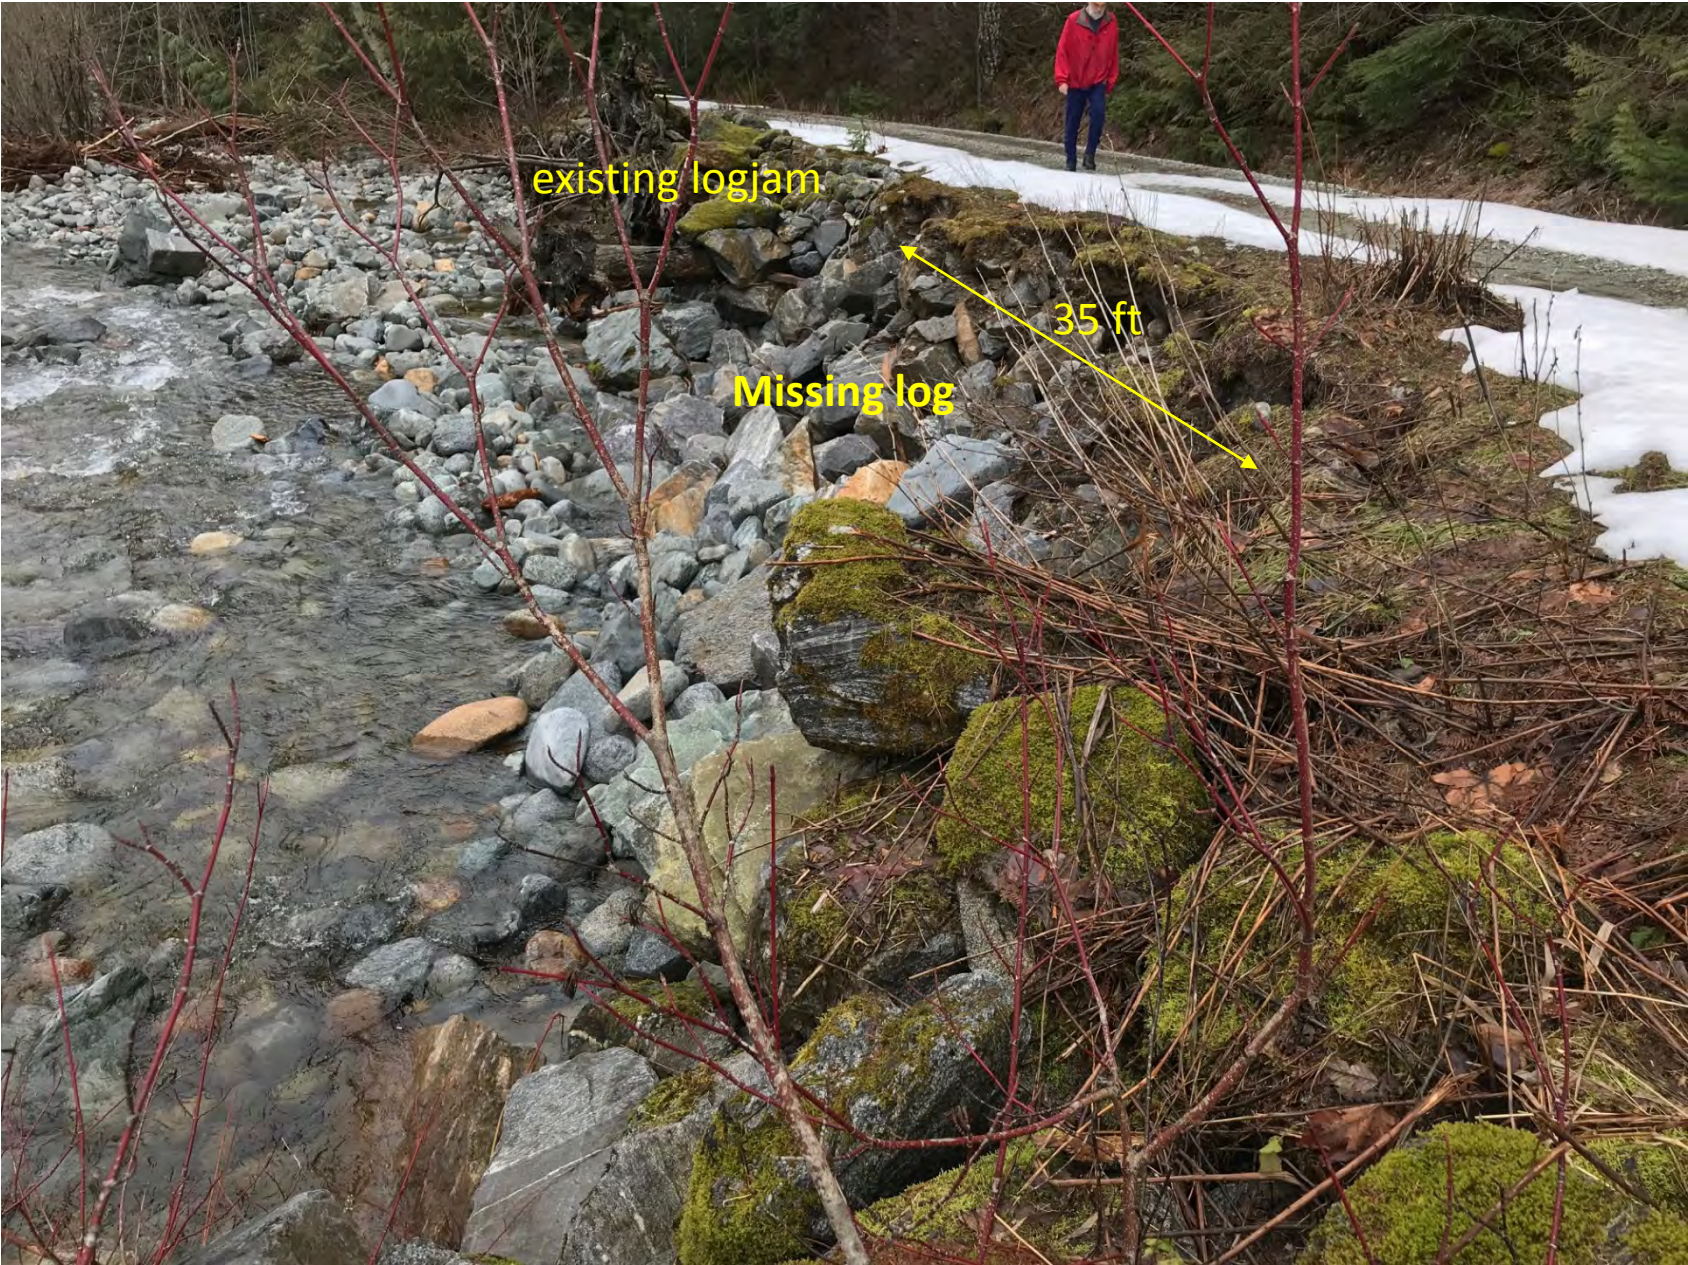
Cascade Road. Site D. View downstream at site of missing log

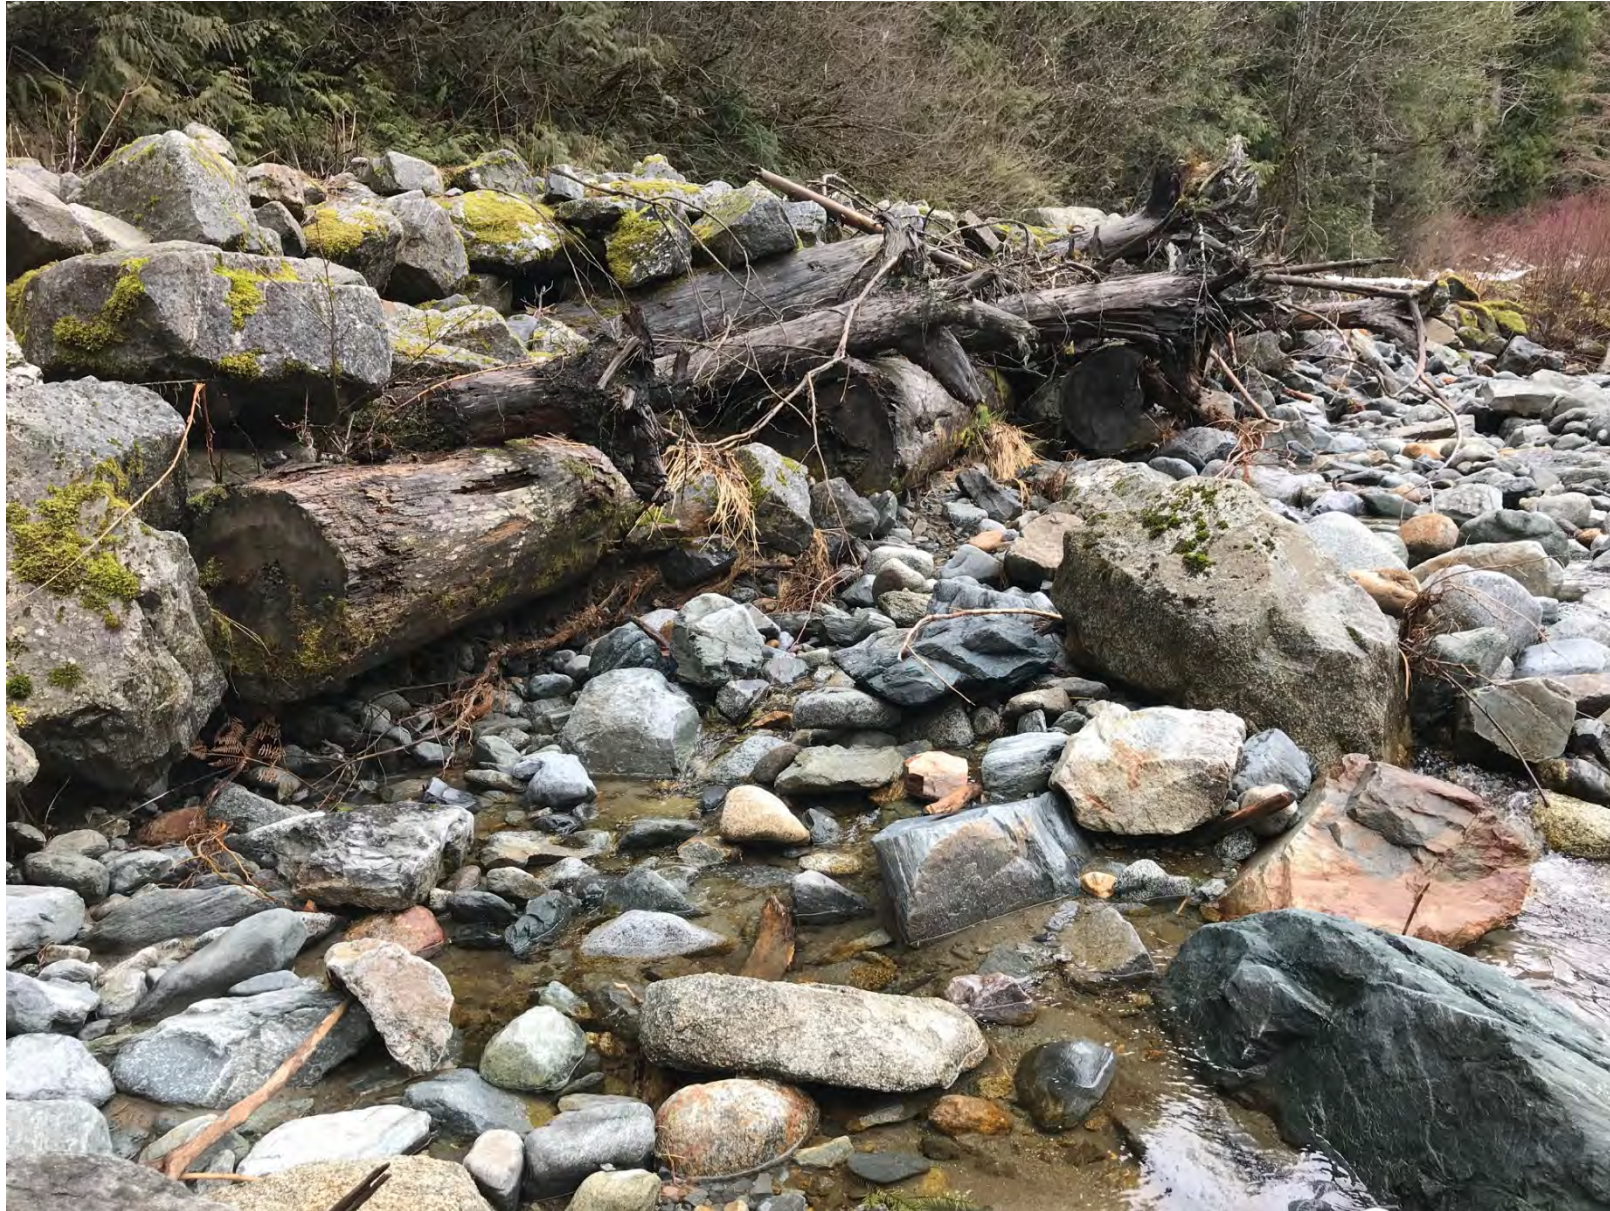
Cascade Road. Site D. View Upstream of Intact Logjam

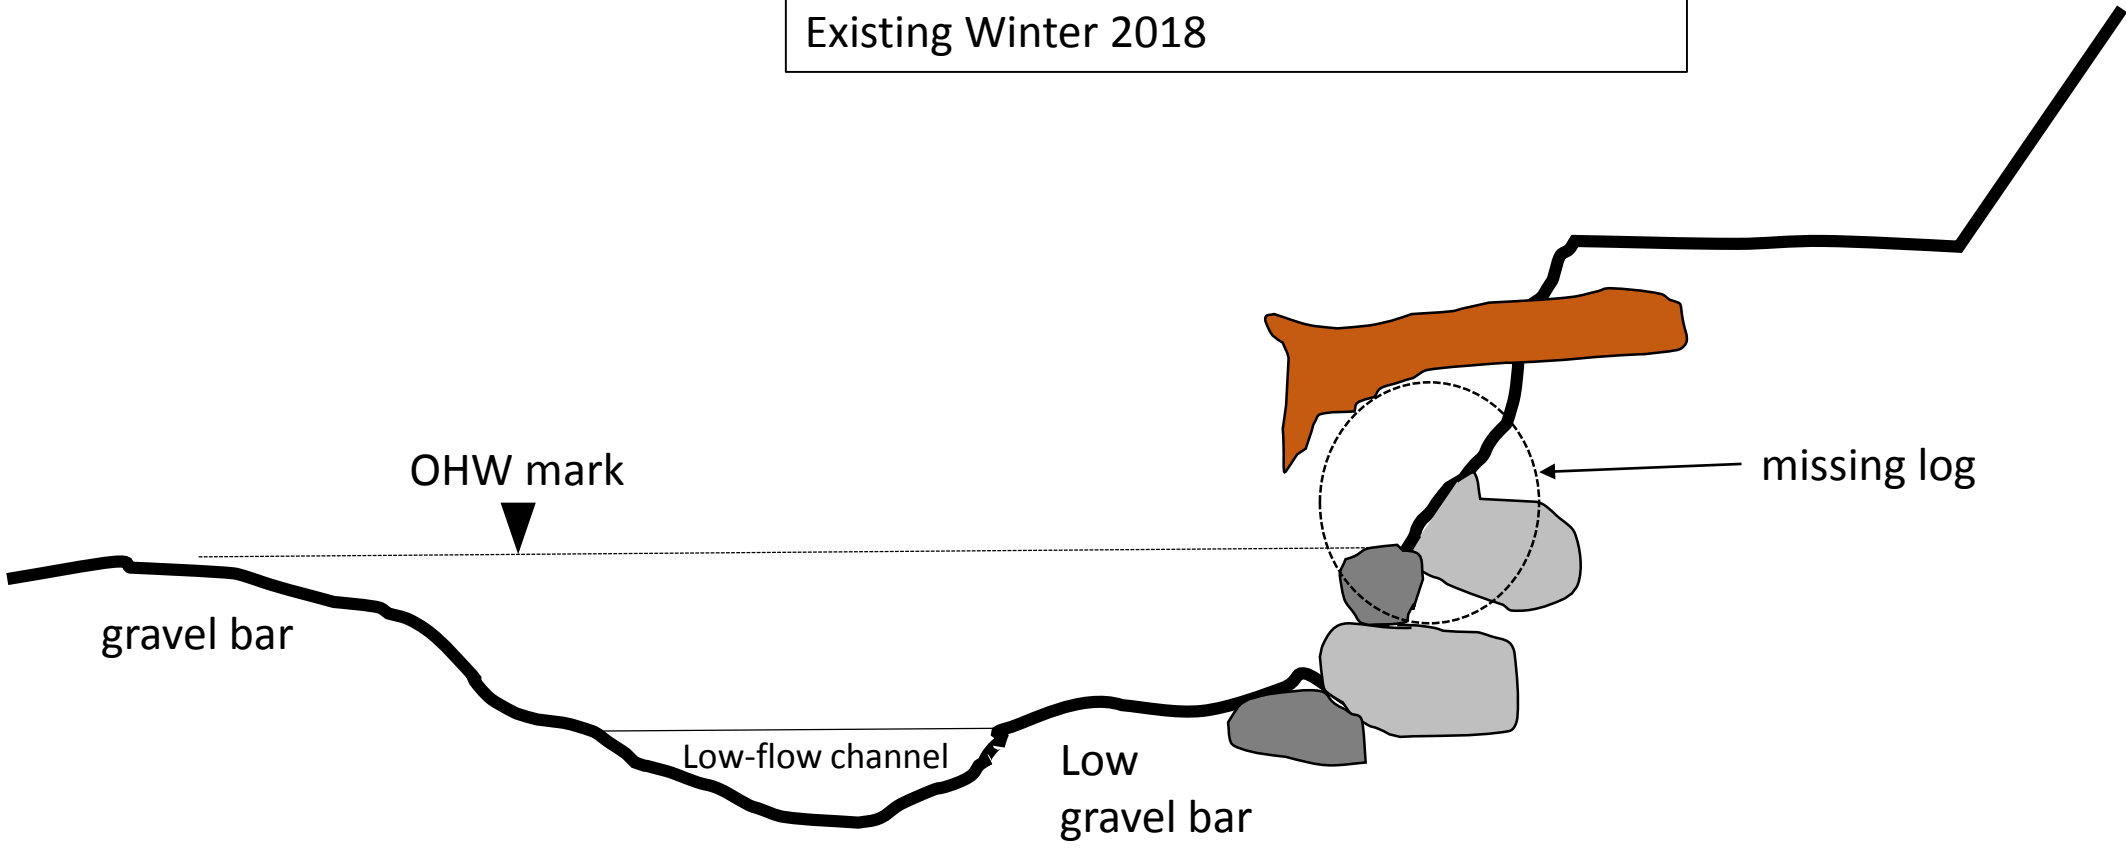
Cascade River Road near Eldorado Trailhead  
Site D Cross-Section View Downstream  
Existing Winter 2018

missing log
