## 4 REACH 10 CONCEPTUAL PROJECTS

#### 4.1 Project Area 1 (River Mile 50 to 48.9)

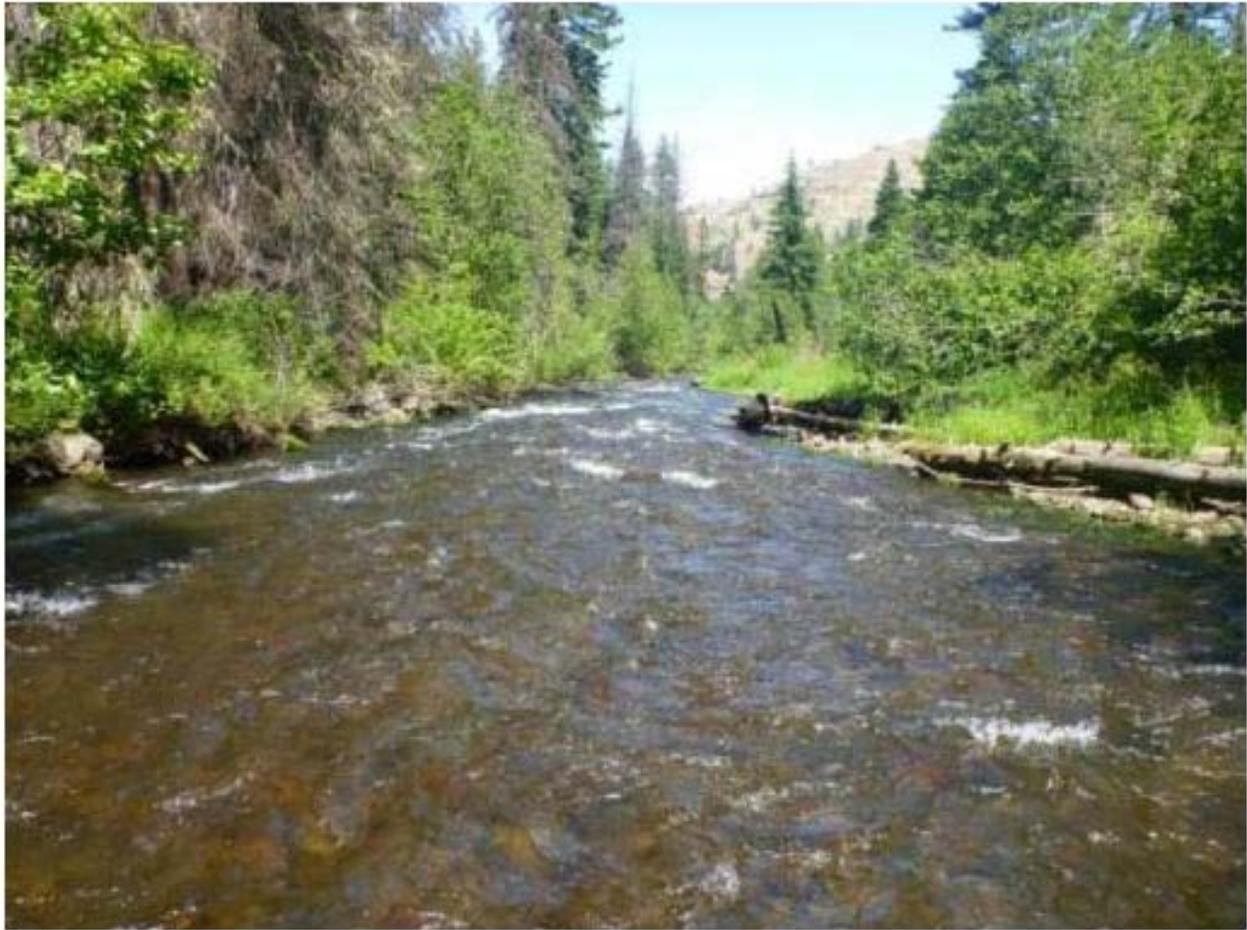
**Photograph 4-1**

The channel through PA-1 is characterized as a single-thread, plane-bed channel with local rapid sections (Photograph 4-1). This area is located in a relatively steep, narrow section of the valley. Five rock weirs are located within the project area and likely contribute to grade control of the channel profile. Multiple rock-rootwad restoration features were also observed throughout. Several minor side channels were observed during site reconnaissance, although many of these features are likely dry during the low-flow period. At approximately RM 49.05, a spring originates south of the campground and flows parallel to the river for approximately 0.1 miles.

**PA-1 near RM 49.6, looking downstream**

The quality of instream habitat is limited by the lack of hydraulic and bedform complexity in the channel. Very few key logs were observed, so pools and instream cover were generally limited to the locations of man-made structures and small side channels. Overall, woody debris retention and temporary sediment storage was low.

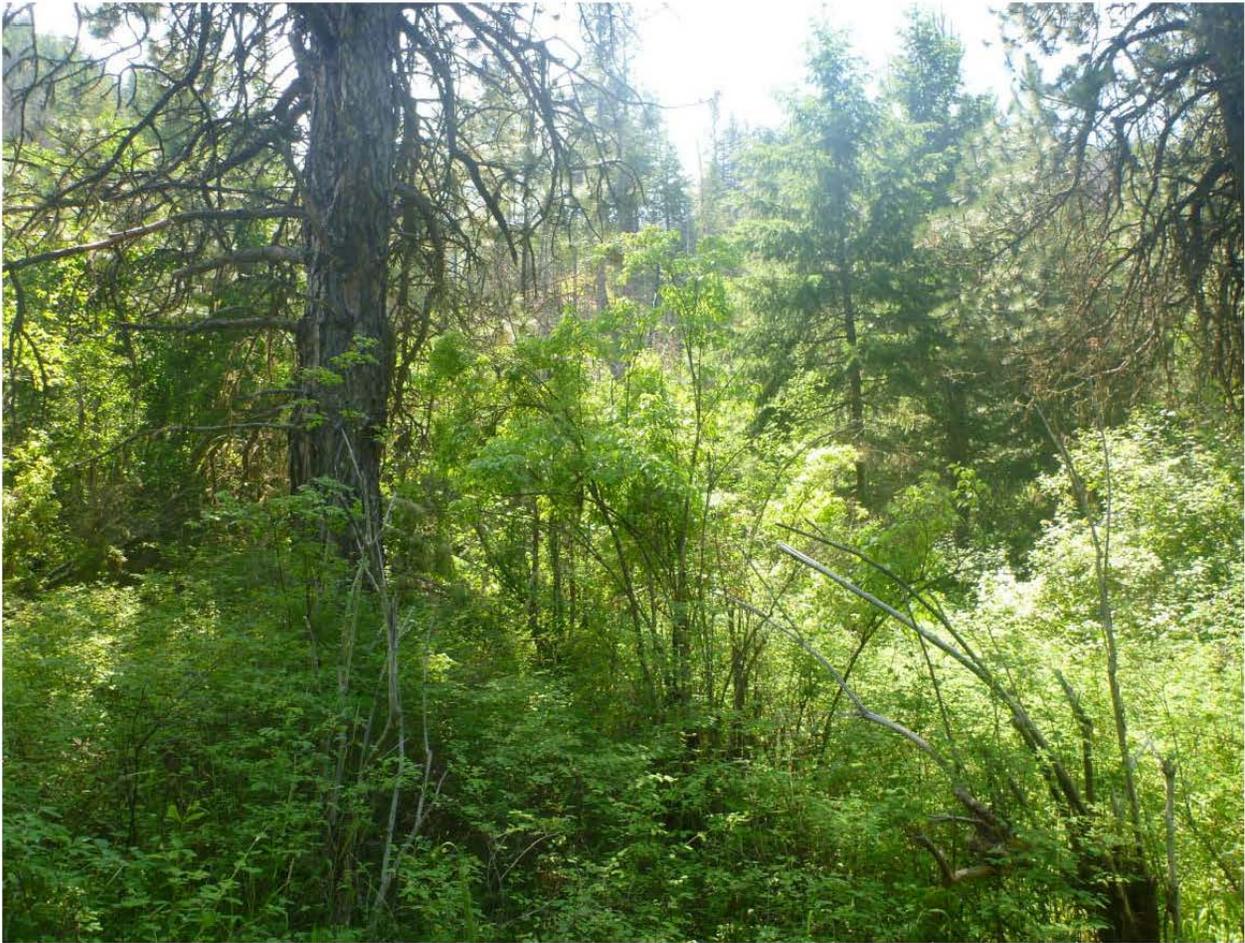
**Photograph 4-2**

by Ponderosa pine and dogwood. Understory vegetation is generally thick and healthy, containing fern and saplings that provide overhanging shade in the spring channel (Photograph 4-2). Species are moderately diverse, but contain many invasive plants, including reed canarygrass, St. John's wart, teasel, and creeping buttercup.

**Vegetation on the floodplain at the existing spring channel near RM 49.0**

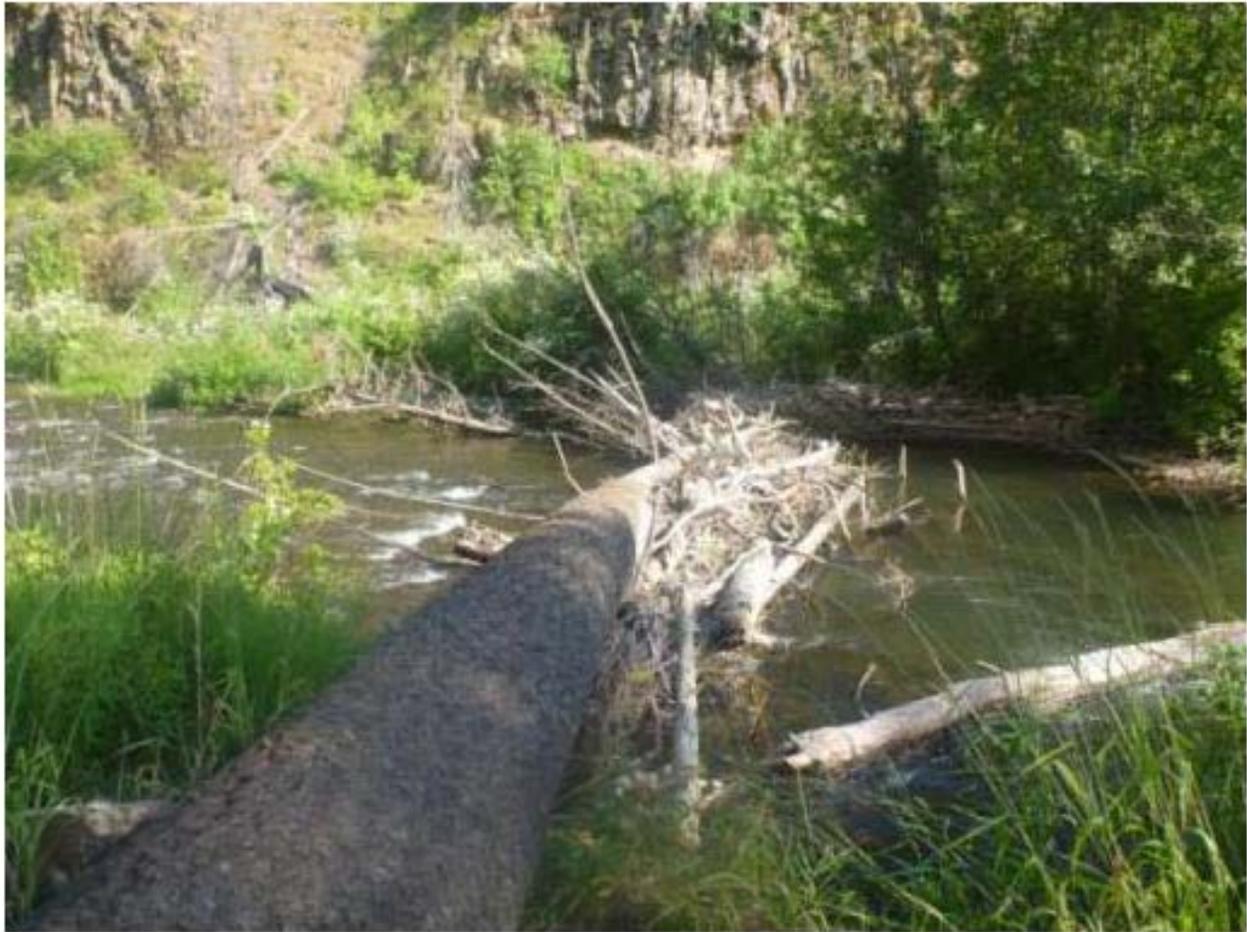
**Photograph 4-3**

The availability and quality of instream habitat is limited by lack of complexity and hydraulic conditions that prevent the retention of sufficient volumes of LWD and sediment. The spatial distribution of existing LWD is limited. Large jams and sediment deposits are present but sporadic (Photograph 4-3); the log jams that were observed were typically associated with local areas of high temporary sediment storage, split flow, and side channels. However, the majority of the project area is made up of long, straight, plane-bed stretches that lack any adequate cover or hydraulic complexity.

**A channel-spanning log jam near RM 47.5**

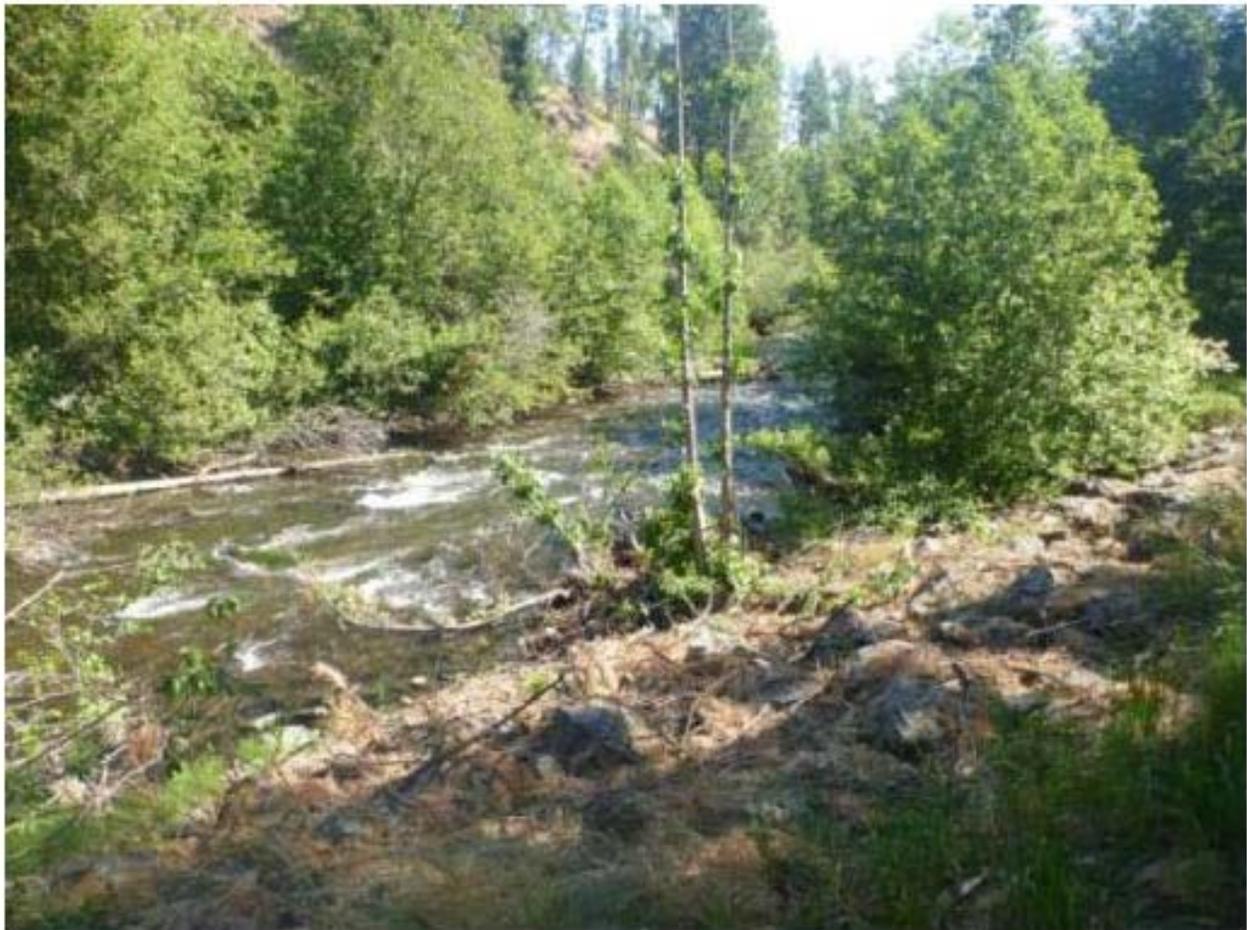
**Photograph 4-4**

In the upper portion of the project area from RM 46.8 to 46.65, the river contains multiple rapid/run channels separated by forested islands. Downstream of RM 46.65, the river and floodplain are highly confined between a levee and the road grade, which has resulted in a single-thread, high-velocity channel with large armor substrate and angular riprap banks (Photograph 4-4). The levee on the right bank currently serves as an access road to the upstream side of the Camp Wooten facilities, including Donnie Lake. The lake outfall channel flows along the toe of the road, meeting the main channel at approximately RM 46.55. Several juvenile fish were observed in the outfall channel. It is not clear if the pond itself is spring-fed or receives water via diversion from the river.

**PA-4 near RM 46.5, looking downstream from the right bank levee**

The quality of instream habitat in this project area is limited by the lack of hydraulic and bedform complexity in the channel. In the upper multiple-thread channel, some mobile debris has accumulated at the apex of islands and along the channel margins. The different flow paths create variable hydraulic conditions that are likely to be active year-round. Although a few trees were observed in the lower portion of the channel, the high-velocity conditions likely prevent any retention of mobile debris or sediment deposition, and these trees likely will be transported downstream during the next high-flow event.

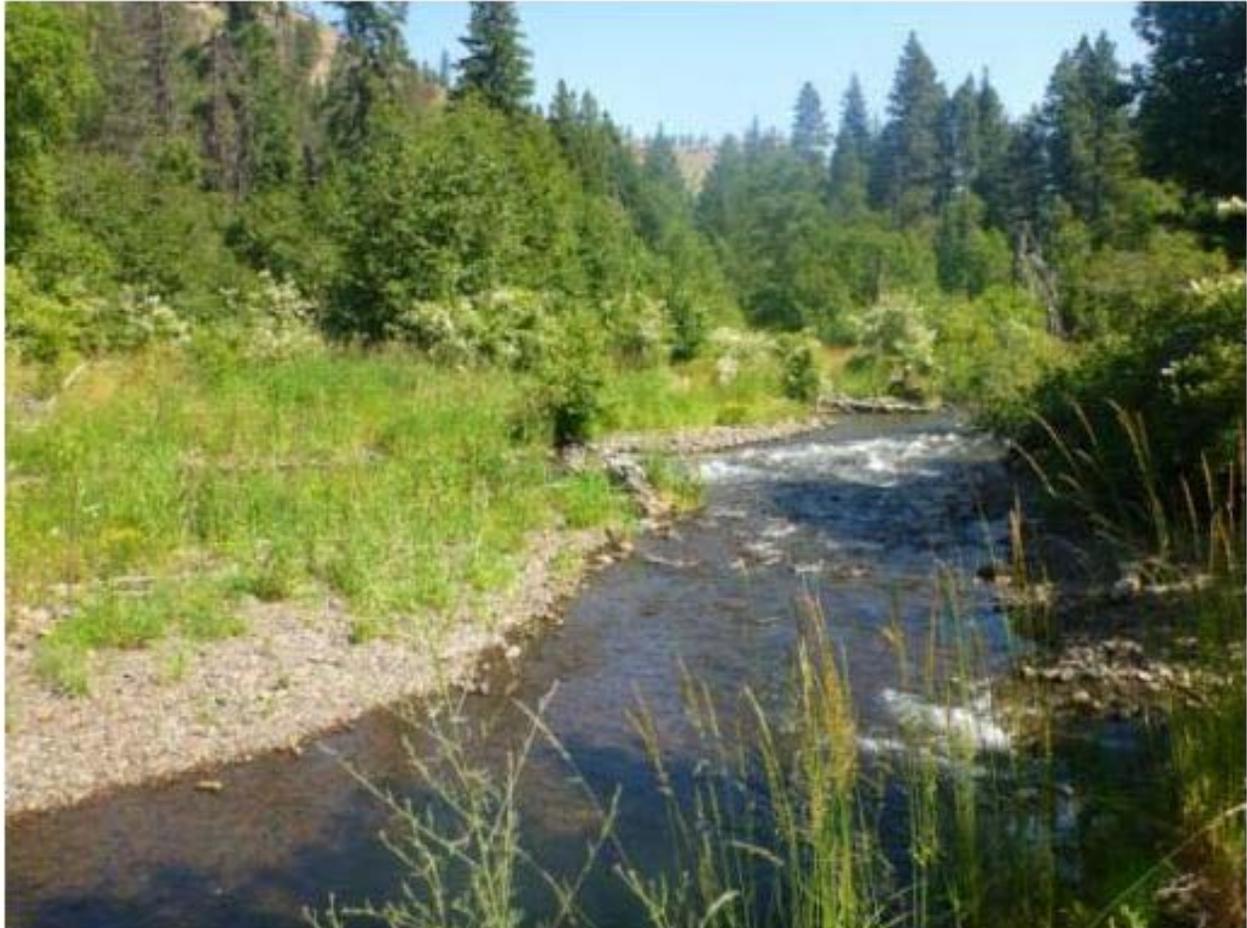
**Photograph 4-5**

Throughout the project area, the river is characterized by multiple channels separated by unvegetated gravel bars or forested islands. This portion of the channel is located downstream of a tightly confined section (PA-4). The active channel area is relatively wide and wood and sediment is more likely to deposit resulting in a relatively dynamic reach with a greater volume of LWD, temporary sediment storage, and channel migration than has been observed in upstream reaches (Photograph 4-5). Steady migration of meander bends was observed in many of the outside meander bends, most notably at RM 46 along the left bank. Side channels ranging from perennial to high-flow were observed with variable depths and

presence of LWD. Many side channels, however, were relatively wide, shallow, and lacking complexity.

**A secondary flow path within PA-5 near RM 46.1, looking downstream**

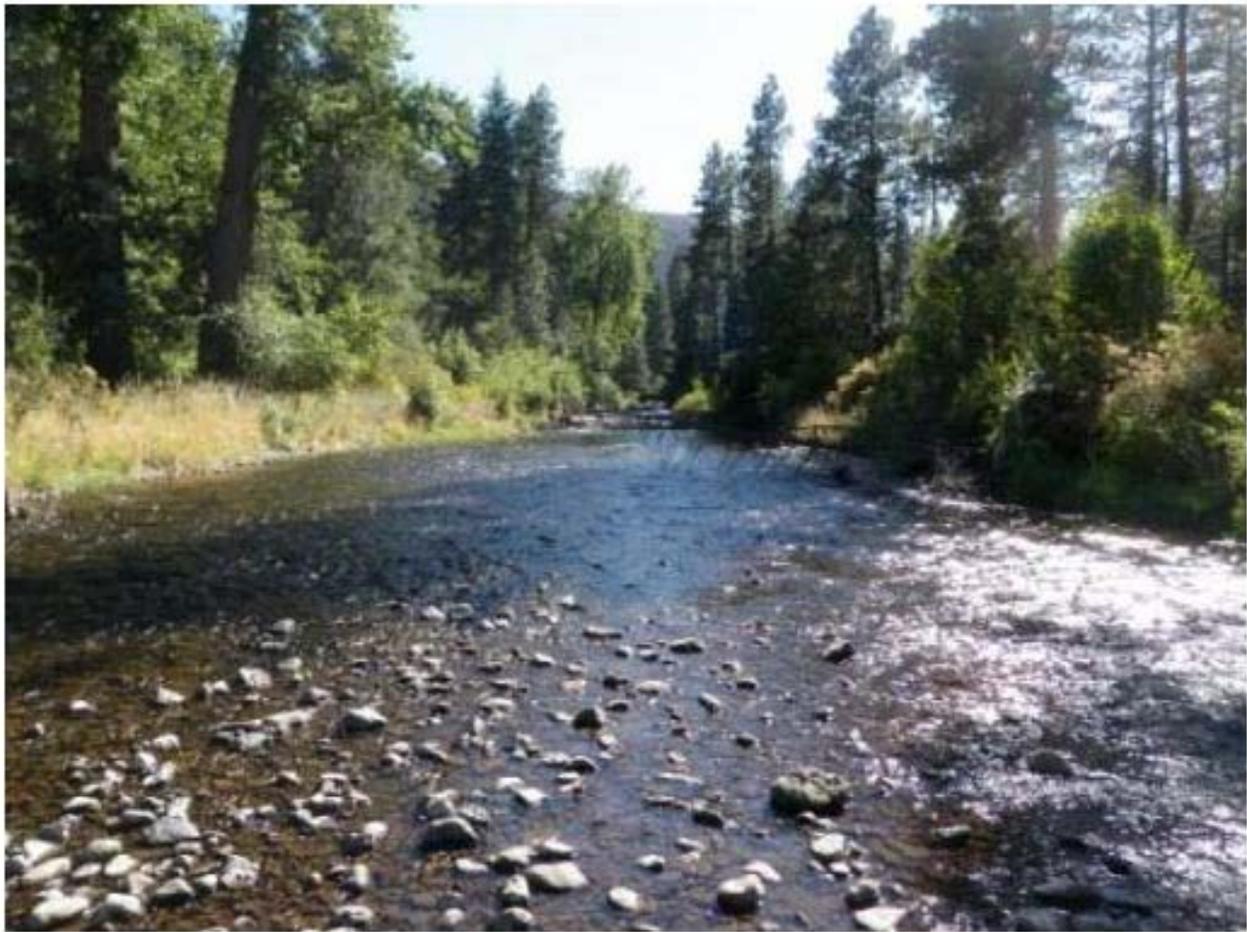
**Photograph 4-6a**

In the upper portion of the project area from RM 45.95 to 45.7, the channel is a single-thread, plane-bed channel with little complexity (Photograph 4-6a). Two vortex weirs between RM 46.0 and 45.8 hold the channel grade and form deep pools on the downstream end. This portion of the channel contains very little LWD or other hydraulic complexity, other than the pools at the weirs. Very little suitable habitat for juvenile fish was observed except near the channel margins. Habitat conditions may also be affected in the summer months by recreational use as this portion of the river is adjacent to the campground.

**The plane-bed section of the channel during low flow near RM 45.8, looking upstream**

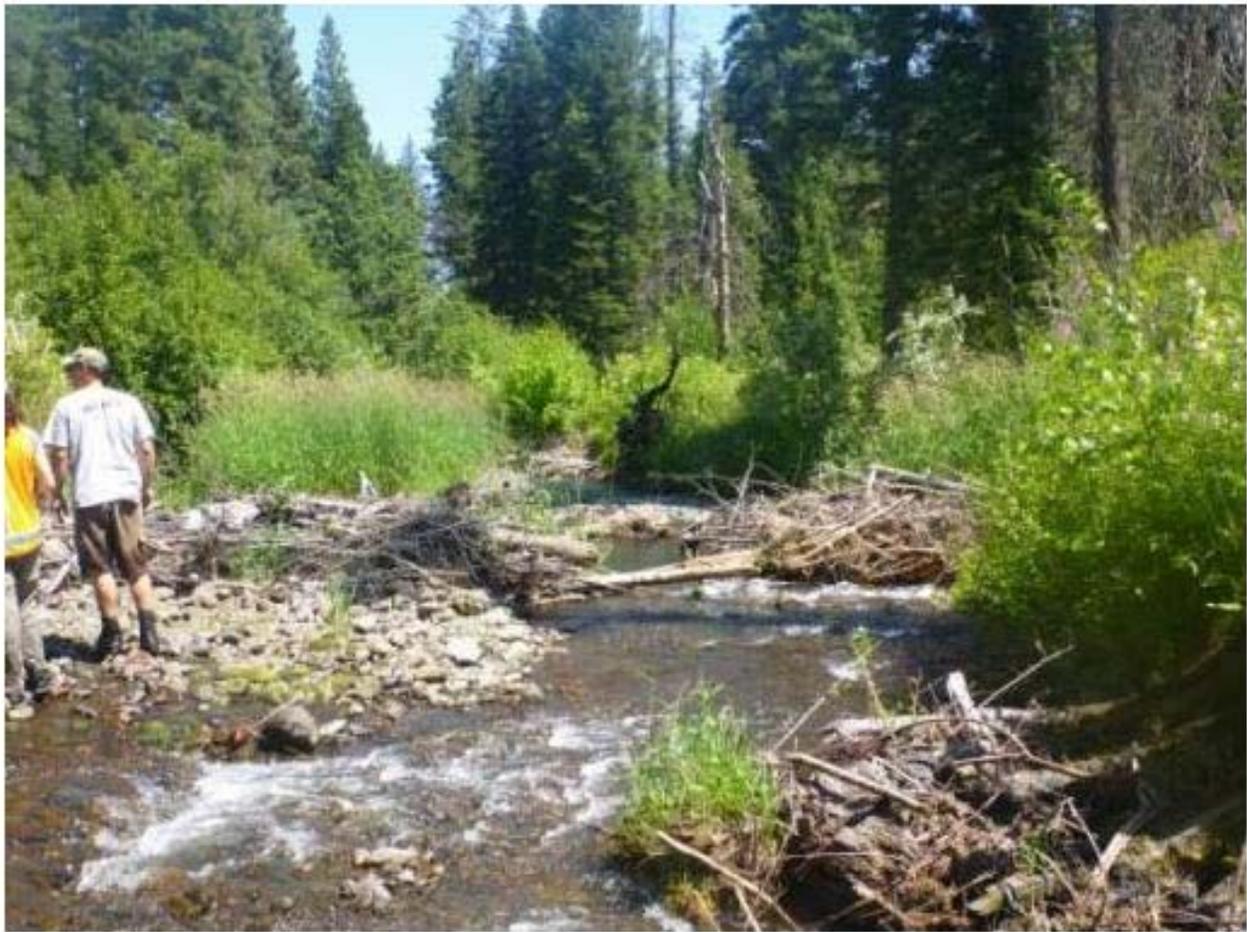
**Photograph 4-6b**

Between RM 45.7 and 45.3, the channel is a more complex, multi-channel configuration with forced pools and riffles at LWD and along the bedrock valley wall (Photograph 4-6b). Instream habitat conditions in the main channel are generally good, due to the presence of large LWD that retains additional mobile wood and forces deep pools. Two large side channels that meet the main river at approximately RM 45.5 and RM 45.3 provide good off-channel rearing habitat with ample cover, depth, and low velocities.

**A side channel with moderate woody debris near RM 45.4, looking downstream**

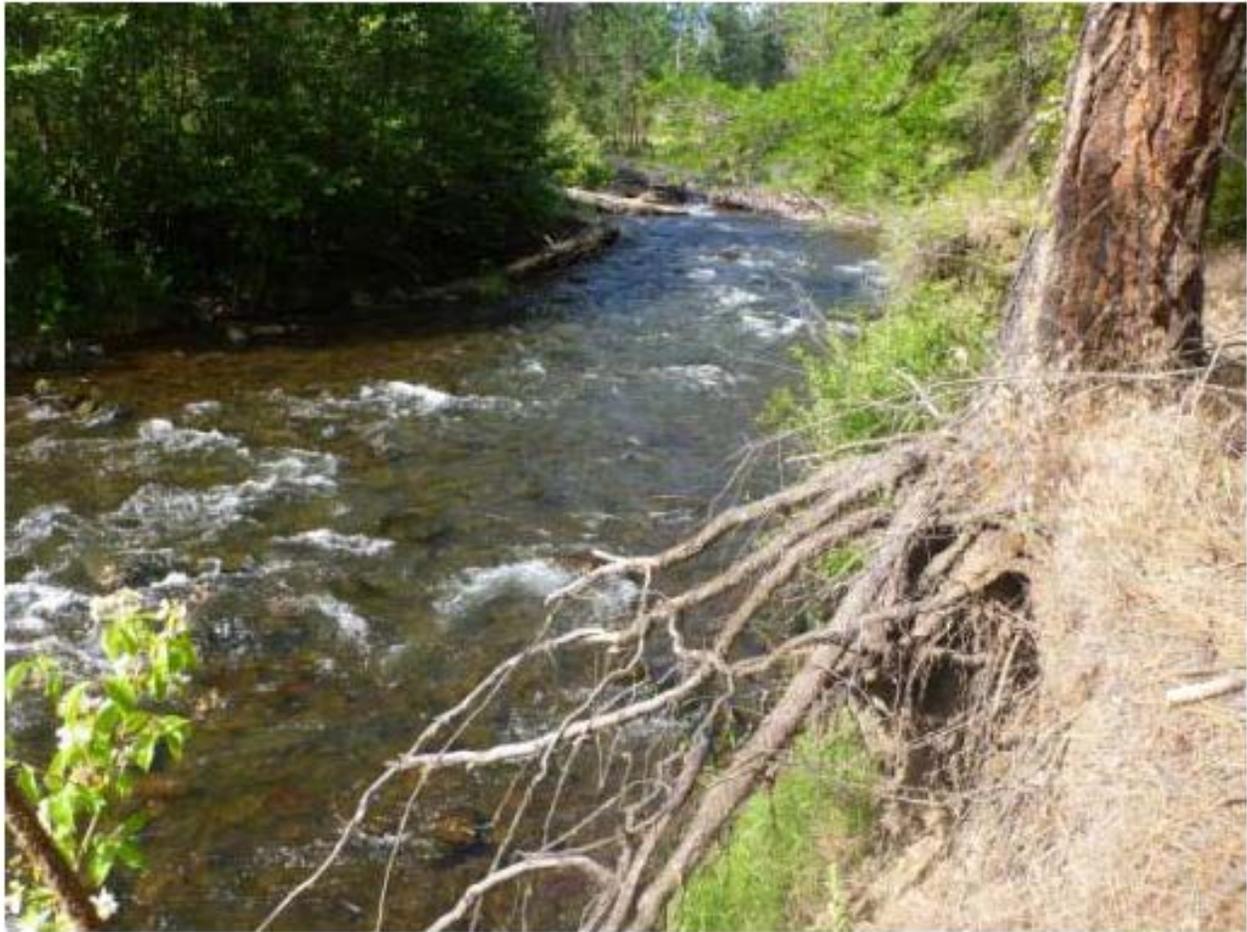
**Photograph 4-7**

Within this project area, the channel is a single-thread, plane-bed channel with local rapid sections. Between RM 45.2 and 45, the channel is entrenched and incised between alluvial fan deposits and Tucannon Road, which appears to be built mostly on remnant fan deposits. An approximately 10-foot high bank between RM 44.9 and the Curl Lake intake also indicates an incised condition (Photograph 4-7). The section of the channel between RM 45.3 and RM 44.9 contains multiple rock and rootwad restoration features that force pools along the margin of the channel. Immobile boulders in the channel bed also provide a minor amount of pool formation and hydraulic complexity. Some riprap is present along the channel banks between RM 45.1 and 45.05, although it likely has no effect on channel migration in its currently entrenched state. At the Curl Lake intake, the channel is roughened with boulders and cobbles.

**An incised section of the main channel near RM 44.9, looking upstream**

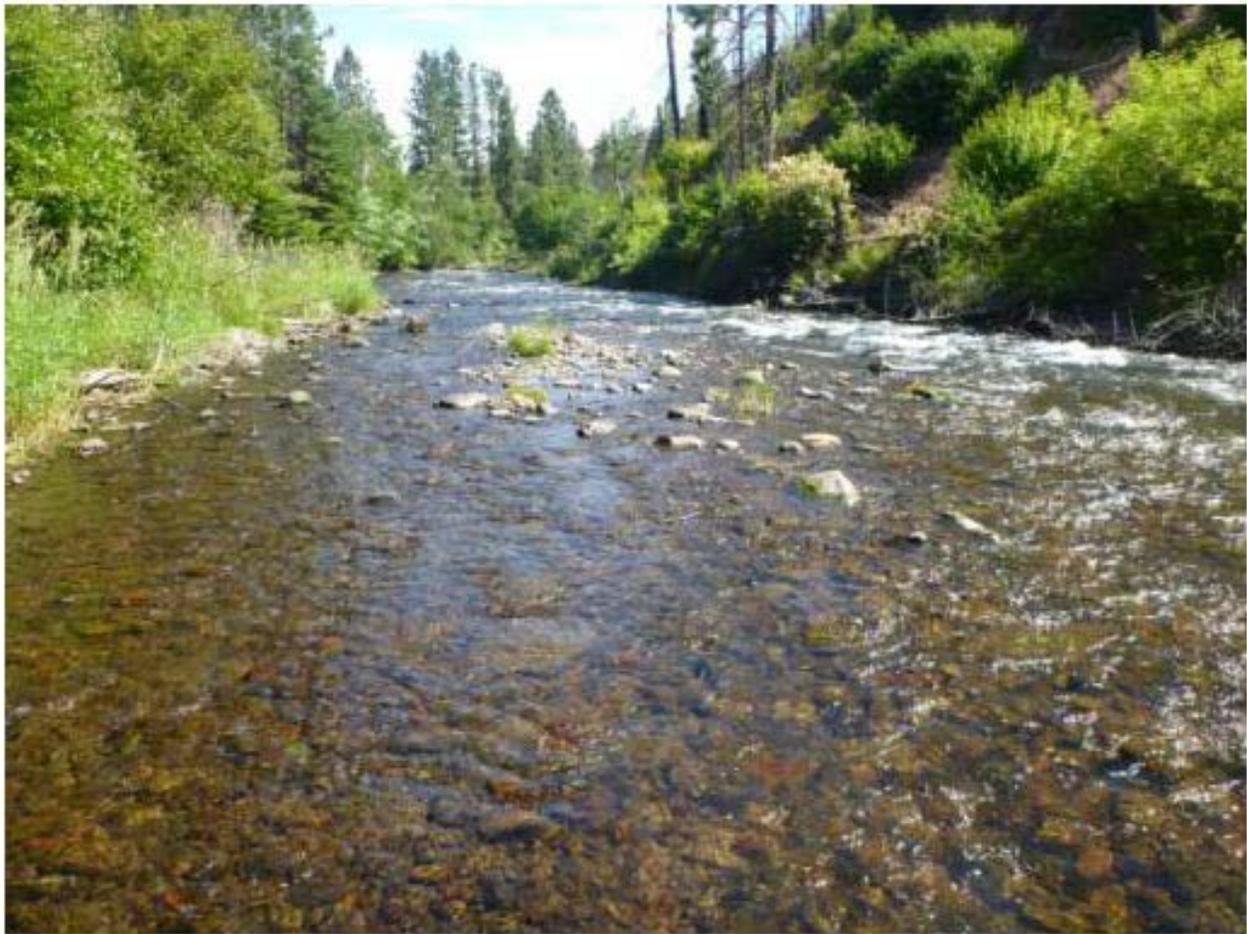
Throughout the project area, the single-thread channel is typically wide, shallow, and plane-bed. A few local high-velocity areas occur along the toe of the bedrock valley wall (Photograph 4-8). Levees are present along much of the left bank, confining the active channel and low floodplain to the far side of the valley. No side channels or secondary flow paths were identified. A large ELJ is present on the right bank at RM 44.8 and provides some cover and pool habitat. The channel contains little other LWD except small, transient material. Although juvenile fish may use the shallow margins of the channel, the lack of cover, complexity, and pools results in generally poor habitat conditions throughout this section of the river.

**Photograph 4-8**  
**The mainstem channel near RM 44.7, looking downstream**

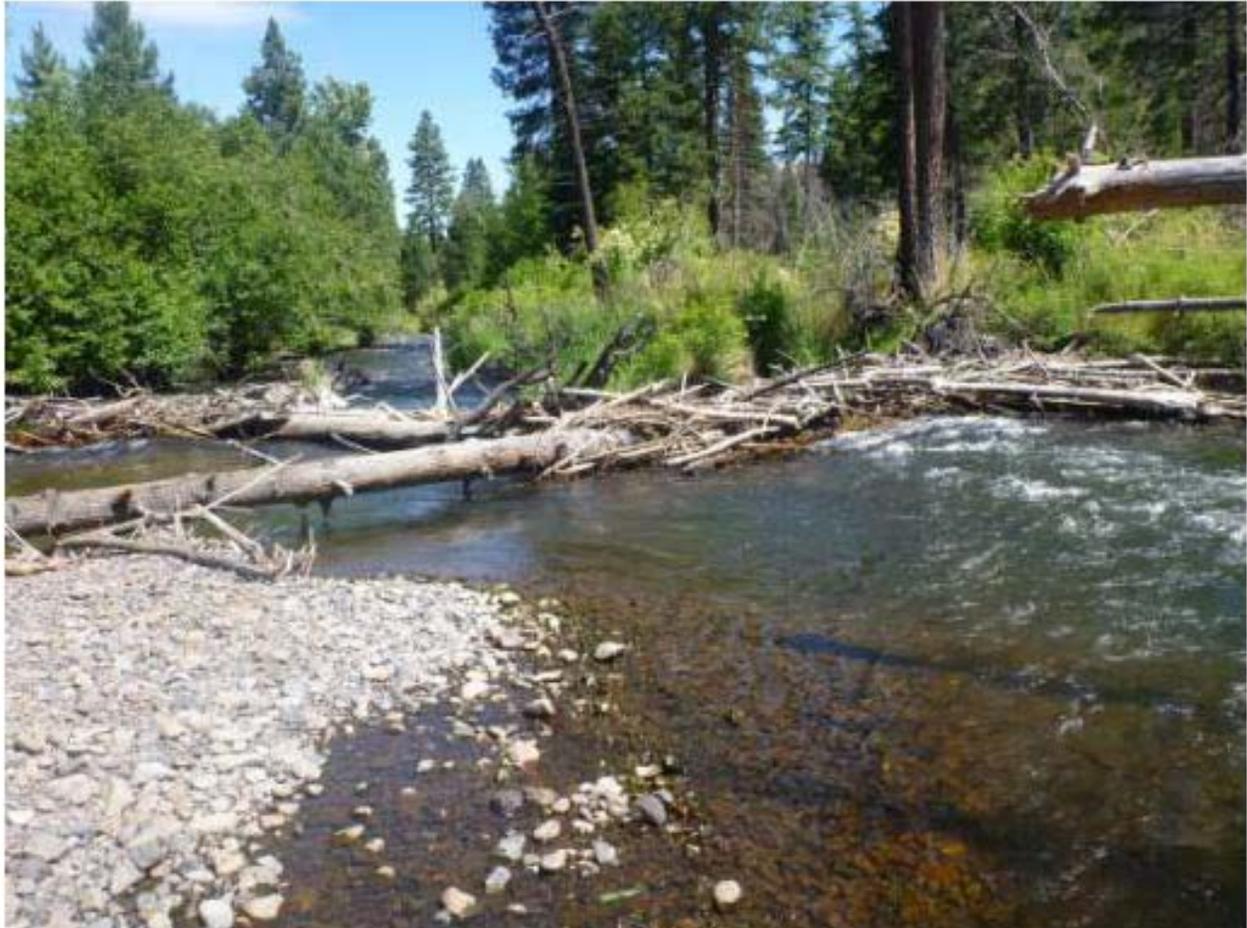
**Photograph 4-9**

Throughout PA-9, the river is characterized by multiple-channel pathways containing a variety of hydraulic conditions forced by the presence of LWD, including several pools and secondary flow paths (Photograph 4-9). Local channel expansion is occurring in the project area from just upstream of RM 44.4 to RM 44.25, as evidenced by bank erosion and multiple-flow path development, recently recruited trees in the channel and side channels, and high amounts of temporary sediment storage. A levee is located along the right bank from approximately RM 44.4 to RM 44.3 at the diversion structure to Big Four Lake. The structure is composed rock armoring and some rootwads along the toe. The channel adjacent to the levee is wide, shallow, and relatively well-armored due to locally high velocities. A straight, plane-bed stretch of channel adjacent to Big Four Lake near RM 44.1 had a well-armored bed lined with large cobbles. In general, the project area has good side channel

**Deep pools and complex hydraulic conditions caused by LWD, near RM 44.4**

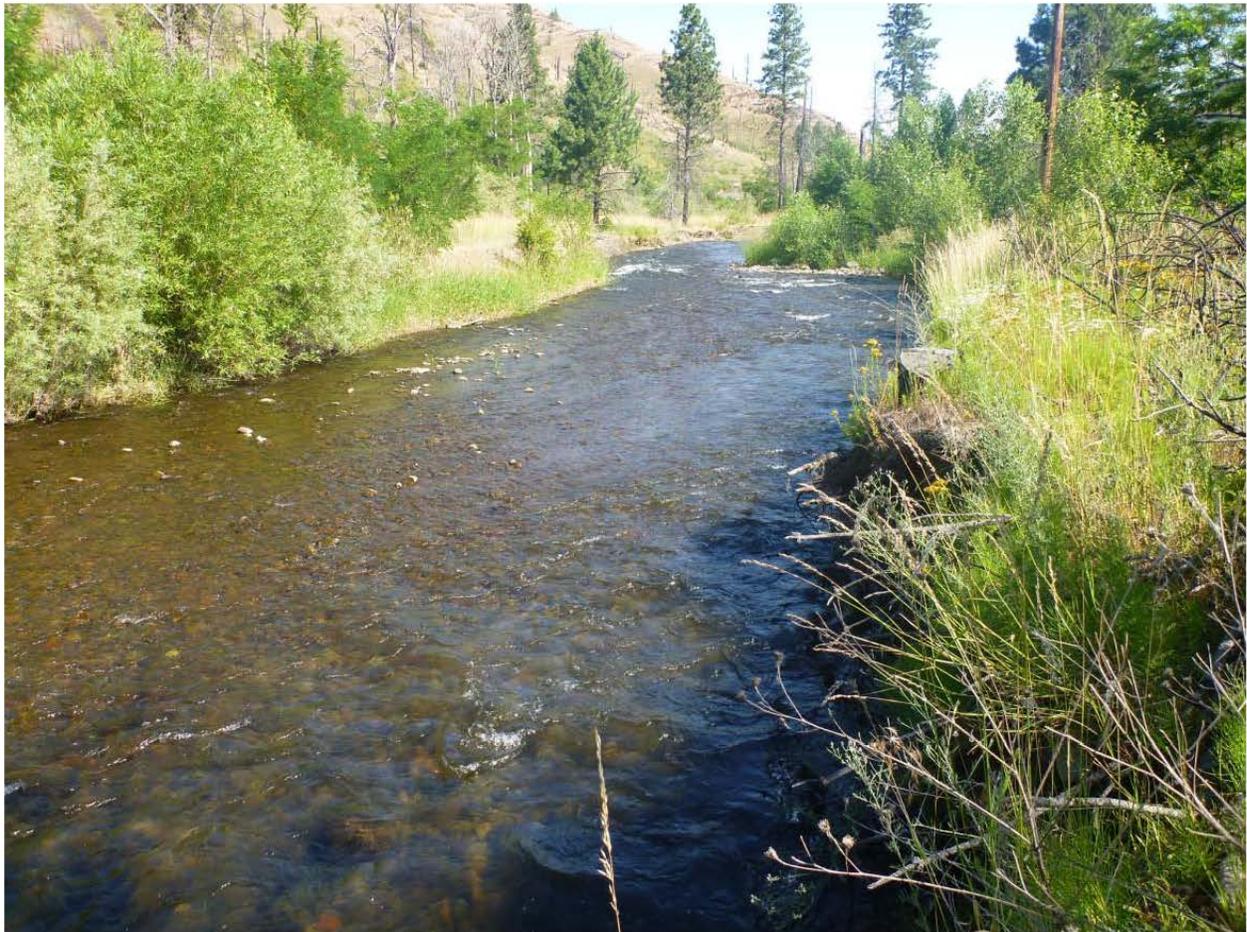
The channel through PA-10 is typically a single-thread, plane-bed channel. The channel contains very little hydraulic complexity and is highly incised throughout a majority of the project area. One section of the project area between approximately RM 43.85 and 43.65 is a highly dynamic, aggrading channel containing many flow paths forced by LWD that has been placed by the WDFW in previous years. The downstream sections of the project area are more characteristic of a single-thread channel with forced pools and riffles (Photograph 5-1). In addition to the placed LWD, rock/rootwad placements and other rock structures such as barbs were observed in a few locations. Multiple armored rock and “sugar dike”-style levees were observed throughout the project area from approximately RM 43.1 to 42.85. The left bank levee at RM 42.9 confines the channel against the valley wall at Waterman Creek, resulting in a deep, narrow, rapid section with high velocities. The upstream end of the

**Photograph 5-1**  
**A section of the main channel in PA-10 near RM 42.6**

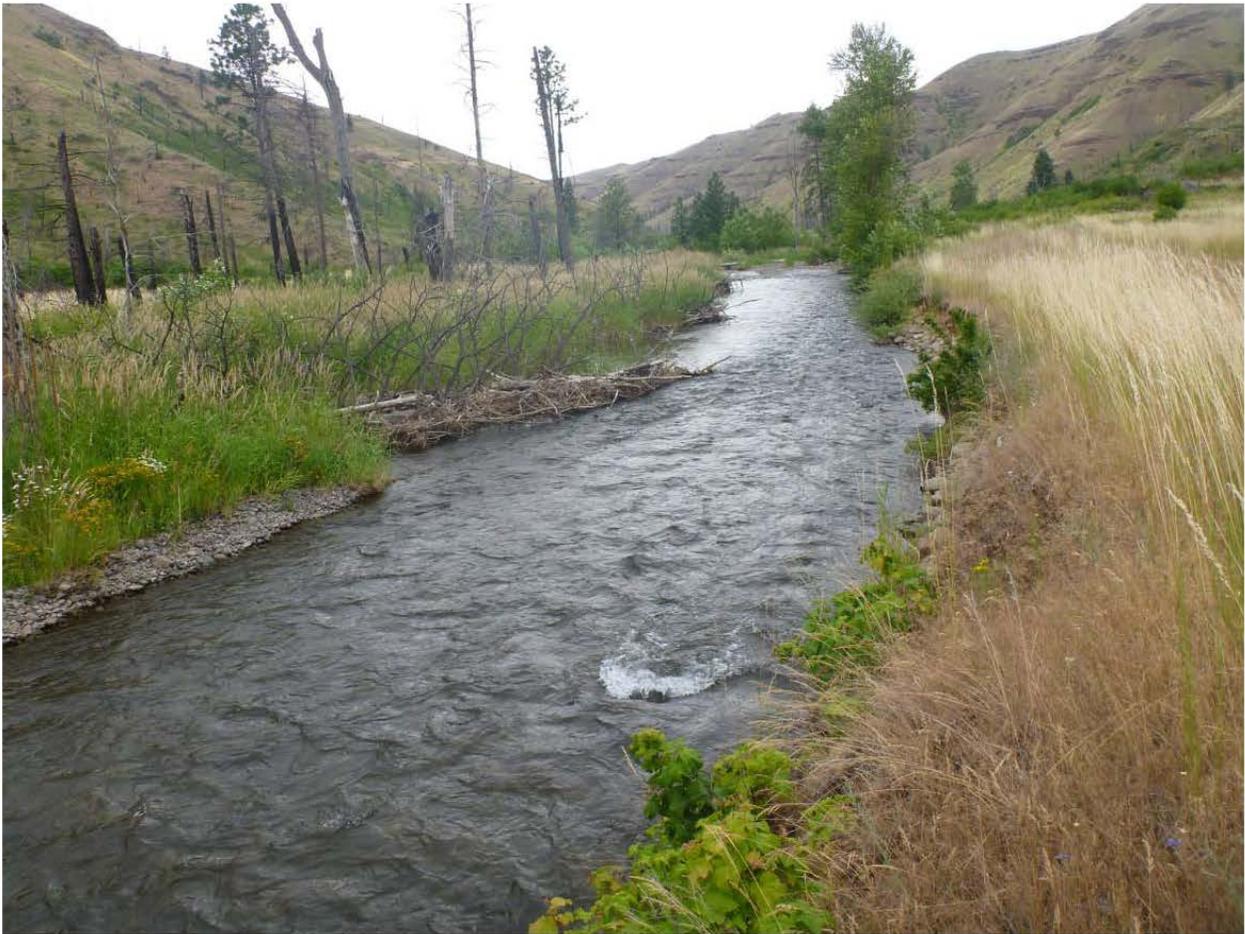
**Photograph 5-2**

The channel through PA-11 between approximately RM 42.3 and RM 41.4 is characterized as a single-thread, plane-bed channel with few LWD-forced pools (Photograph 5-2). The channel is relatively straight and somewhat incised and was likely channelized historically. Downstream of RM 41.4, a large log jam has initiated an anabranching channel pattern and that extends to the downstream end of the project area. This portion of the channel contains more diverse channel types, although it is also somewhat incised and lacking instream complexity. Three weirs are located adjacent to Watson and Beaver lakes, along with some rock and LWD placements along the banks at the lake access footbridge. An armored levee associated with the bridge and parking lot is located along the left bank from approximately RM 42.1 to 42. The intake for Deer Lake, which includes an armored levee, is located at the downstream end of the eastern split flow channel near RM 40.9. Few side channels were observed upstream of RM 41.4. Several flow pathways are present between approximately RM 41.4 and 41.1.

**The main channel in PA-11 near RM 41.75, looking downstream**

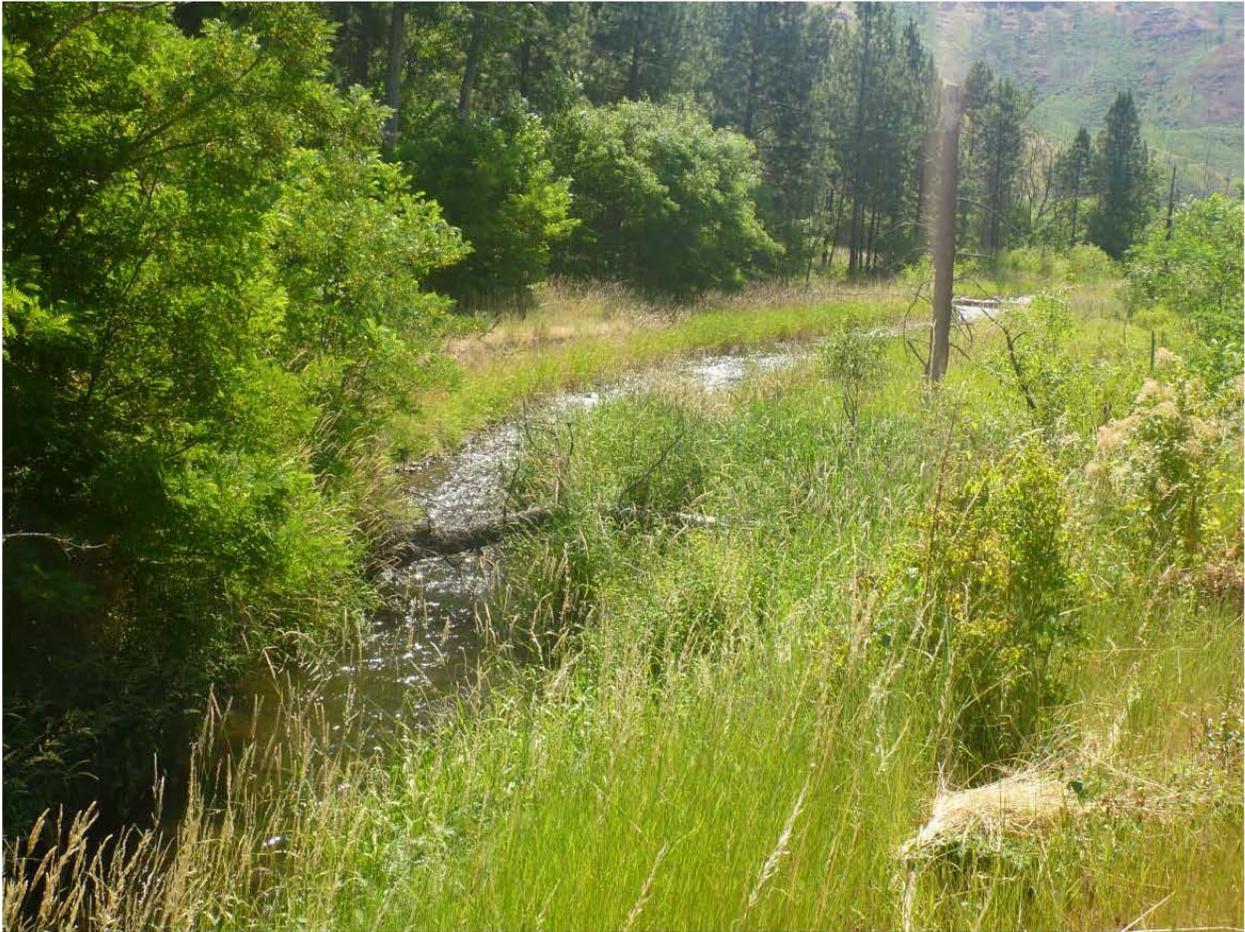
**Photograph 5-3**

The channel through PA-12 is relatively complex with many flow pathways through a relatively wide corridor; natural processes are occurring that are aiding in recovery through this area. No major infrastructure was observed within the channel, although the Hatchery Dam at the downstream end of the project area is a significant grade control. Several side channels were observed, a majority of which are initiated by LWD. An anabranching channel pattern is located between RM 40.5 and 40.1, where a significant side channel has cut through the floodplain along the left valley floor (Photograph 5-3). This channel runs below a power line adjacent to the road through a grassy area. Another major side channel observed between approximately RM 40.2 and 40.0 conveyed at least a third of the total discharge at the time of observation.

**The side channel in the west floodplain near RM 40.4, looking upstream**

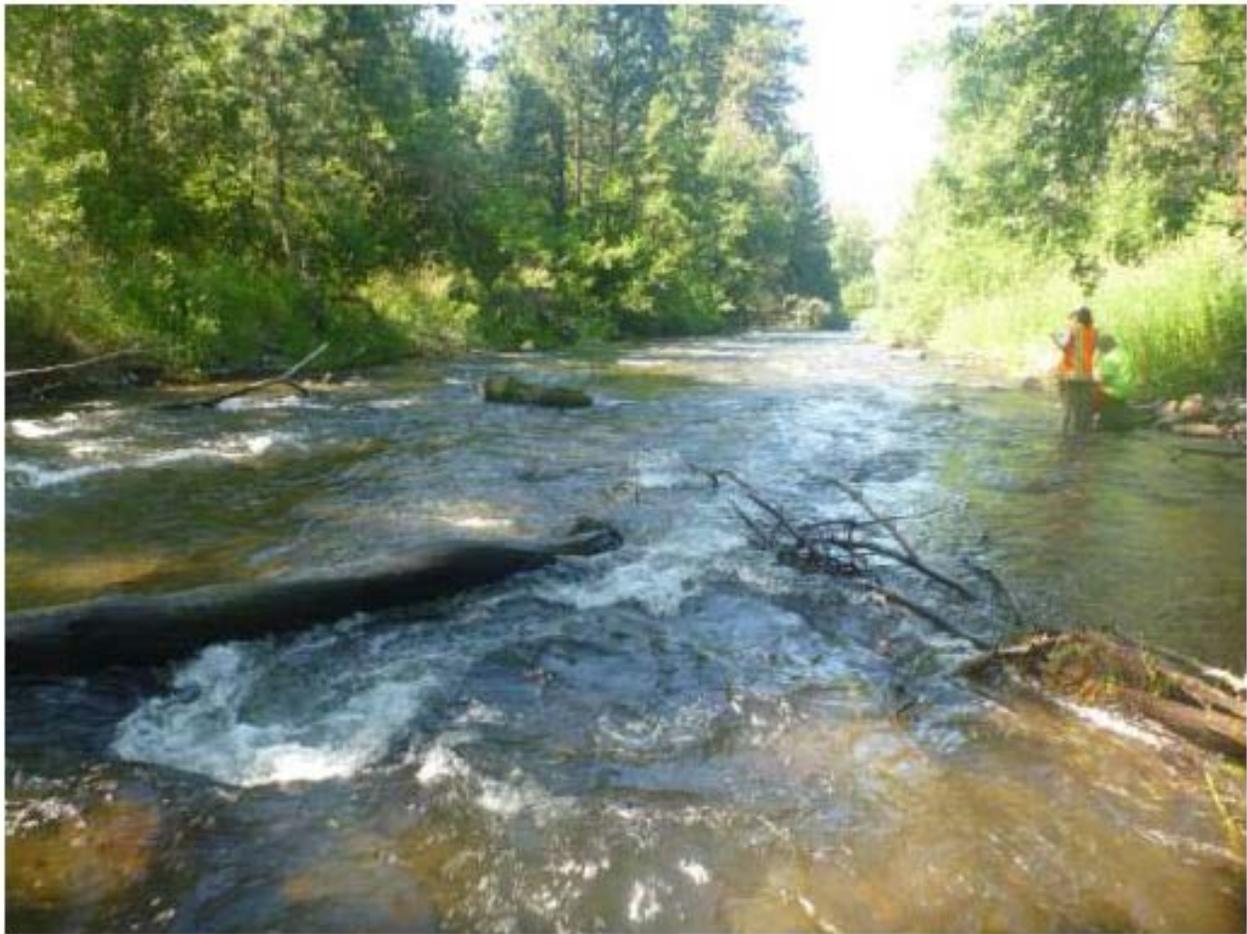
**Photograph 6-1**

The channel through PA-13 is characterized as a single-thread, plane-bed channel with forced pool-riffle and local rapid sections (Photograph 6-1). The channel is typically straight, wide, and contains little complexity in much of the project area. Large levees confine the channel along the right bank from approximately RM 39.95 to 39.8, at RM 39.6, and from RM 39.5 to 39.2. The levees are typically heavily armored with large angular boulders. The hatchery dam at the upstream end of the project area controls the channel grade. At the time of field observation, the dam had an approximately 3-foot drop in water surface elevation with a deep plunge pool on the downstream side. No significant side channels or off-channel areas were observed in the project area at the time of field reconnaissance.

**The main channel near RM 39.6 just upstream of the large levee on the right bank, looking downstream**

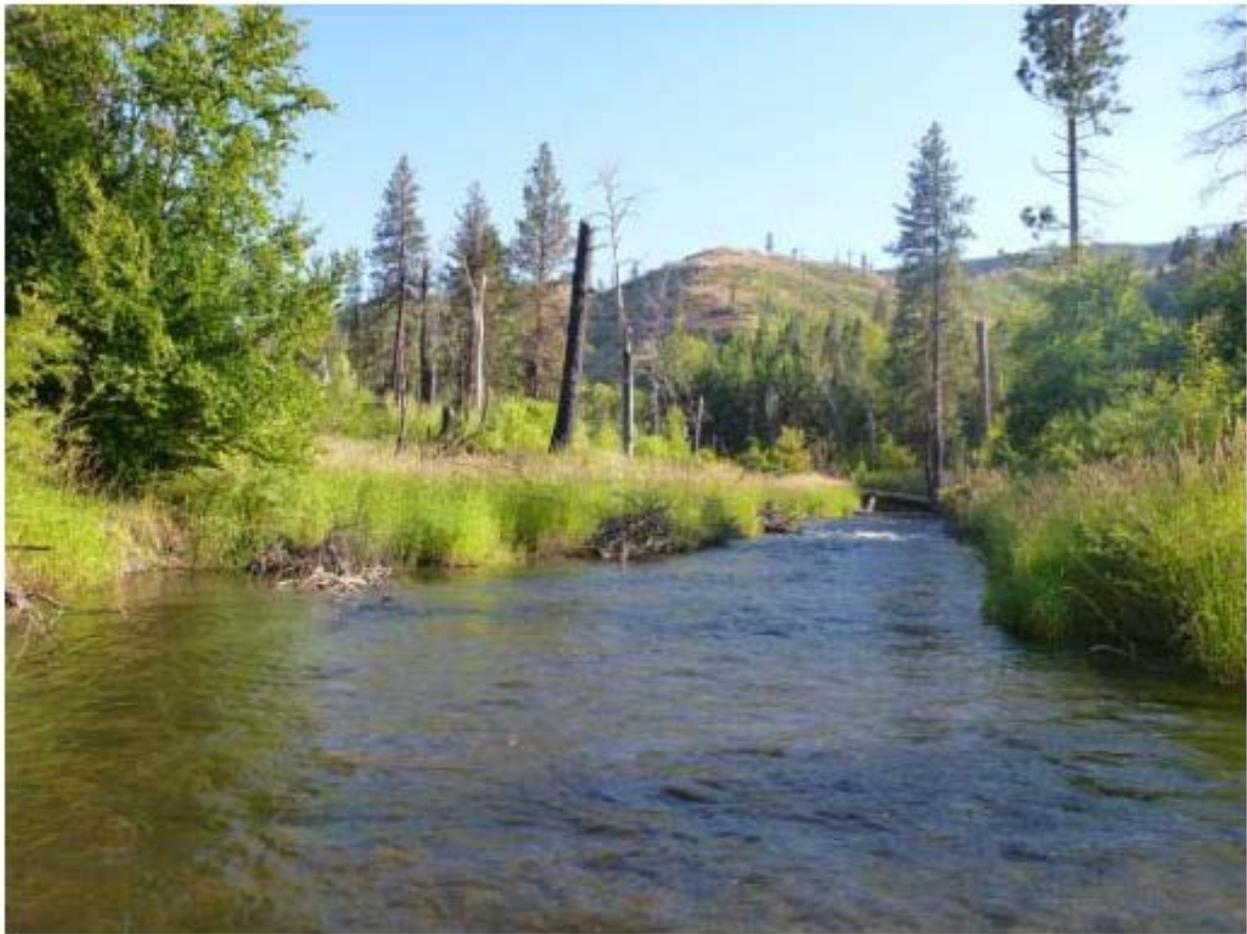
**Photograph 6-2a**

The channel through PA-14 is primarily a single-thread, plane-bed channel with local forced pool-riffle and boulder rapids (Photograph 6-2a). Adjacent to the hatchery, the channel is relatively straight and simplified. Existing WDFW hatchery infrastructure, including the hatchery bridge and the levee adjacent to the hatchery ponds, confines the channel from approximately RM 39.2 to 39.0. From RM 39.0 to RM 38.5, the active channel widens slightly and a few side channels and split-flow paths are present.

**The main channel and floodplain near RM 38.3, looking upstream**

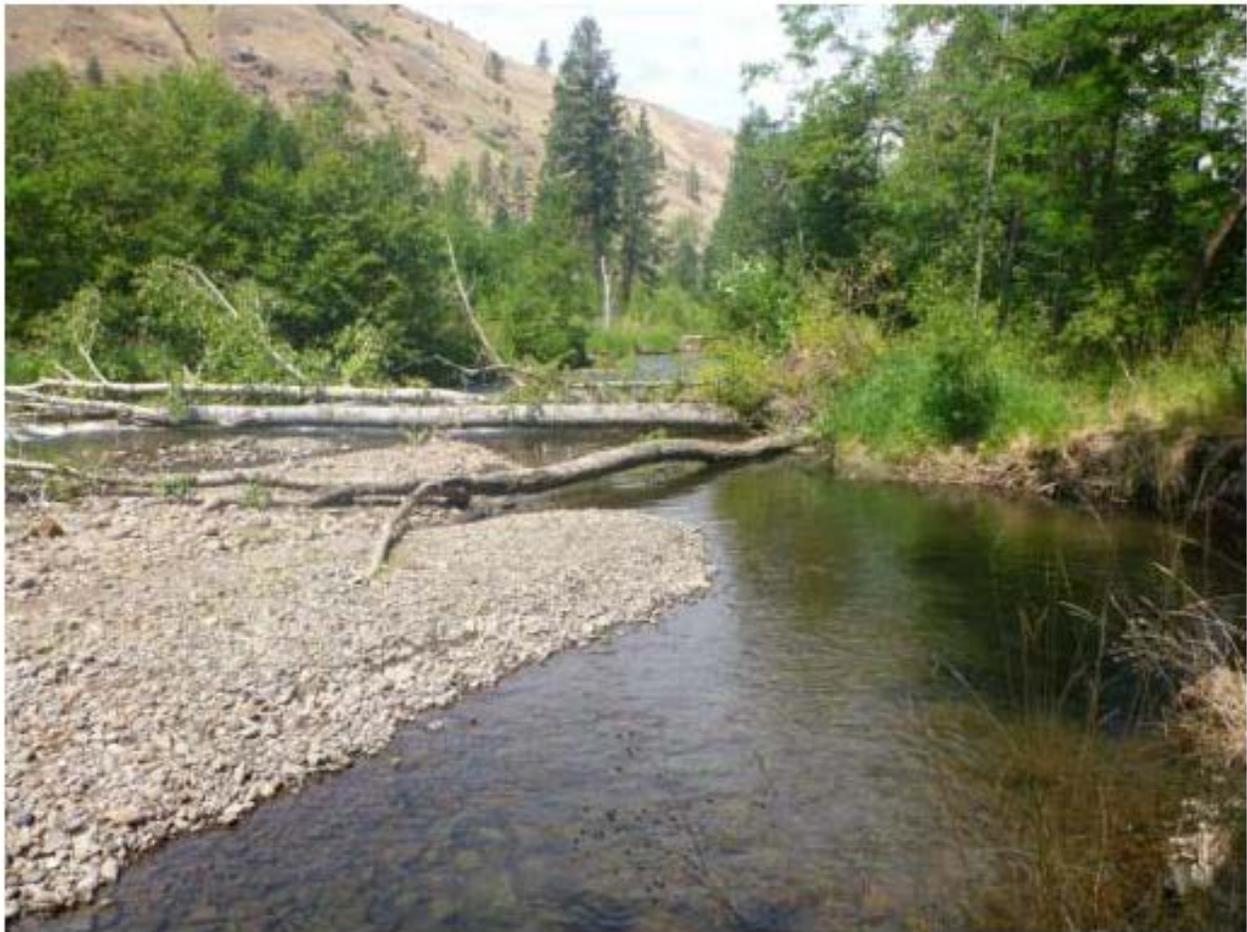
**Photograph 6-2b**

**Wood recruitment in the channel near RM 37.5**
