## 4 REACH 10 CONCEPTUAL PROJECTS

#### 4.1 Project Area 1 (River Mile 50 to 48.9)

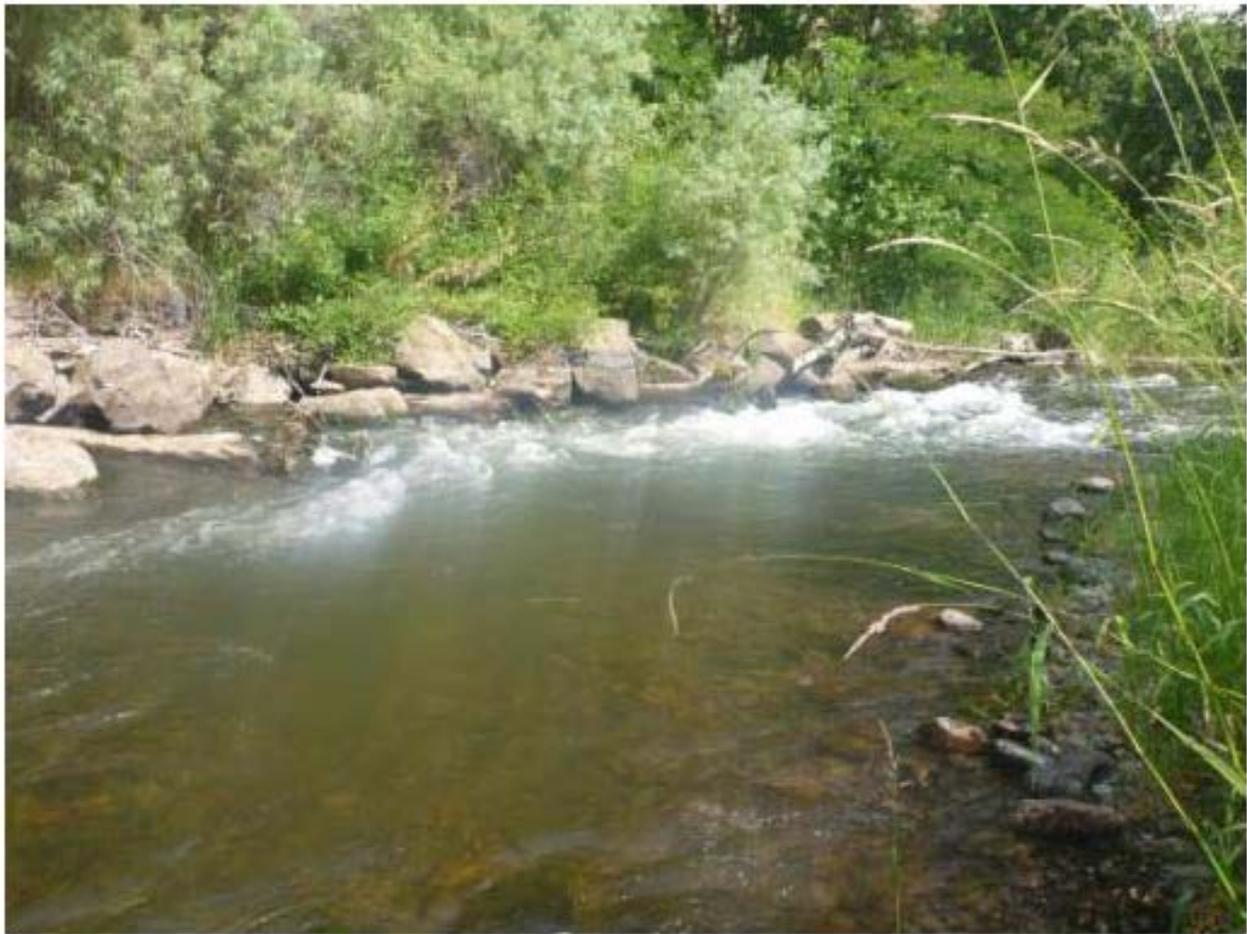
**Photograph 6-3**

**Local incision and rapid velocities along the face of a rootwad and rock revetment**

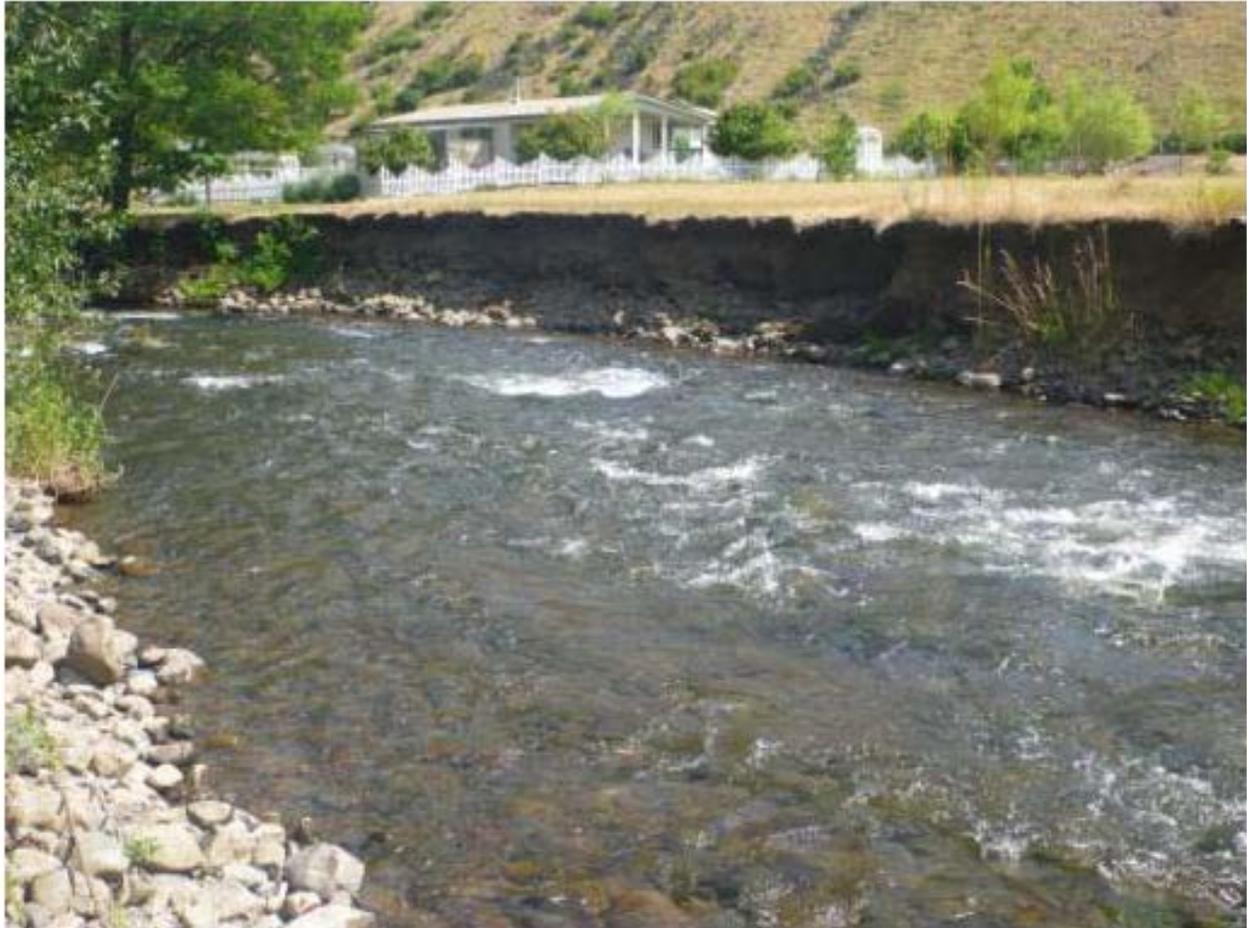
**Photograph 6-4**

**Bank erosion adjacent to private infrastructure near RM 35.1, looking across at right bank**

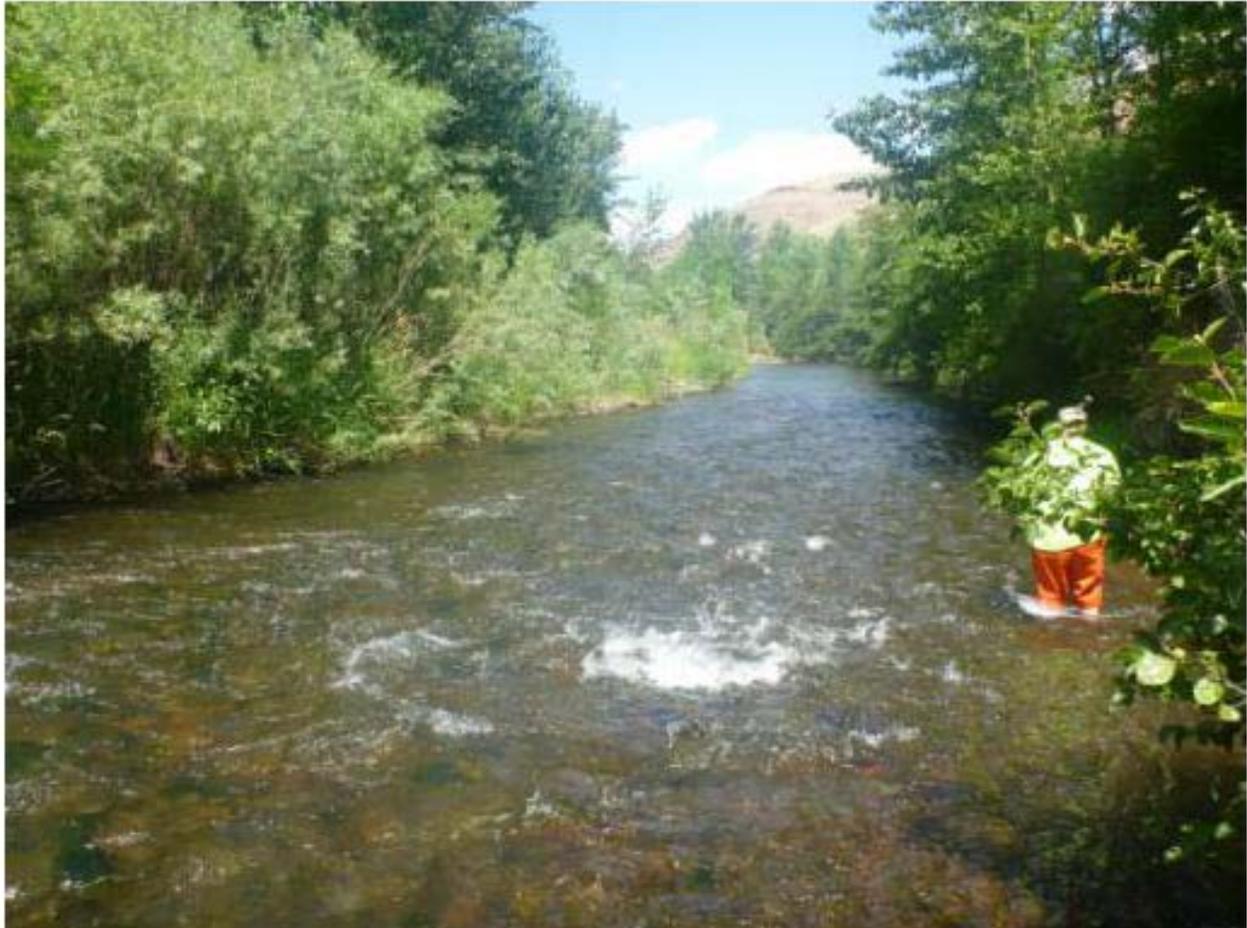
**Photograph 6-5**

The channel through PA-17 is characterized as a single-thread, plane-bed channel with local deep, rapid sections that contain little hydraulic complexity (Photograph 6-5). Resistant fine-grained material is located along much of the left bank. Bank armoring was observed in the upstream portion of the project area between RM 34.85 and 34.75 on both the left and right banks. From this section to approximately RM 34.7, the channel is incised and disconnected from the floodplain; riparian planting projects undertaken here have been largely unsuccessful, likely due to poor hyporheic exchange with the channel. Downstream of RM 34.7, the channel is wide and plane-bed with some deeper areas adjacent to the

**A plane-bed section of the channel that flows along the base of a high terrace (right bank) near RM 34.4**
