SITE INFORMATION

Site Identifier : AL1LB7 **Landowner Type :** Private
Site Name : **Landowner Name :**
WRIA : 03.0359X **Address :**
Region : NS **Address2 :**
Trib to : Alder Cr **City :**
River Mile : 1.20 **State :**
River System : Alder Cr **Zipcode :**
Legal Description : SE1/4S7T35NR7E **Phone :**
County : Skagit
Habitat Type : terrace tributary

Date : 02/03/1997 **Observer :** Olis **Survey Type :** initial

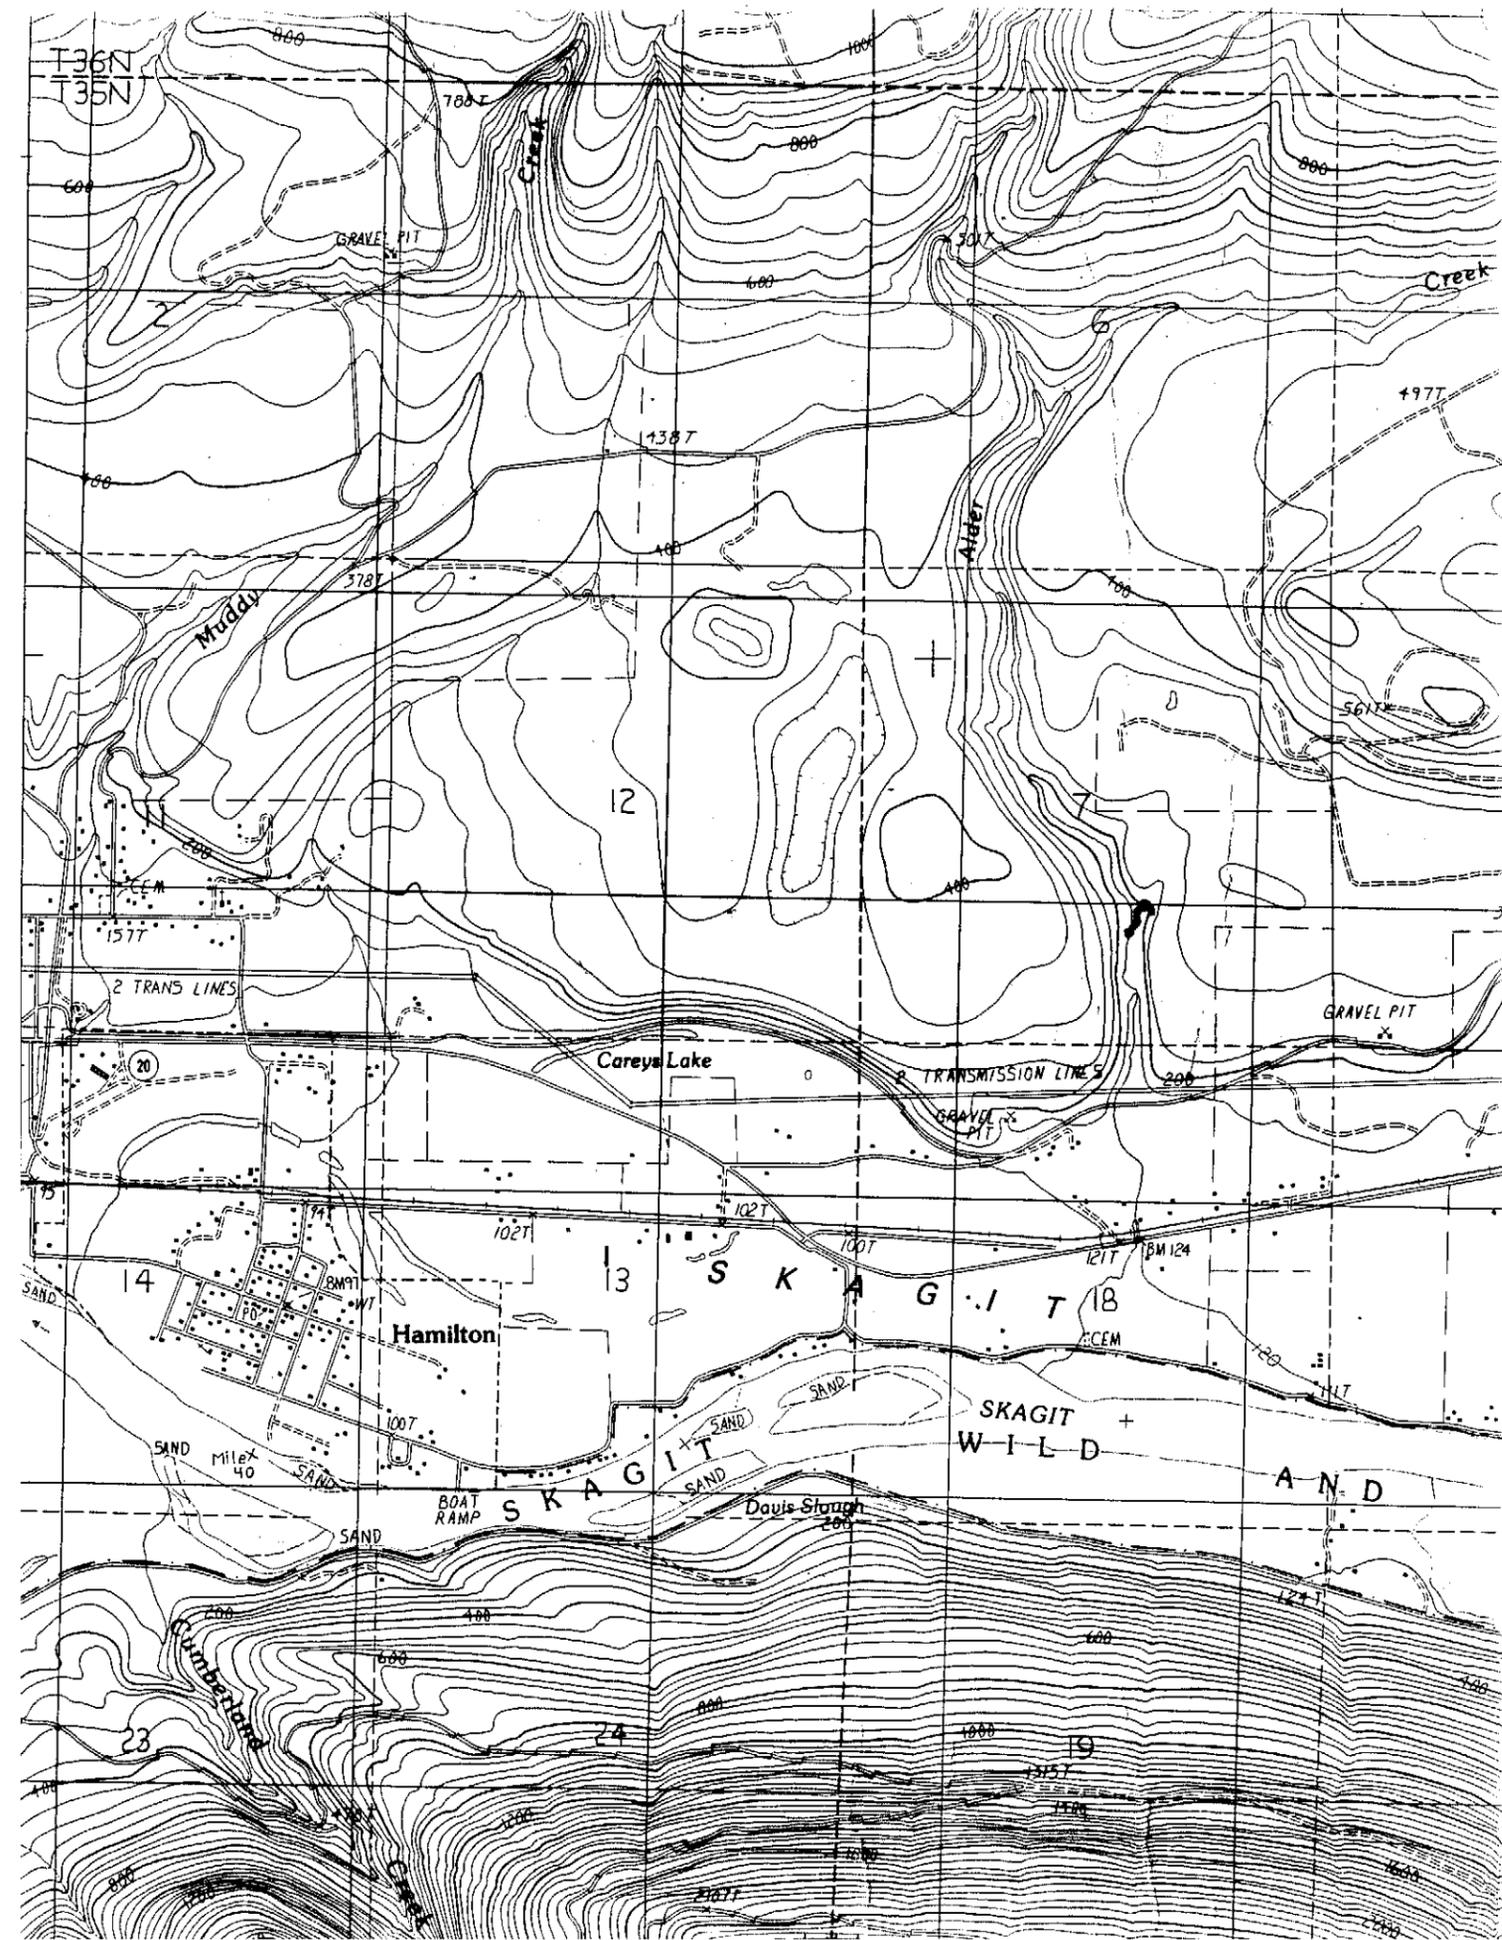
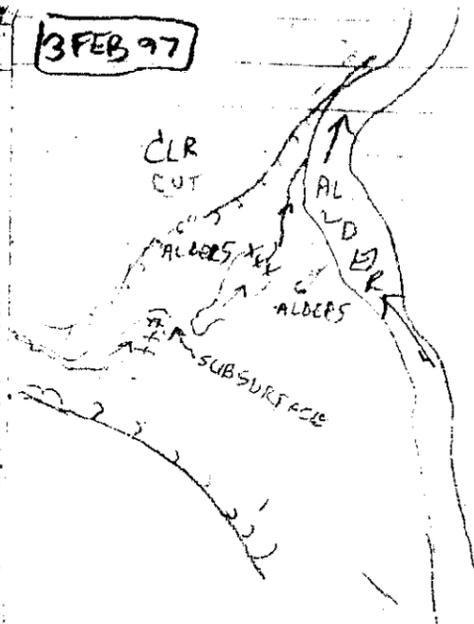
AL1LB7

- FLOW 0.5 CFS
- STRM TEMP 45°
- REC WTR 41°
- NICE EDDY POOL @ ENTRY
- 29m ww 1m
- 40/60 P-RIFE
- SILTY SUBSTRATE
- @ 4' HIGH B&R DAM
- 12 m LONG
- WTR SEEPING THROUGH BUT LOOKS LIKE A BARRIER
- 43m ww 8m
- SHALLOW, SLOW MOVING
- VERY SILT LADEN

- FLOW IS SUBSURFACE
@ AS IT FLOWS AROUND
SILTED BUR DAM &
UNDER GROUND.

- MOSTLY SHALLOW
RIFF.

- SOME 1-3" GRAVEL
IN SUBSTR.
- MAYBE 4M² OF SPAWN
HAB.

- GRADIENT IS TOO
STEEP

- IN CLEAR CUT
- INCISED BANKS W/
SILTY SUBSTRATE
- CASCADES W/
WOODY DEBRIS CLOGGING
STREAM
- WTR TEMP 45°

- SOME OVERWINTER
REARNG W/ SPAWNING
HAB ABOVE BARRIER
DAM.

- SURFACE FED &
INTERMITTANT

~~STREAM HAS~~ VERY HIGH
FLOWS ↑

NO FISH SEEN
