SITE INFORMATION

Site Identifier : AN1RB1 **Landowner Type :** Private
Site Name : **Landowner Name :** Vandar Sar Dairy
WRIA : 03.0287X **Address :**
Region : NS **Address2 :**
Trib to : Anderson Cr **City :**
River Mile : 0.30 **State :**
River System : Anderson Cr **Zipcode :**
Legal Description : SE1/4S26T35NR5E **Phone :**
County : Skagit
Habitat Type : slough

Field Survey Information

Date : 01/27/1998 **Observer :** Olis **Survey Type :** initial

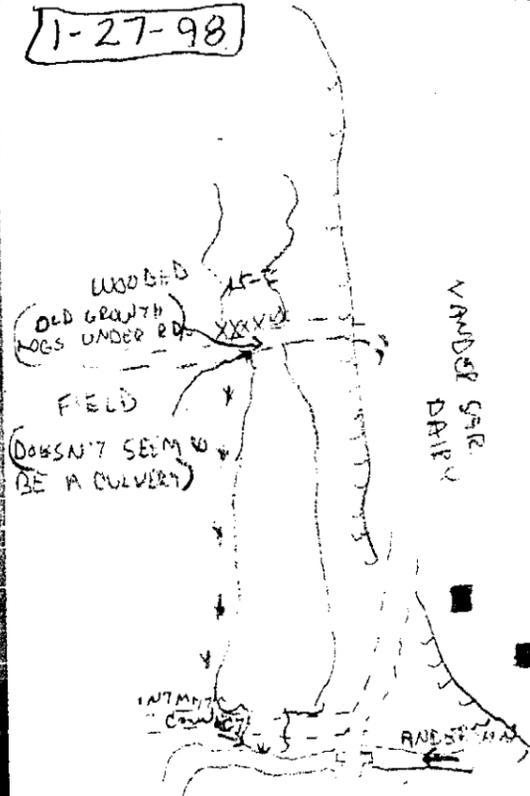
Site id. code: AN1 RB1
Site name:
Scale: 1" = 100m
Observer(s): M. OLIS
Legal location: SEY4 S26 T35NR5E

FIELD WILL BE UNDER WATER
DURING MAJOR FLOOD EVENTS

SORENSEN CREE
MAY BE DIVERTED
THIS WAY
DURING
MAJOR FLOOD
EVENTS
←

BRUSH
ALONG EDGE

THIS CONNECTION
IS INTERMITTENT

CULVERT MAY GET PLUGGED BY BEAVERS

350m
492m
JUVENILE SALMONID SEEN

SOME CANARY GRASS
BRUSHY
