SITE NUMBER: B-R9-03
LOCAL NAME: Falcon Walrus
WRIA: 20.0250C

NORTH COAST OFF CHANNEL SITE INVENTORY DATA

RIVER SYSTEM: Bogachiel R. **DATE:** 8/30/89 **OBSERVER:** Nettnin

CHANNEL TYPE: Wall-based terrace trib.

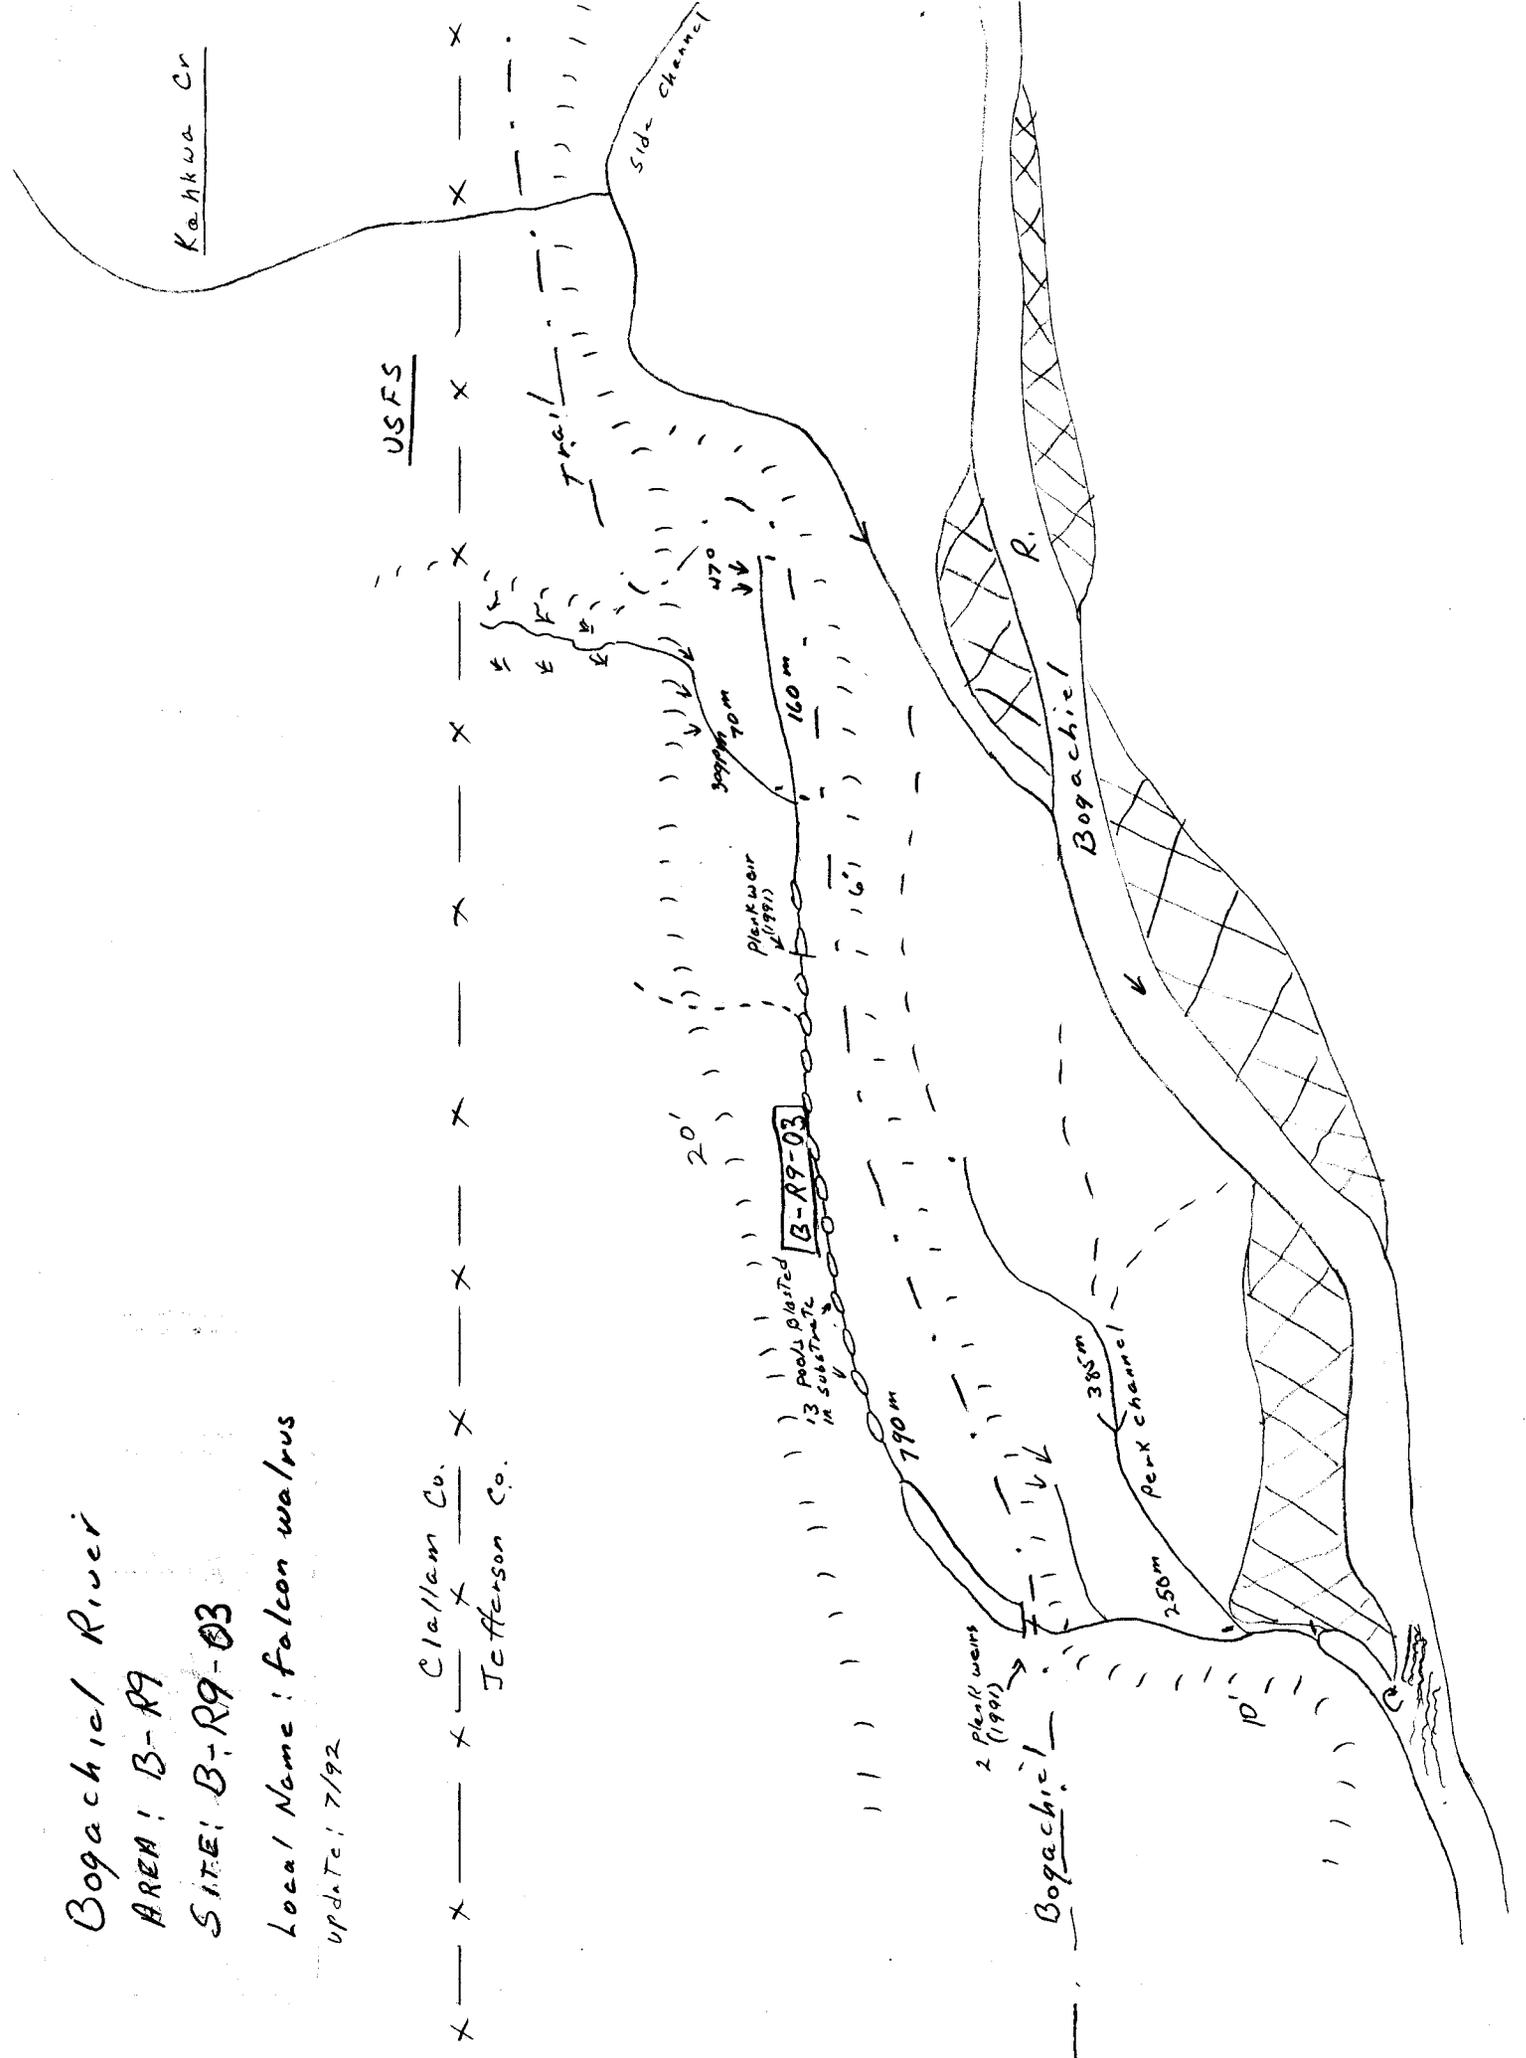
SITE: B-R9-03

13 pools blasted in substrate

2 Plankton weirs (1991)
