**SITE INFORMATION**

**Site Identifier :** BA1LB1 **Landowner Type :** Federal  
**Site Name :** **Landowner Name :** USFS  
**WRIA :** 03.1774X **Address :**  
**Region :** NS **Address2 :**  
**Trib to :** Bacon Cr **City :**  
**River Mile :** 3.50 **State :**  
**River System :** Bacon Cr **Zipcode :**  
**Legal Description :** SE1/4S6T36NR11E **Phone :**  
**County :** Skagit  
**Habitat Type :** overflow channel

**Field Survey Information**

**Date :** 10/27/1997 **Observer :** Olis **Survey Type :** initial

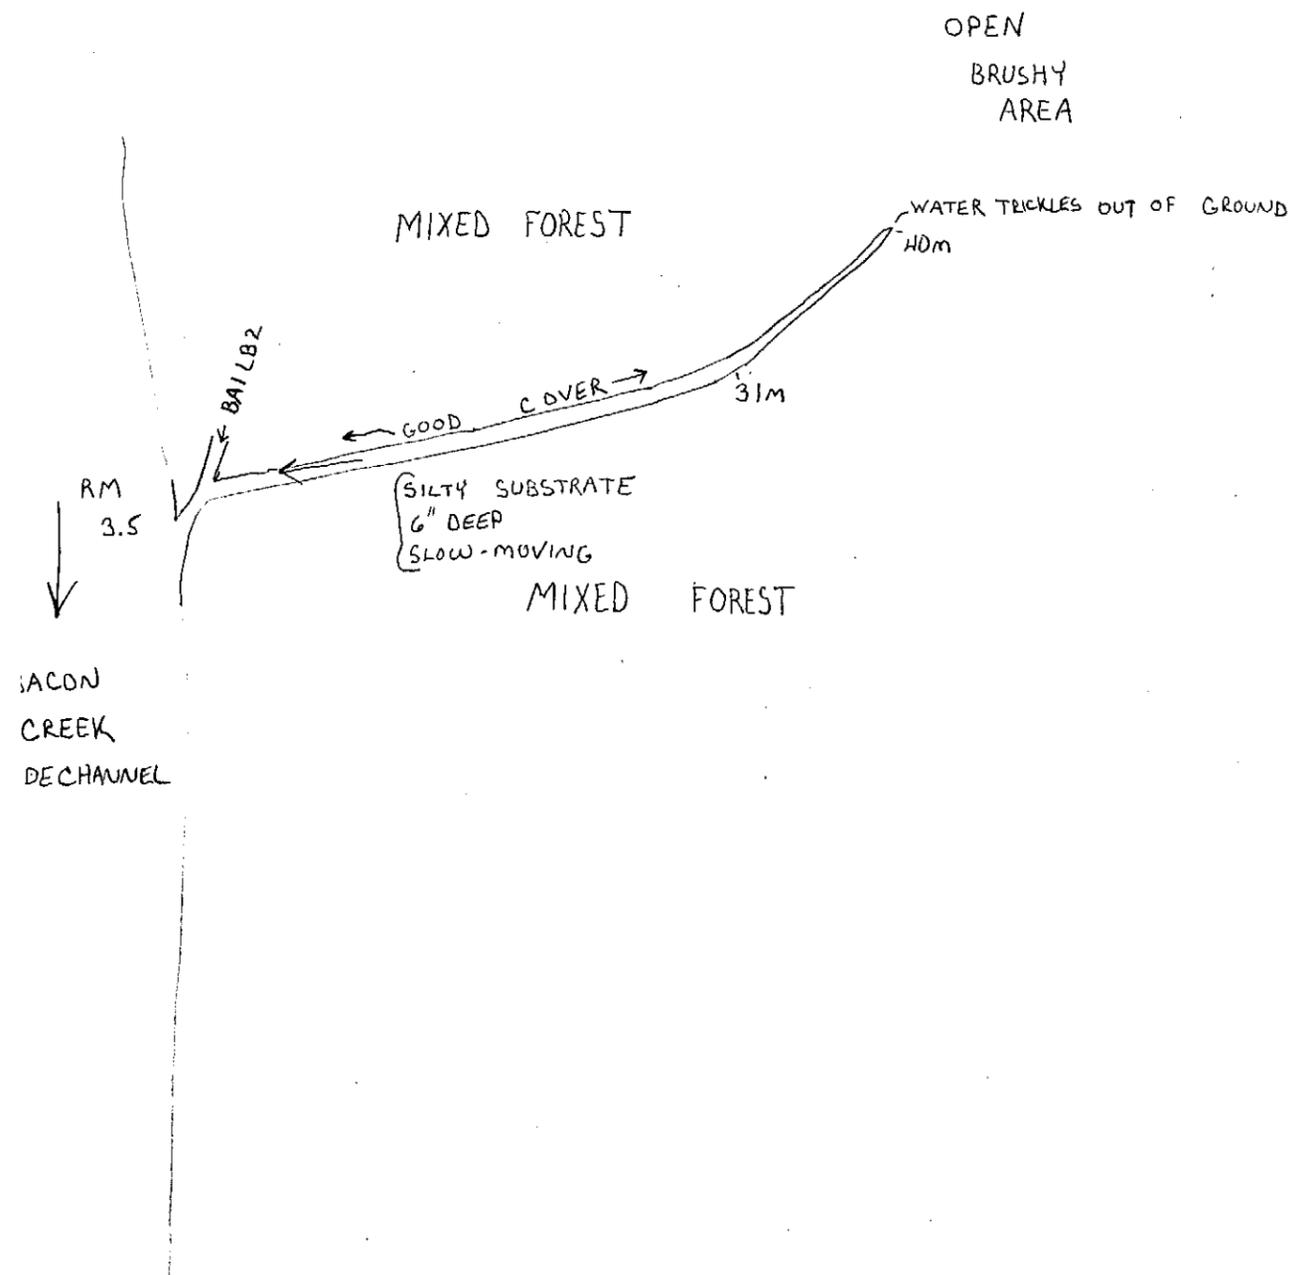
Site id. code: BA1LB1  
Site name:  
Scale: 1" = 10m  
Observer(s): MICHAEL OWLS  
Legal location: SE 1/4 S6 T36 N11E

31m W.W. 1m

- SLOW MOVING

- 6" DEEP

- GOOD COVER

40m W.W. 5m

- TRICKLE

- END OF WAT.

- WTR FLOWS OUT  
FROM UNDERGROUND
- LOOKS LIKE OLD  
RIVER CH.
