SITE IDENTIFIER: ~~CAILB3~~
LOCAL NAME: None

NORTH SOUND OFF CHANNEL SITE INVENTORY DATA

RIVER: Cascade SURVEY DATE: 2/9/95 OBSERVER: B. Barkdull

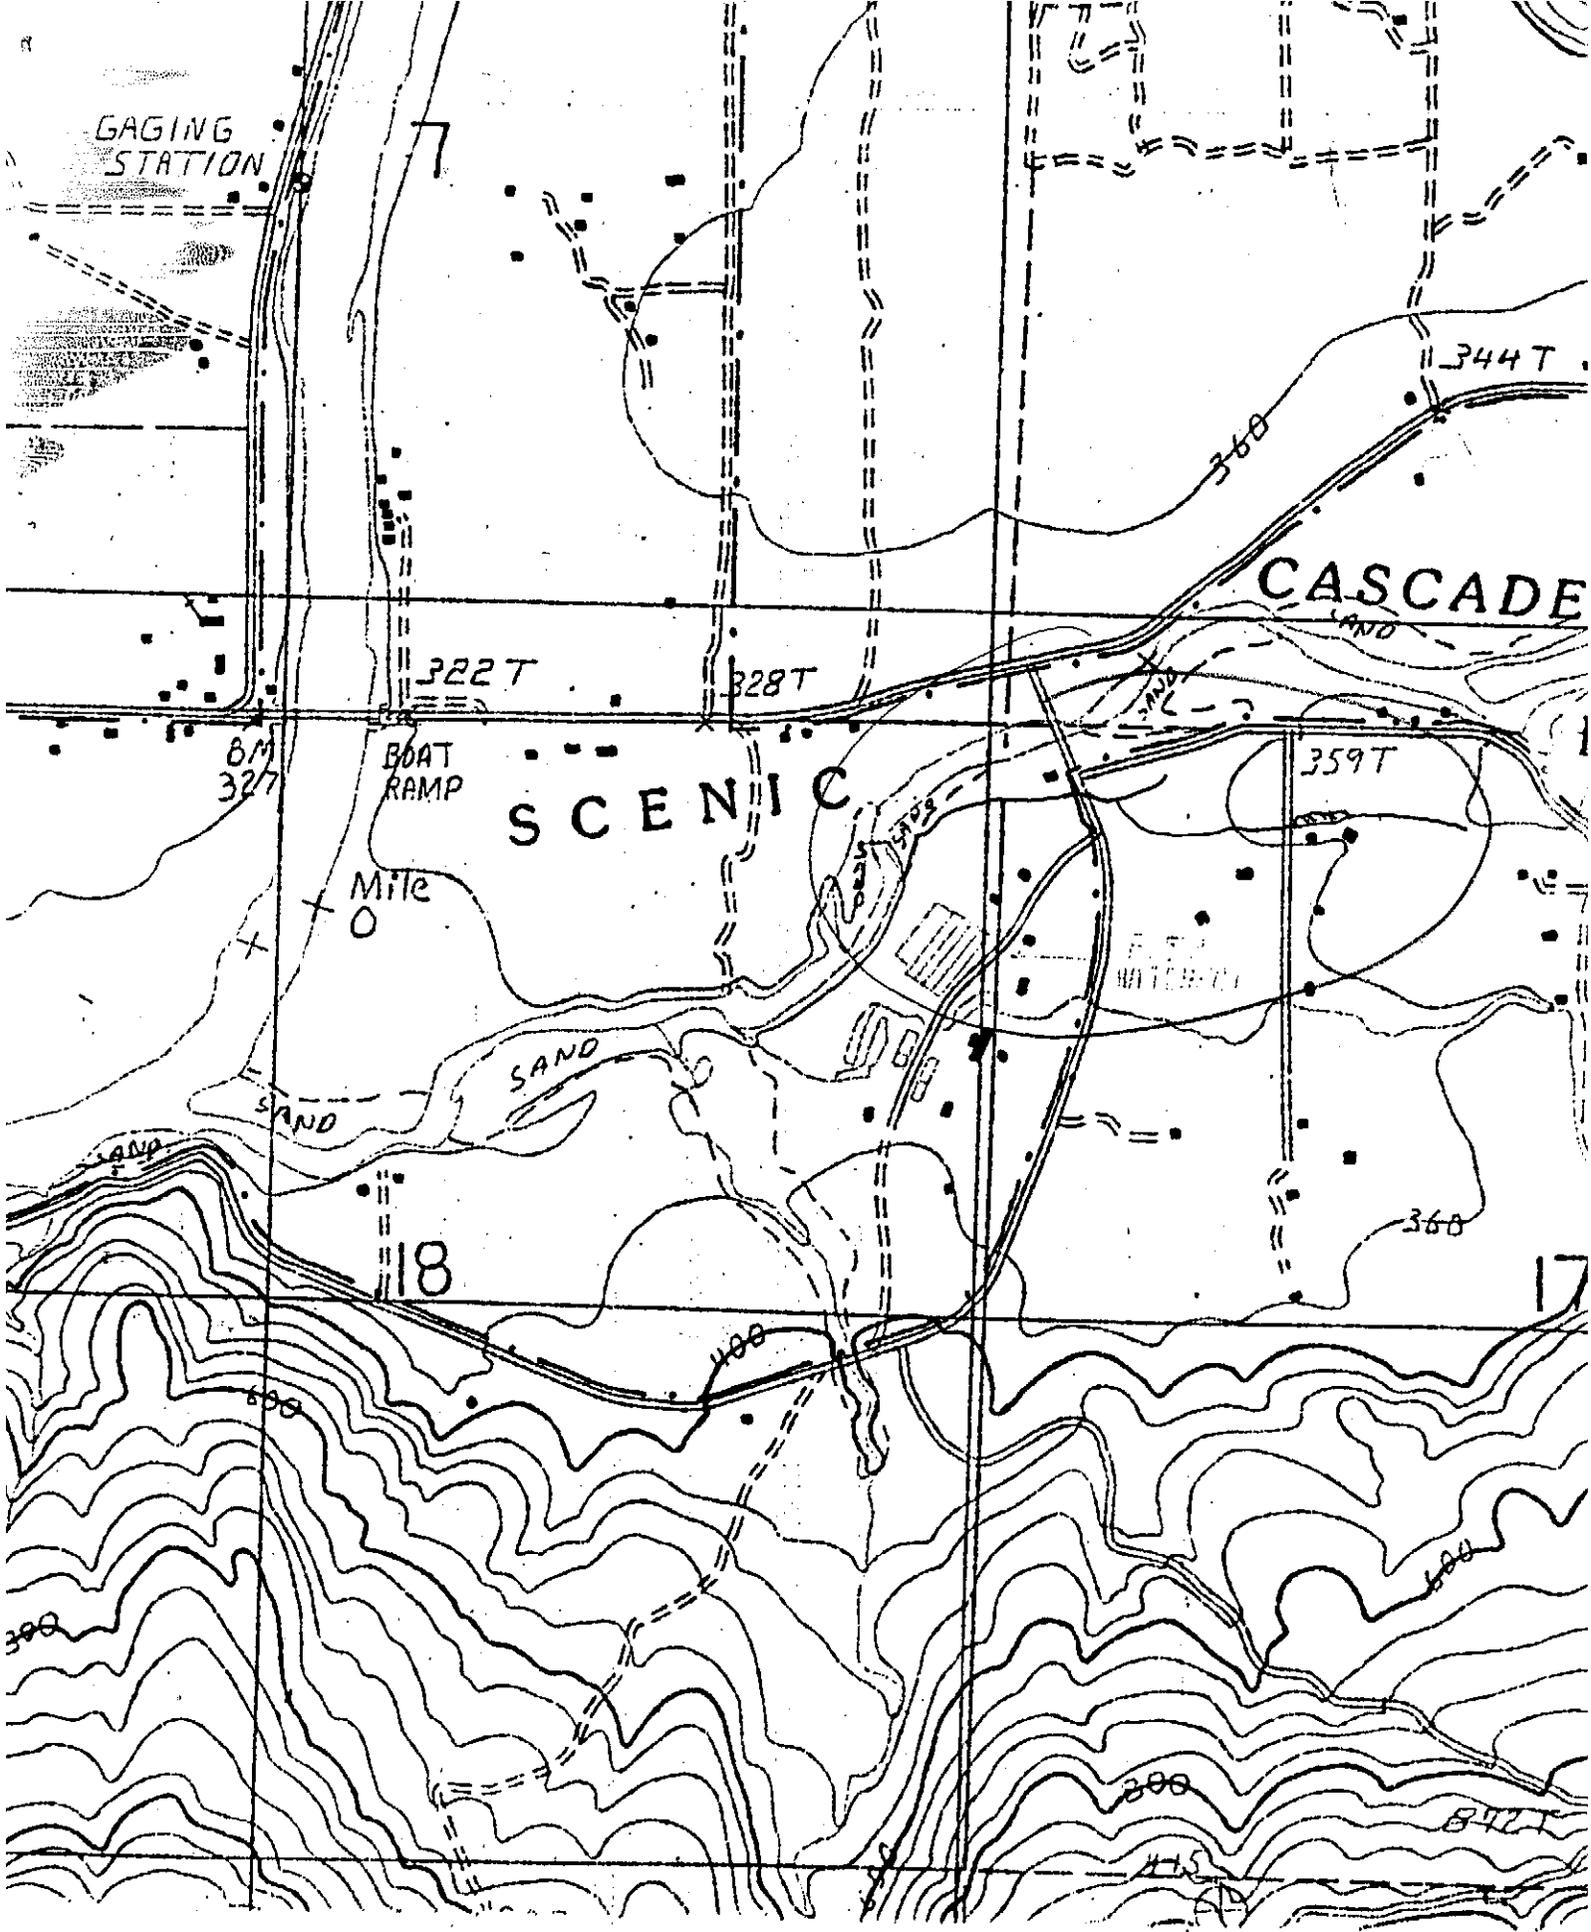
Site id. code: CA1LB3
Site name:
Scale: 1" = 100 m
Observer(s): B. Barbull
Legal location: NW 17, T35N, R1E

ENHANCEMENT OPPORTUNITIES: The lower 118 meters below the Rockport Cascade highway has been ditched and straightened and could use help. Above the highway fencing would be helpful to protect the thin strip of riparian habitat. Three culverts on the site pose partial barriers; the culvert on clark road routinely has a board placed across the lower half in increase the pond level above the pipe.

Project type: Culvert replacement, fencing and planting
