**SITE INFORMATION**

**Site Identifier :** CF1LB5 **Landowner Type :** Private  
**Site Name :** **Landowner Name :**  
**WRIA :** 03.0200X **Address :**  
**Region :** NS **Address2 :**  
**Trib to :** 03.0200 **City :**  
**River Mile :** 1.50 **State :**  
**River System :** Carpenter/Fisher **Zipcode :**  
**Legal Description :** SE1/4S22T33NR4E **Phone :**  
**County :** Skagit  
**Habitat Type :** lower valley wall tributary

**Field Survey Information**

**Date :** 1/2/01 **Observer :** Olis **Survey Type :** initial

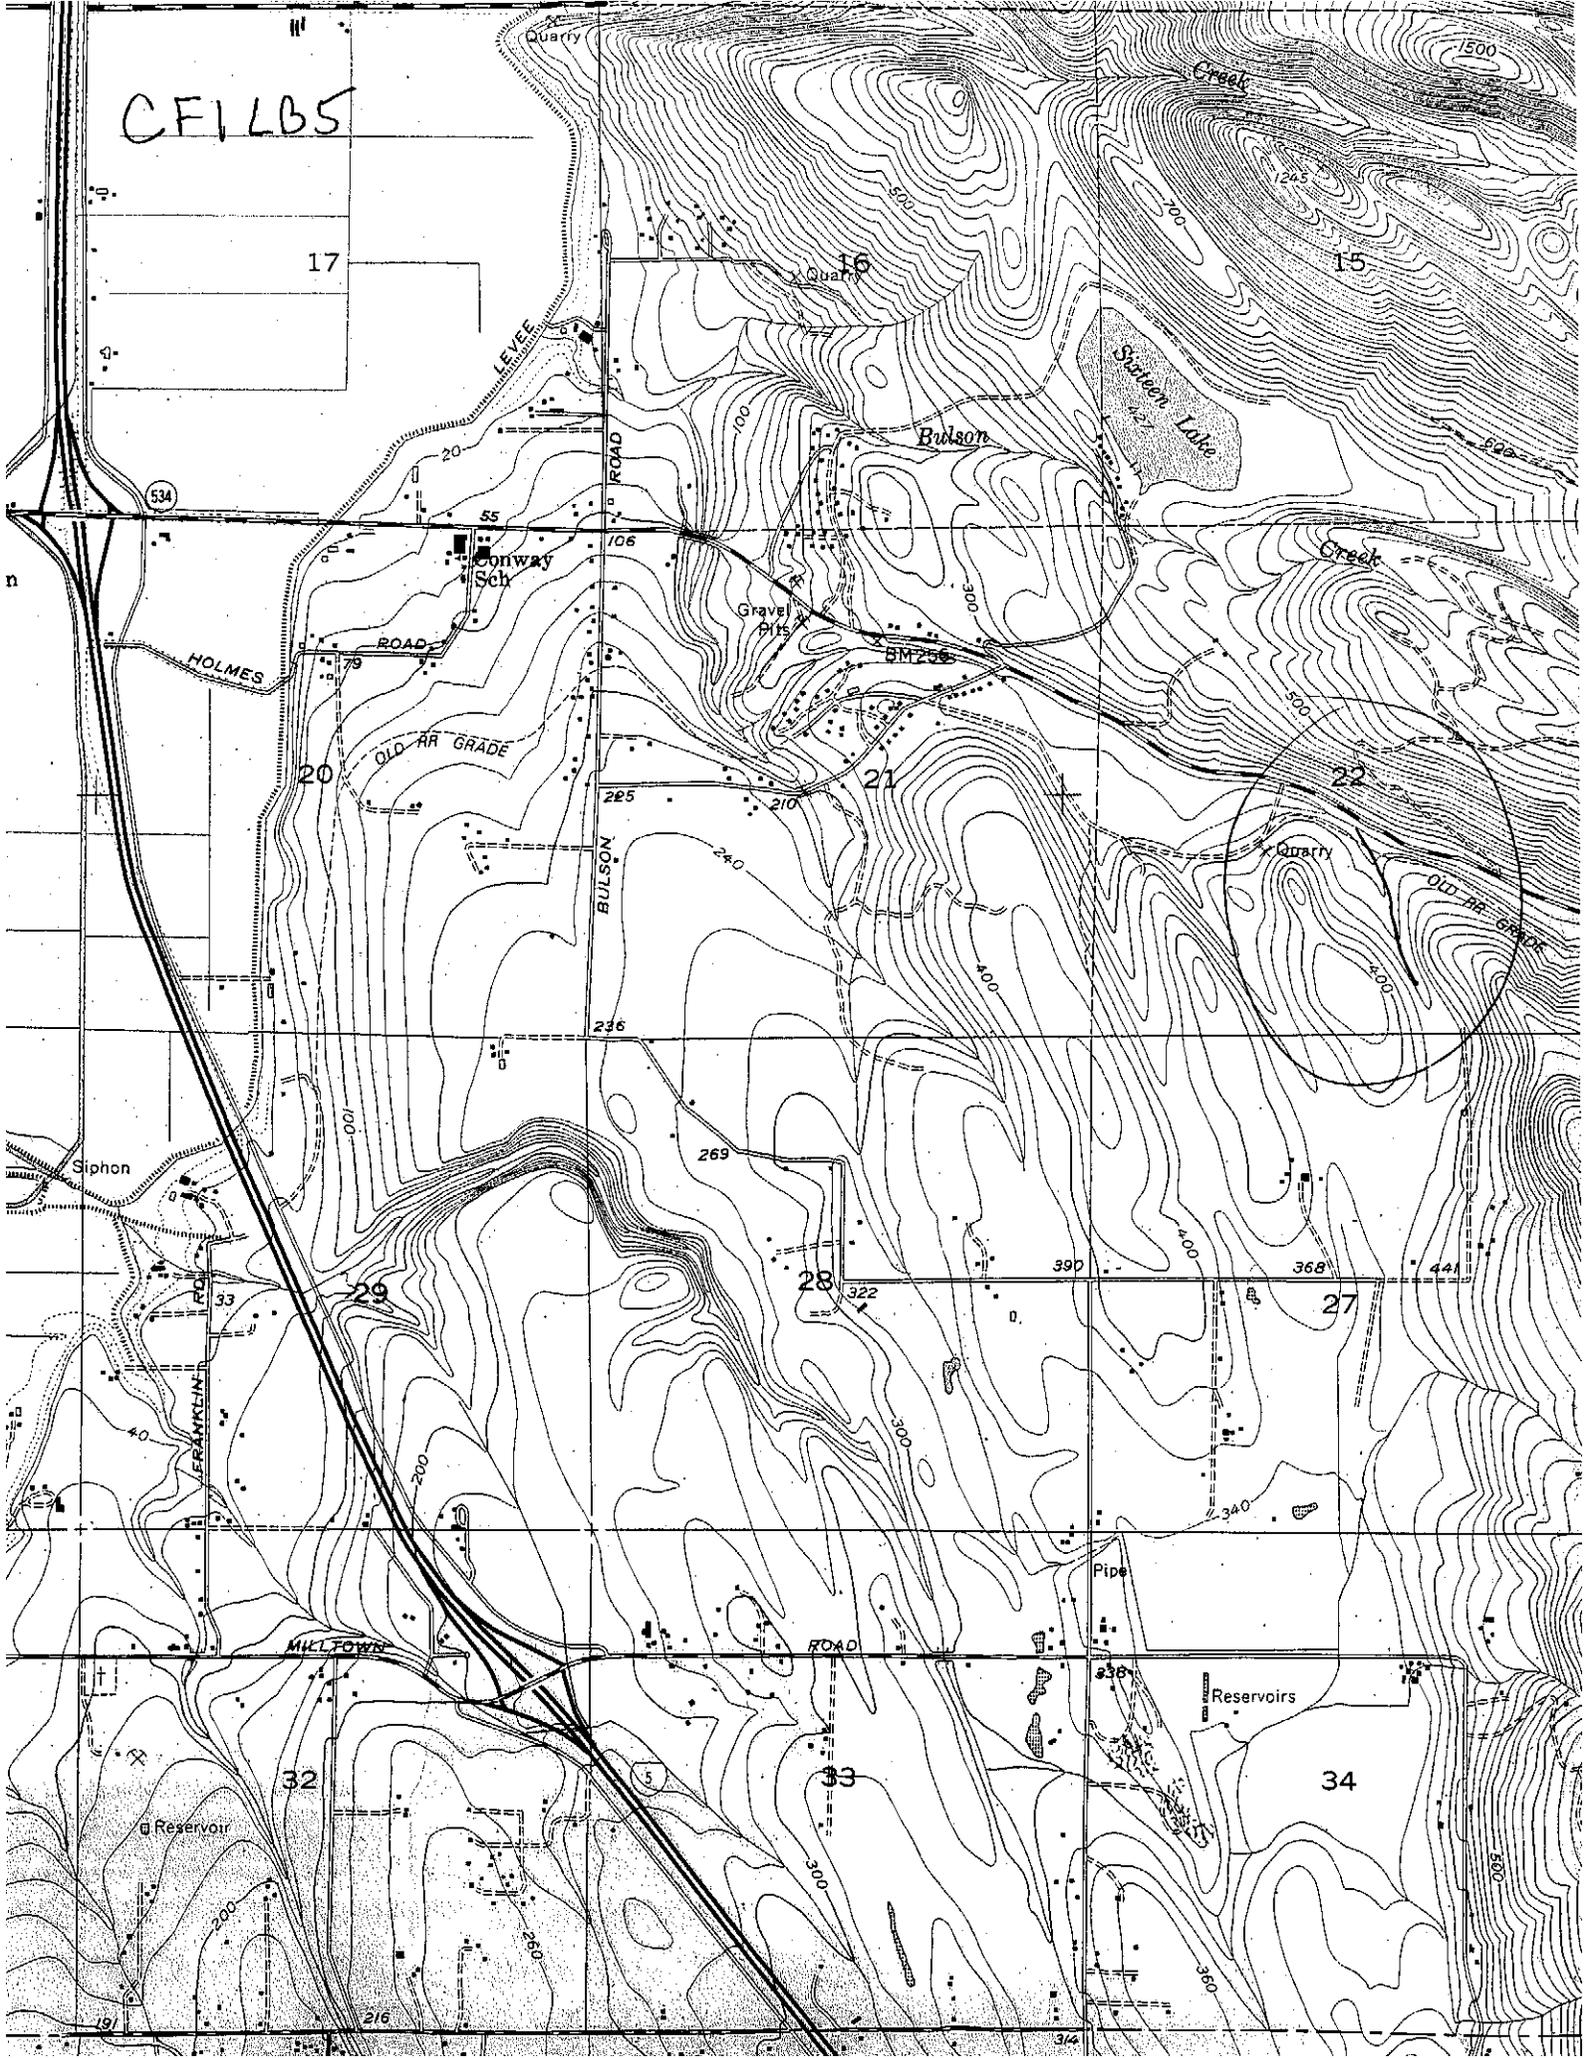
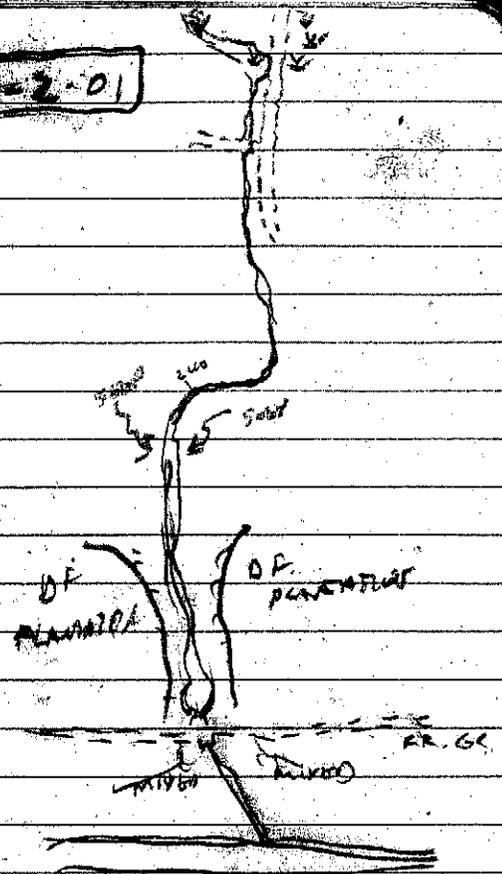
Site id. code: CF12B5  
 Site name:  
 Scale: 1" = 75m  
 Observer(s): OHS  
 Legal location: SE 1/4 S22 T33N R4E

ⓐ CULVERT

= 0.62 - CST - NO MP

- OUT FALL - 0.33

CULVERT

PLUNGE POOL - 2.5L-3W

LENGTH - 22.5 m

UPSTR. END RUSTED OUT

- @ 0.4m DROP

- ABOVE OLD GRADE
- @ CULVERT
- 0.62 CST 10m HT.
- VIS > 1% - WPT. DEP.
- OUTFALL - 0.3m 0.1

- LOWER END RUCTED OUT

ENHANCEMENT OPPORTUNITIES: The culvert at 45 meters could be replaced to facilitate fish passage. This section of the railroad grade is abandoned and overgrown.
