SITE NUMBER: CW-L2-02

LOCAL NAME: Duck pond

NORTH COAST OFF CHANNEL SITE INVENTORY DATA

Clearwater River Site: CW-22
Channel CW-22-02 (Duck pond)

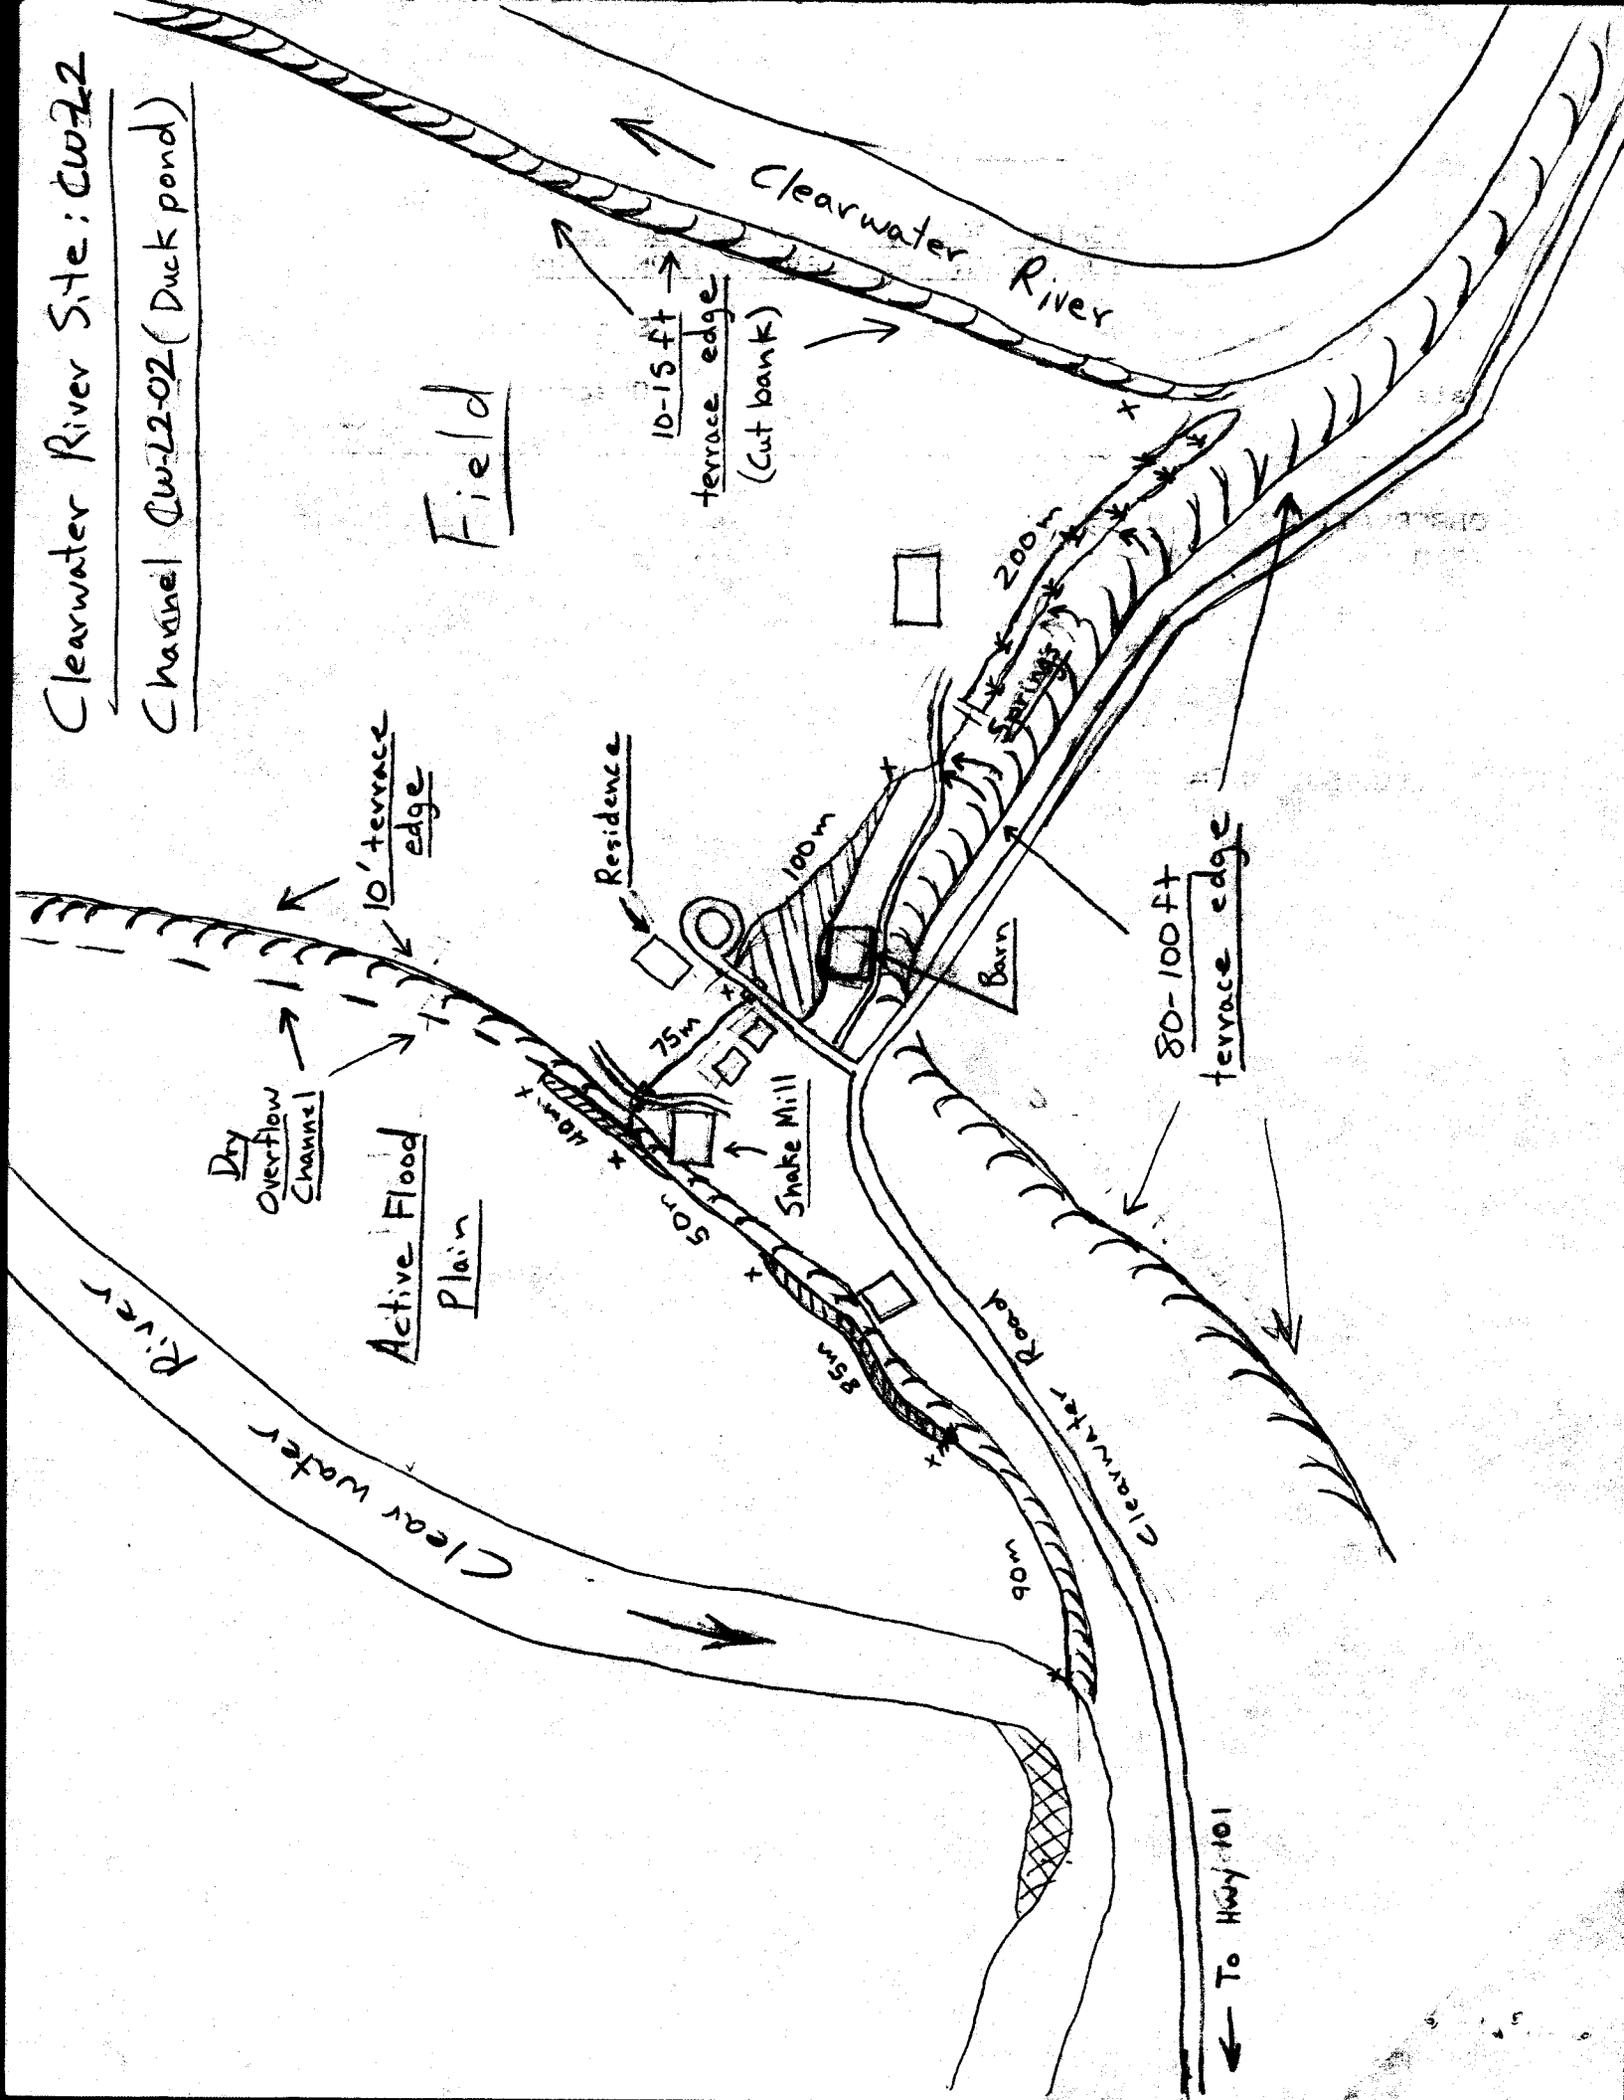
COMMENTS: This pond is a man-made impoundment along a small terrace tributary. It appears to have a gravel & rubble substrate under a thin layer of sediment. It is used by domestic waterfowl and live-stock and also for residential irrigation.

Even after a fairly substantial rainfall the volume of water flowing through this pond is unimpressive. Making this pond accessible to upstream migrants does not appear to be a high priority. Low density fry planting of the pond may be a possibility.
