SITE NUMBER: CW-R3-01
LOCAL NAME: Airport Ponds
WRIA:

NORTH COAST OFF CHANNEL SITE INVENTORY DATA

SITE NUMBER: CW-R3-01
RIVER SYSTEM: Clearwater
(Lower Airport Pond)

POND DATA SUPPLEMENT

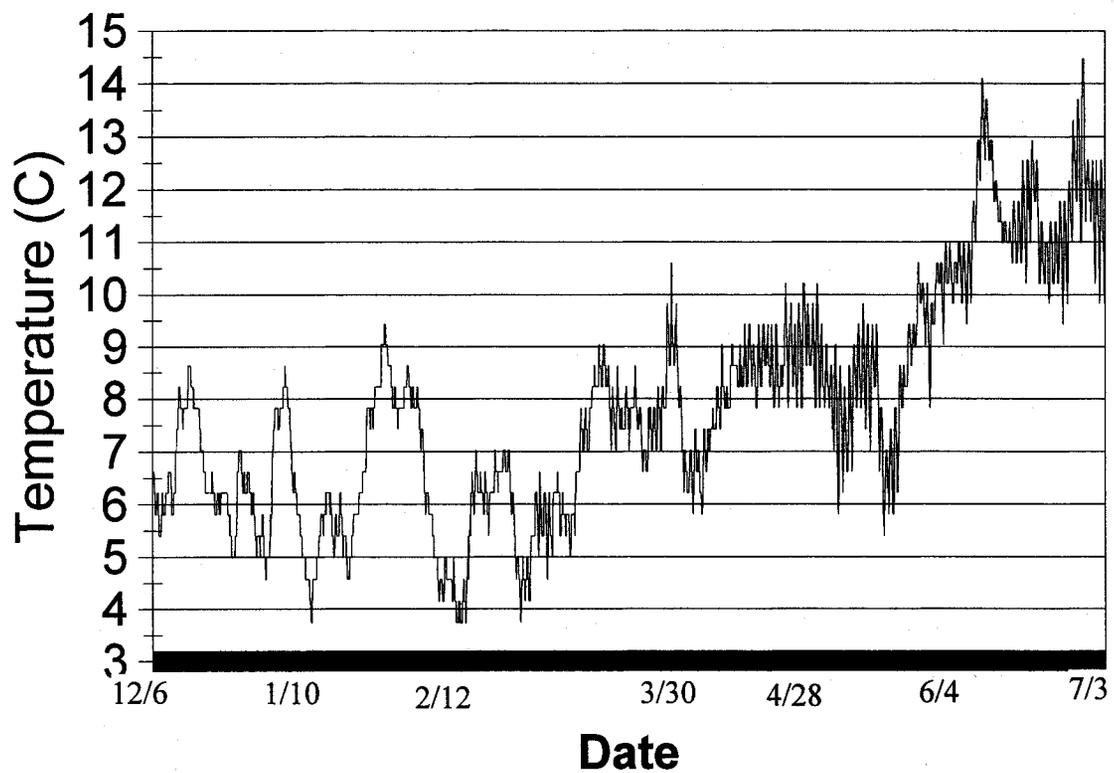
Airport Pond Temperatures - 2002/2003

The project is doing well overall. There is erosion under the wall where the creek bends and impinges on it. Cobble was added in attempt to reduce the effects. Four coho carcasses were on site: two males and two females. Two redds were also observed. Two thermographs were placed in the ponds.

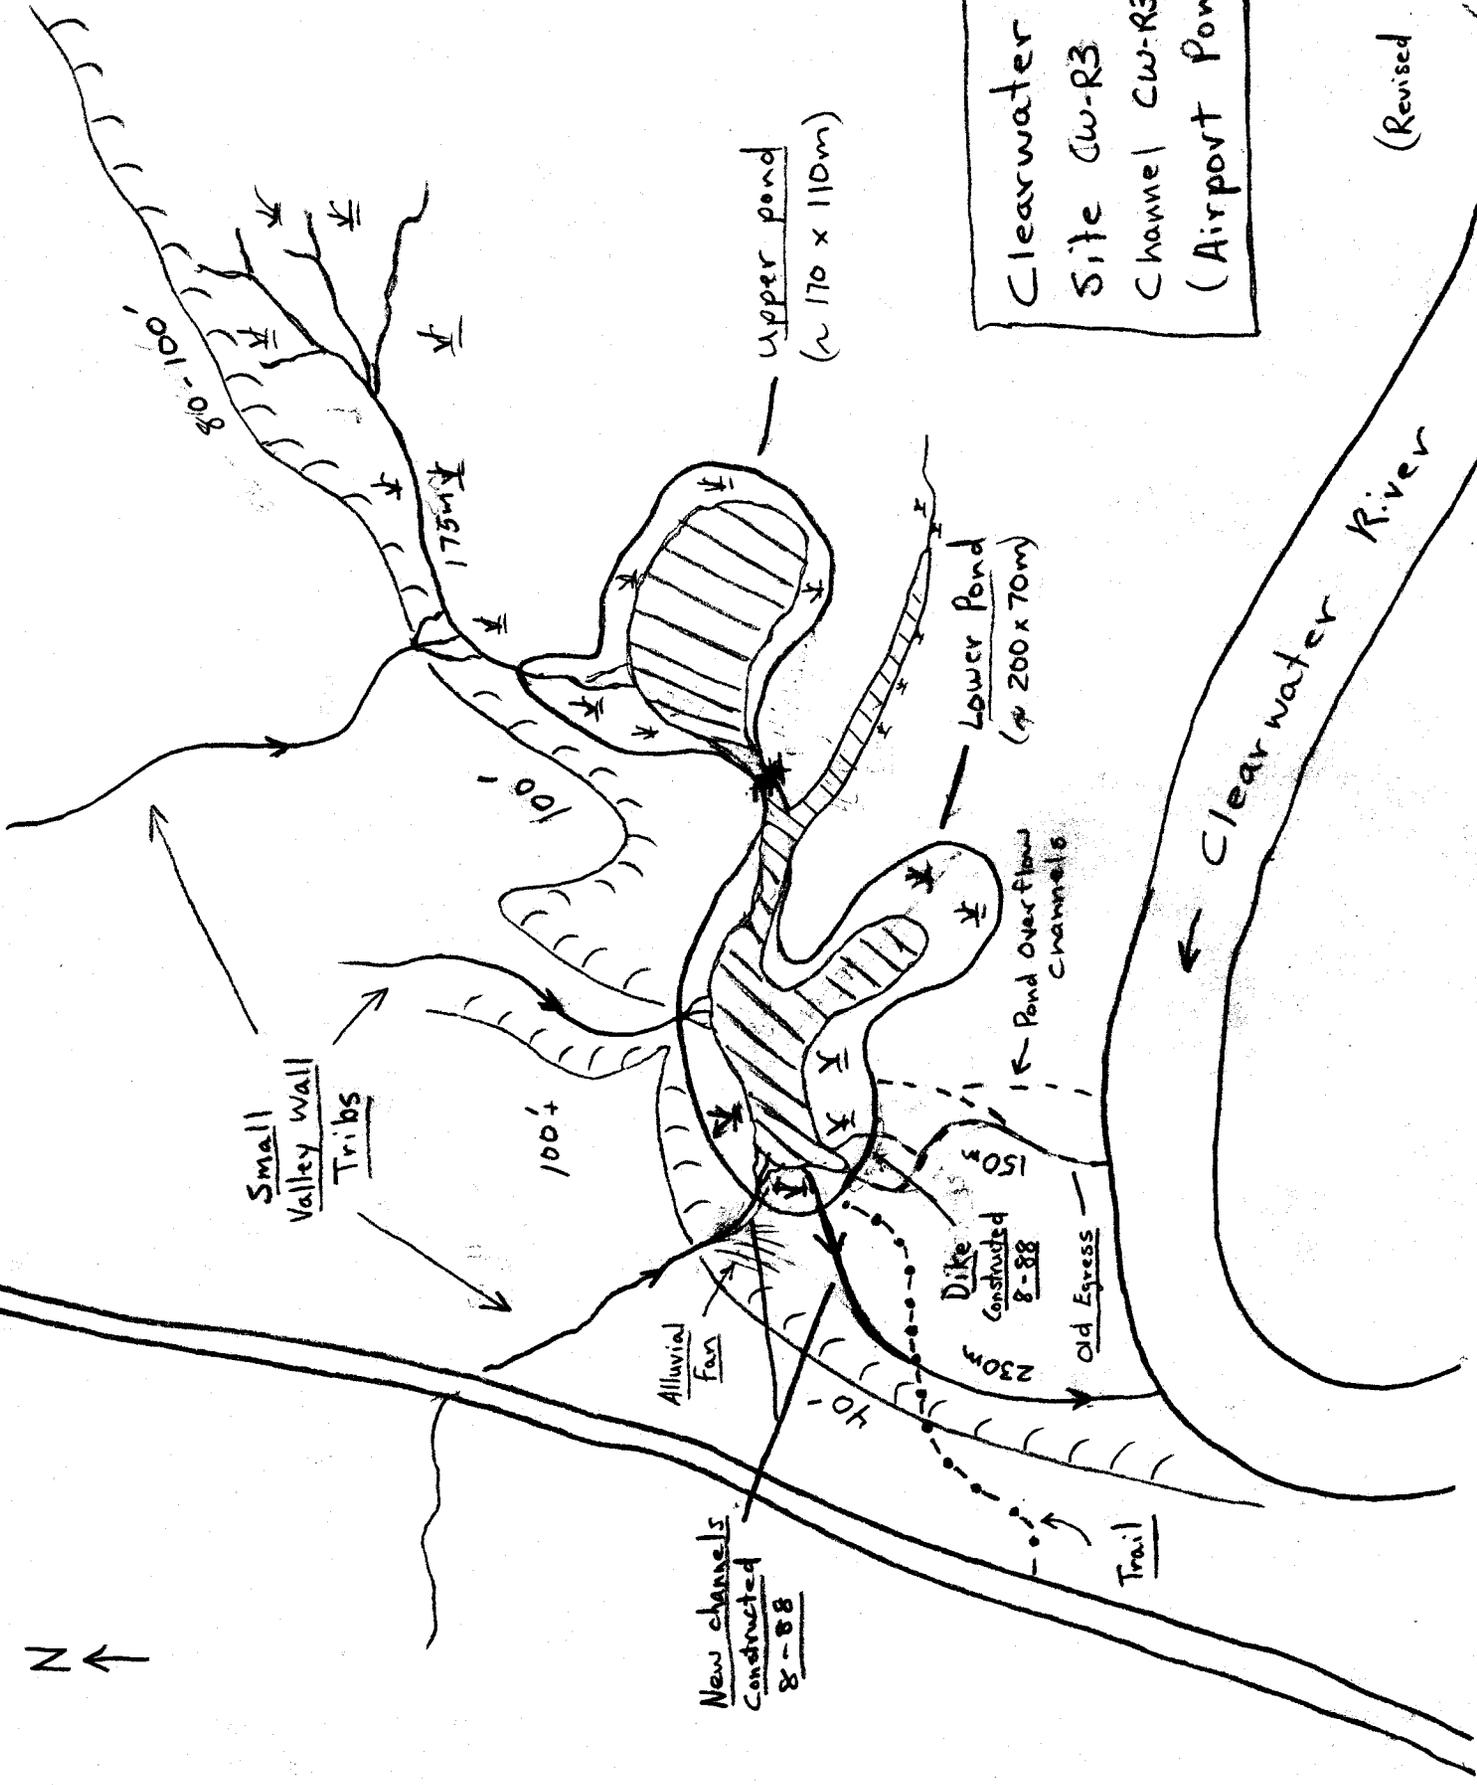
Clearwater River
Site CW-R3
Channel CW-R3-p1
(Airport Ponds)

DATE: 11/29/88
Electroshocked at various spots along the perimeter of the lower pond and at sites near the lower end of the upper pond (see map). Results are listed below:

Area (Sec.)	Effort	Results
1.) Plunge pool at upper end of old main channel.	14	Caught 7 coho and numerous small dace.
2.) Left arm of lower pond.	68	No fish.
3.) Lower pond just downstream of main beaver dam.	122	No fish (Good habitat!).
4.) Two sites near lower end of upper pond (just above beaver dam.	115	No fish.
