**SITE NUMBER:** CW-R8-02  
**LOCAL NAME:** Bull Creek #1  
**WRIA:**

**NORTH COAST OFF CHANNEL SITE INVENTORY DATA**

**RIVER SYSTEM:** Clearwater    **DATE:** 6/28/88    **OBSERVER:** Nettnin

**CHANNEL TYPE:** Terrace tributary

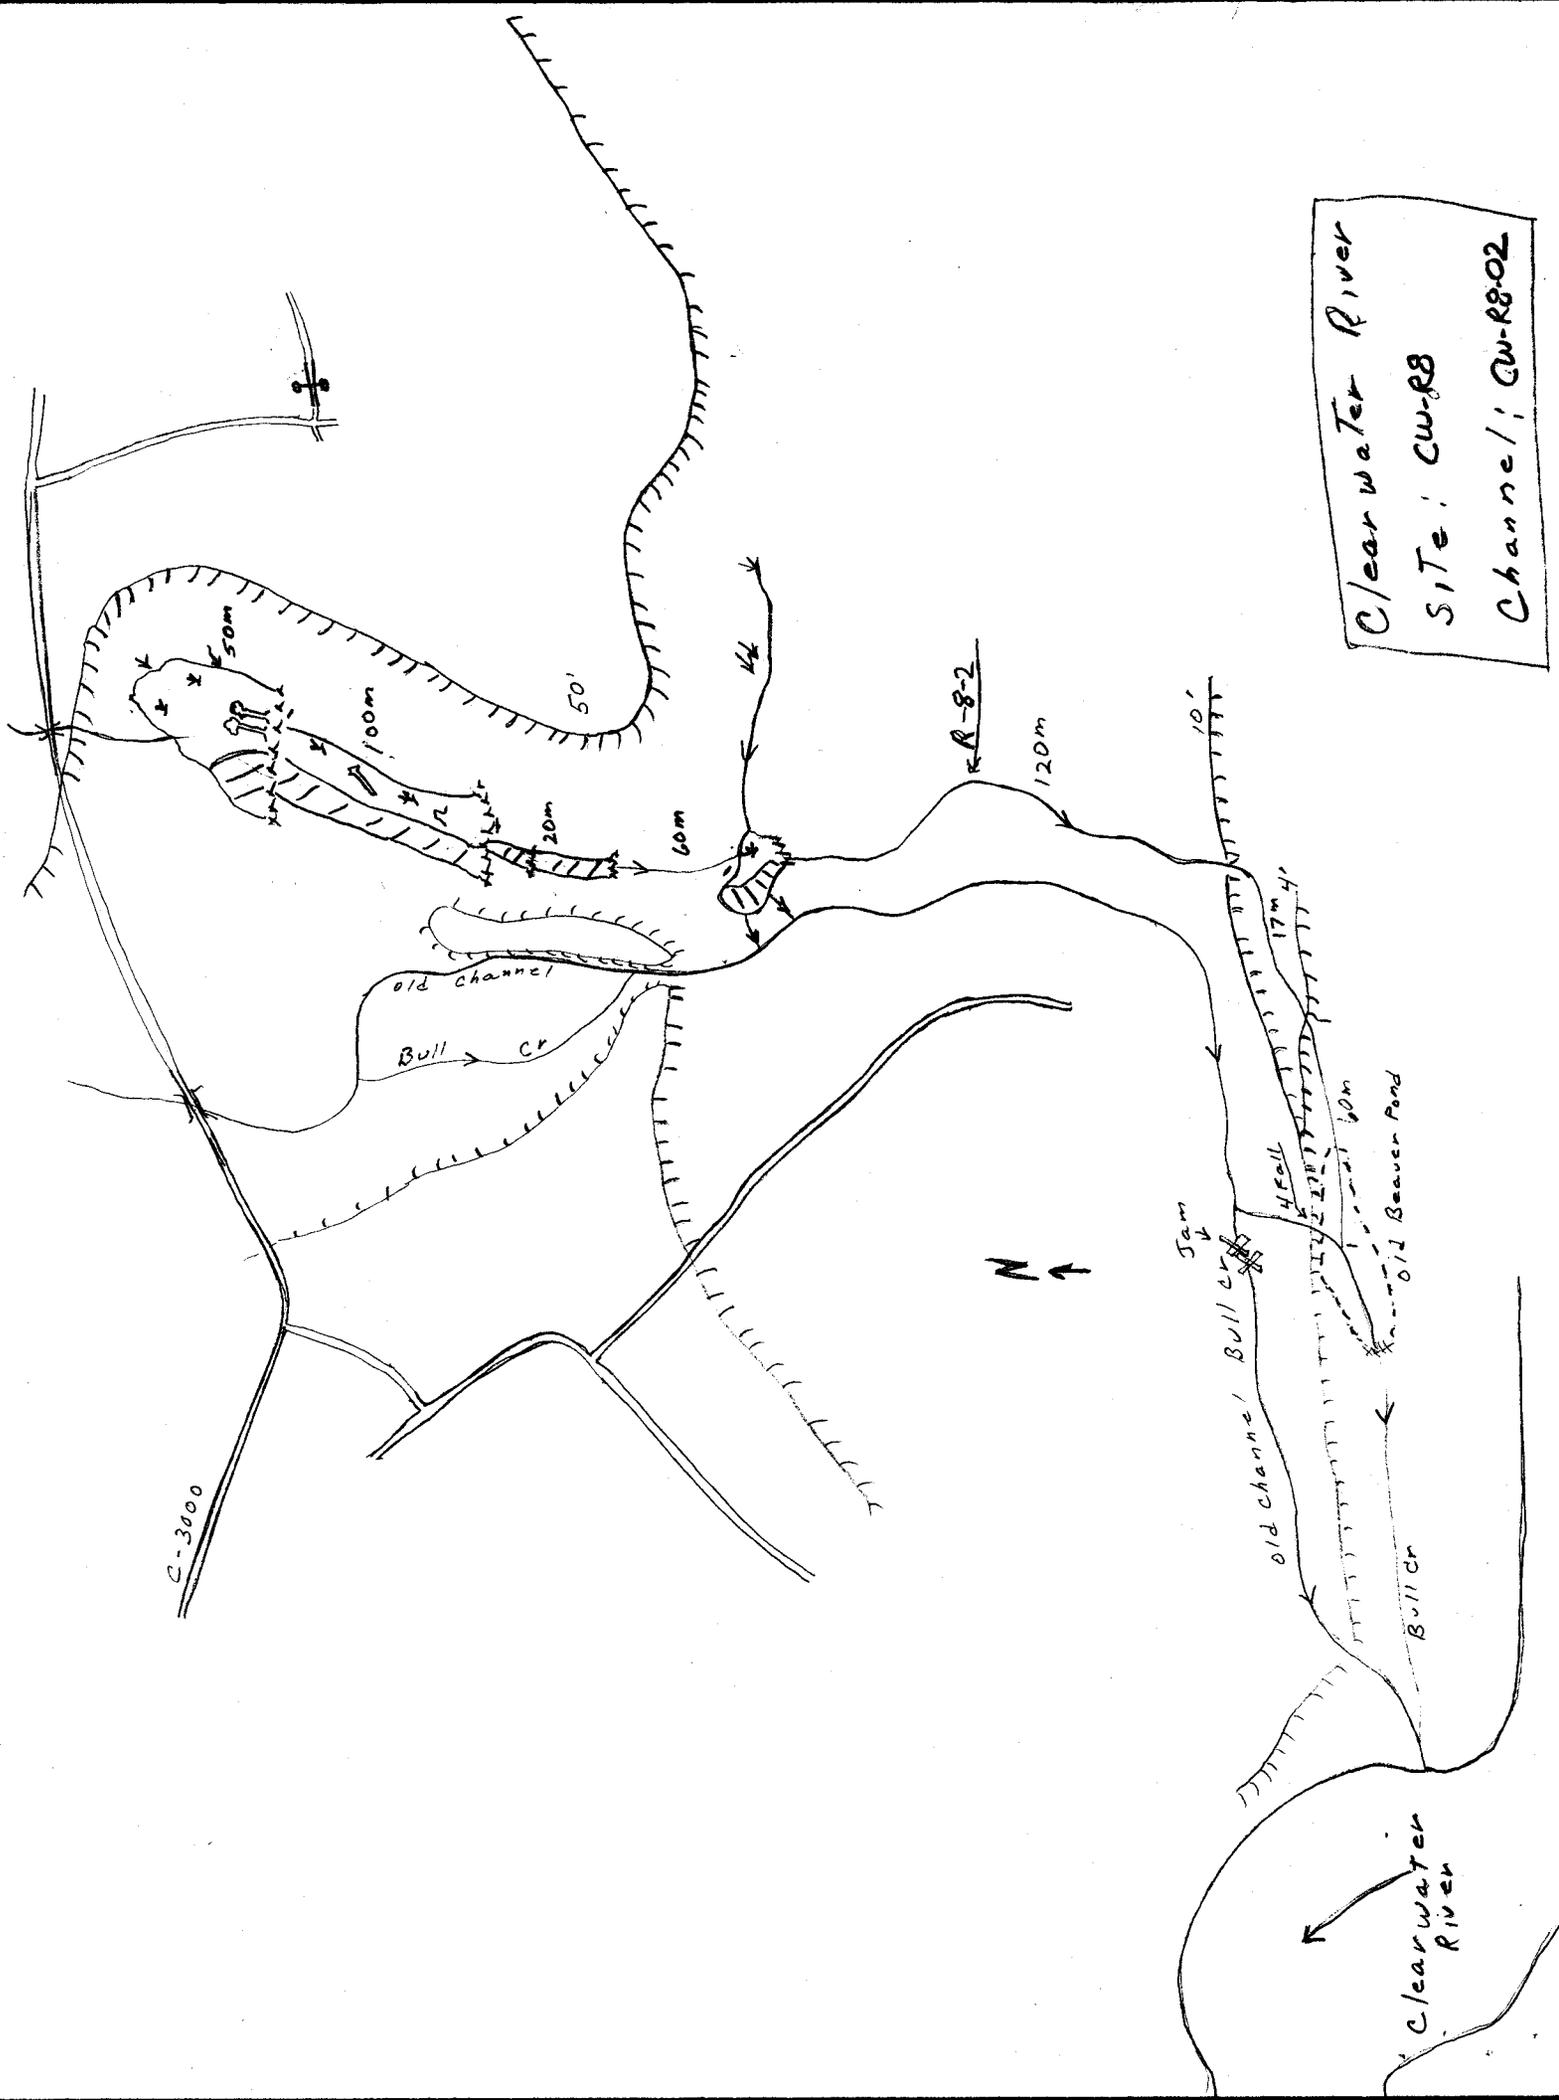
Clearwater River  
 Site: CW-R8  
 Channel: CW-R8-02

Flow in the channel was estimated at about 0.25 cfs. Any fish in the beaver ponds at this time are currently trapped. There is a series of five dams along the mid and upper reaches of this channel. The lower three dams are relatively small, but will limit the upstream migration of juveniles coho during low flow periods. One unidentified fish was seen in the lowermost pond. The upper two dams and ponds are 30 to 40 m wide. The maximum winter depth in these two large upper ponds is 3 to 4 ft. Water temperature at the inlet of the uppermost pond was 52 F. Water temperatures taken in the two upper ponds ranged from 59 to 63 F. (A revised channel map for CW-R8-02 has been included with this write up.)
