SITE NUMBER: D-105R-02 (was D-L3-02)

LOCAL NAME: Mina Springs

NORTH COAST OFF CHANNEL SITE INVENTORY DATA

RIVER SYSTEM: Dickey **DATE:** 1/9/91 **OBSERVER:** Nettnin

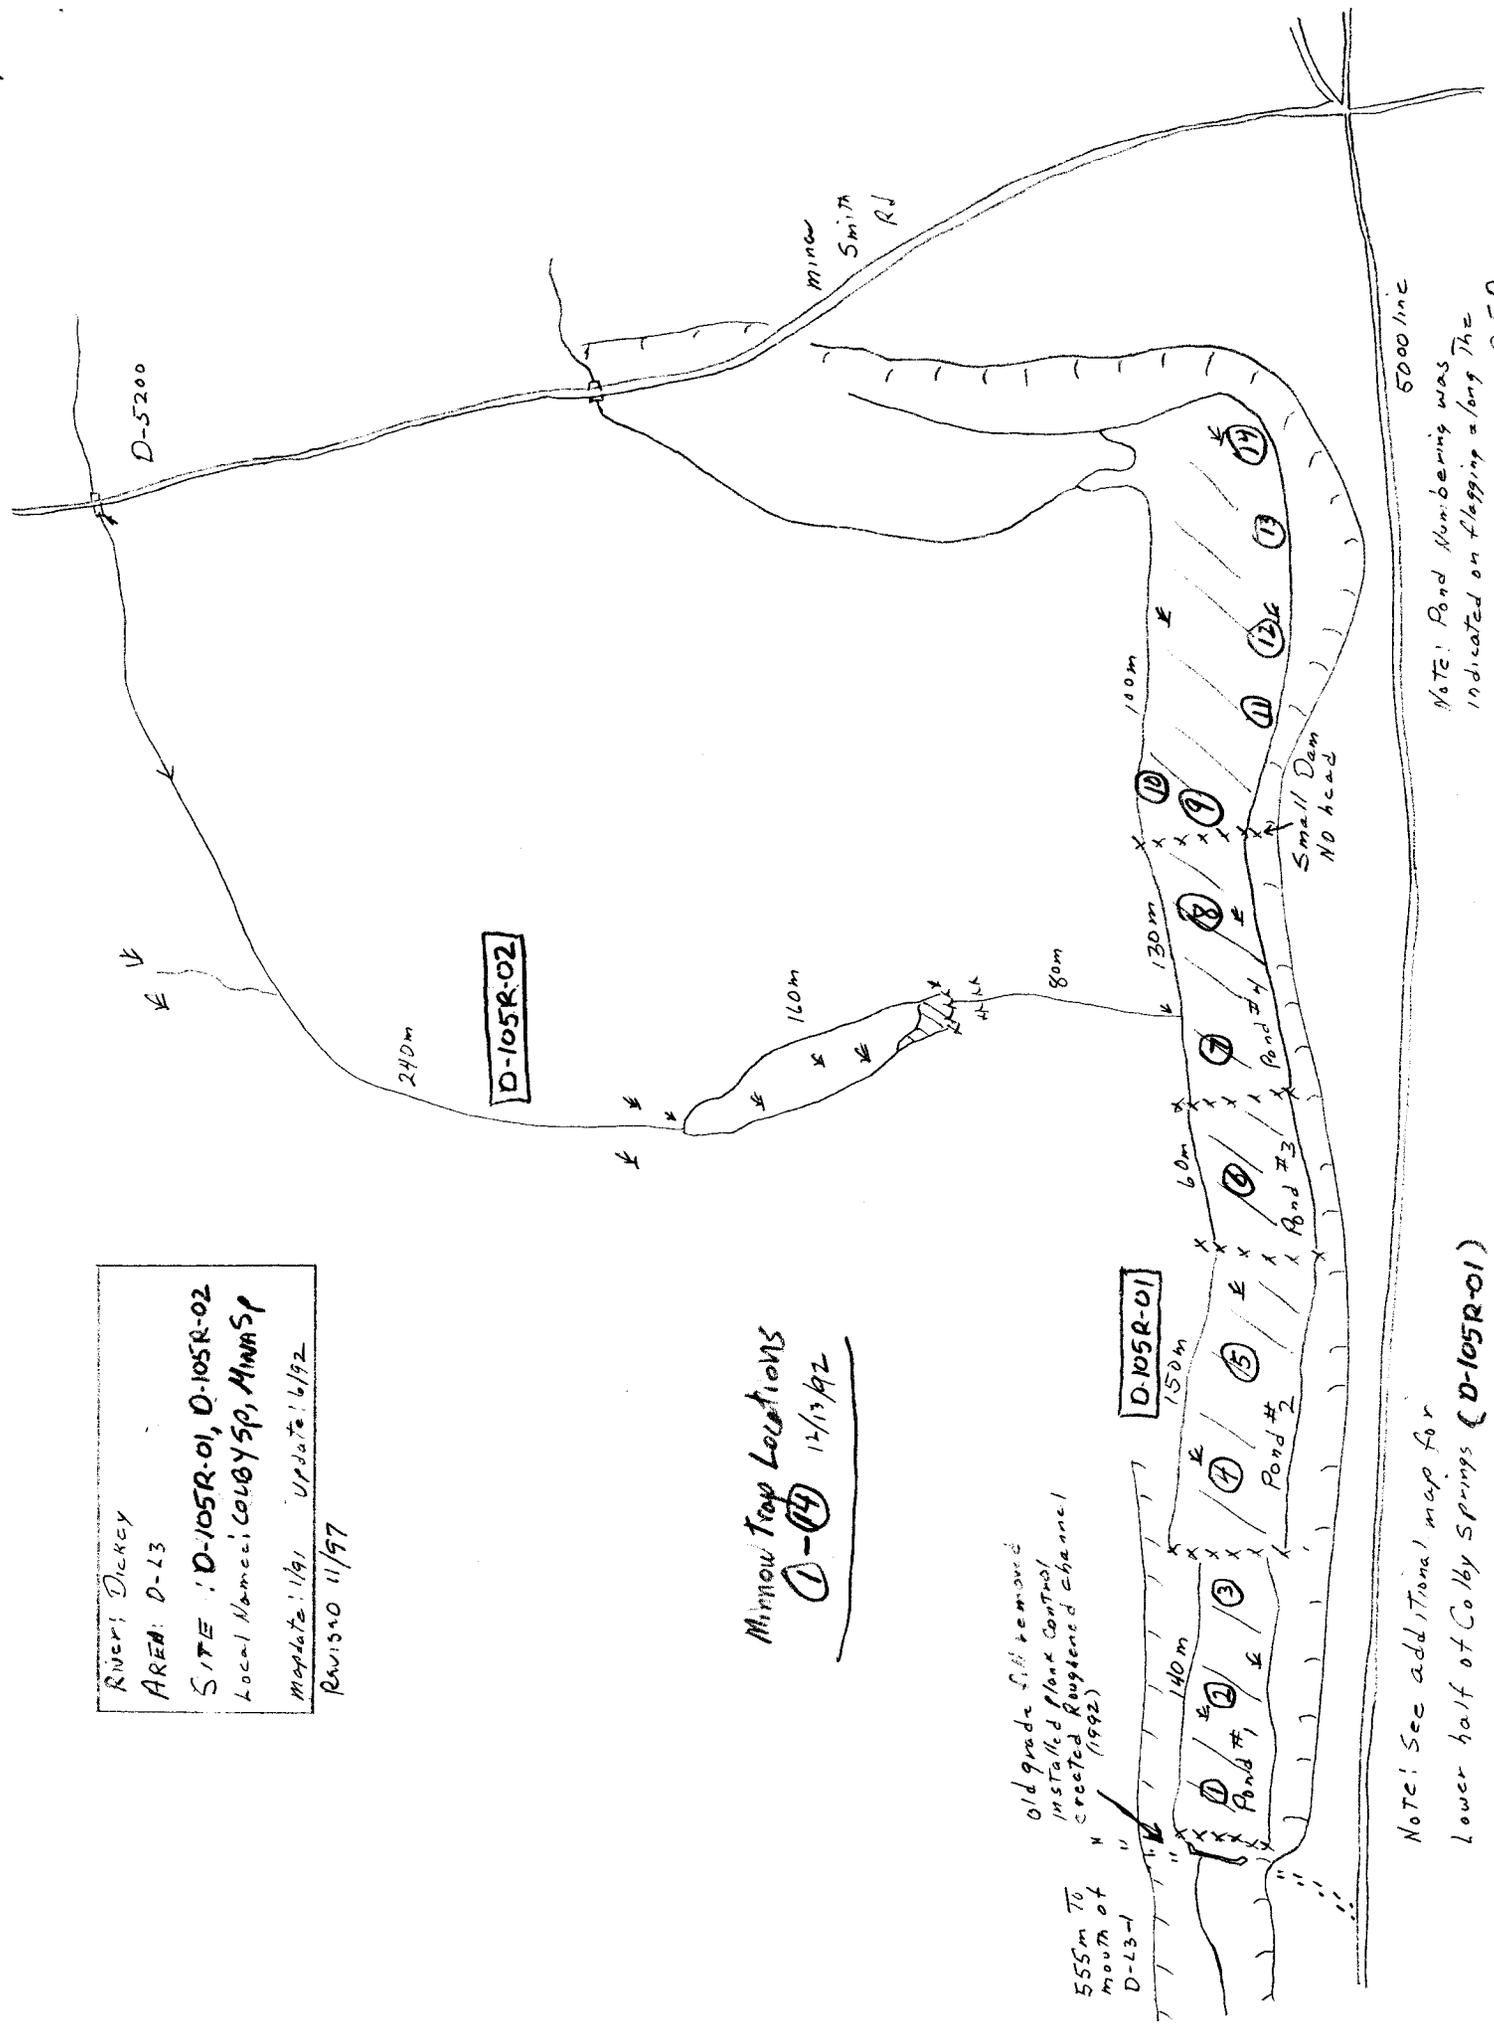
River: Dickey
 AREA: D-13
 SITE: D-105R-01, D-105R-02
 Local Name: Colby Sp, Minn Sp
 Map date: 1/91 Update: 6/92
 Revised: 11/97

Minnow Trap Locations
 ①-⑭ 12/13/92
