**SITE NUMBER:** D-L2-01  
**LOCAL NAME:** Airfield Springs  
**WRIA:** 20.0098F

**NORTH COAST OFF CHANNEL SITE INVENTORY DATA**

**RIVER SYSTEM:** Dickey      **DATE:** 11/08/90      **OBSERVER:** Young

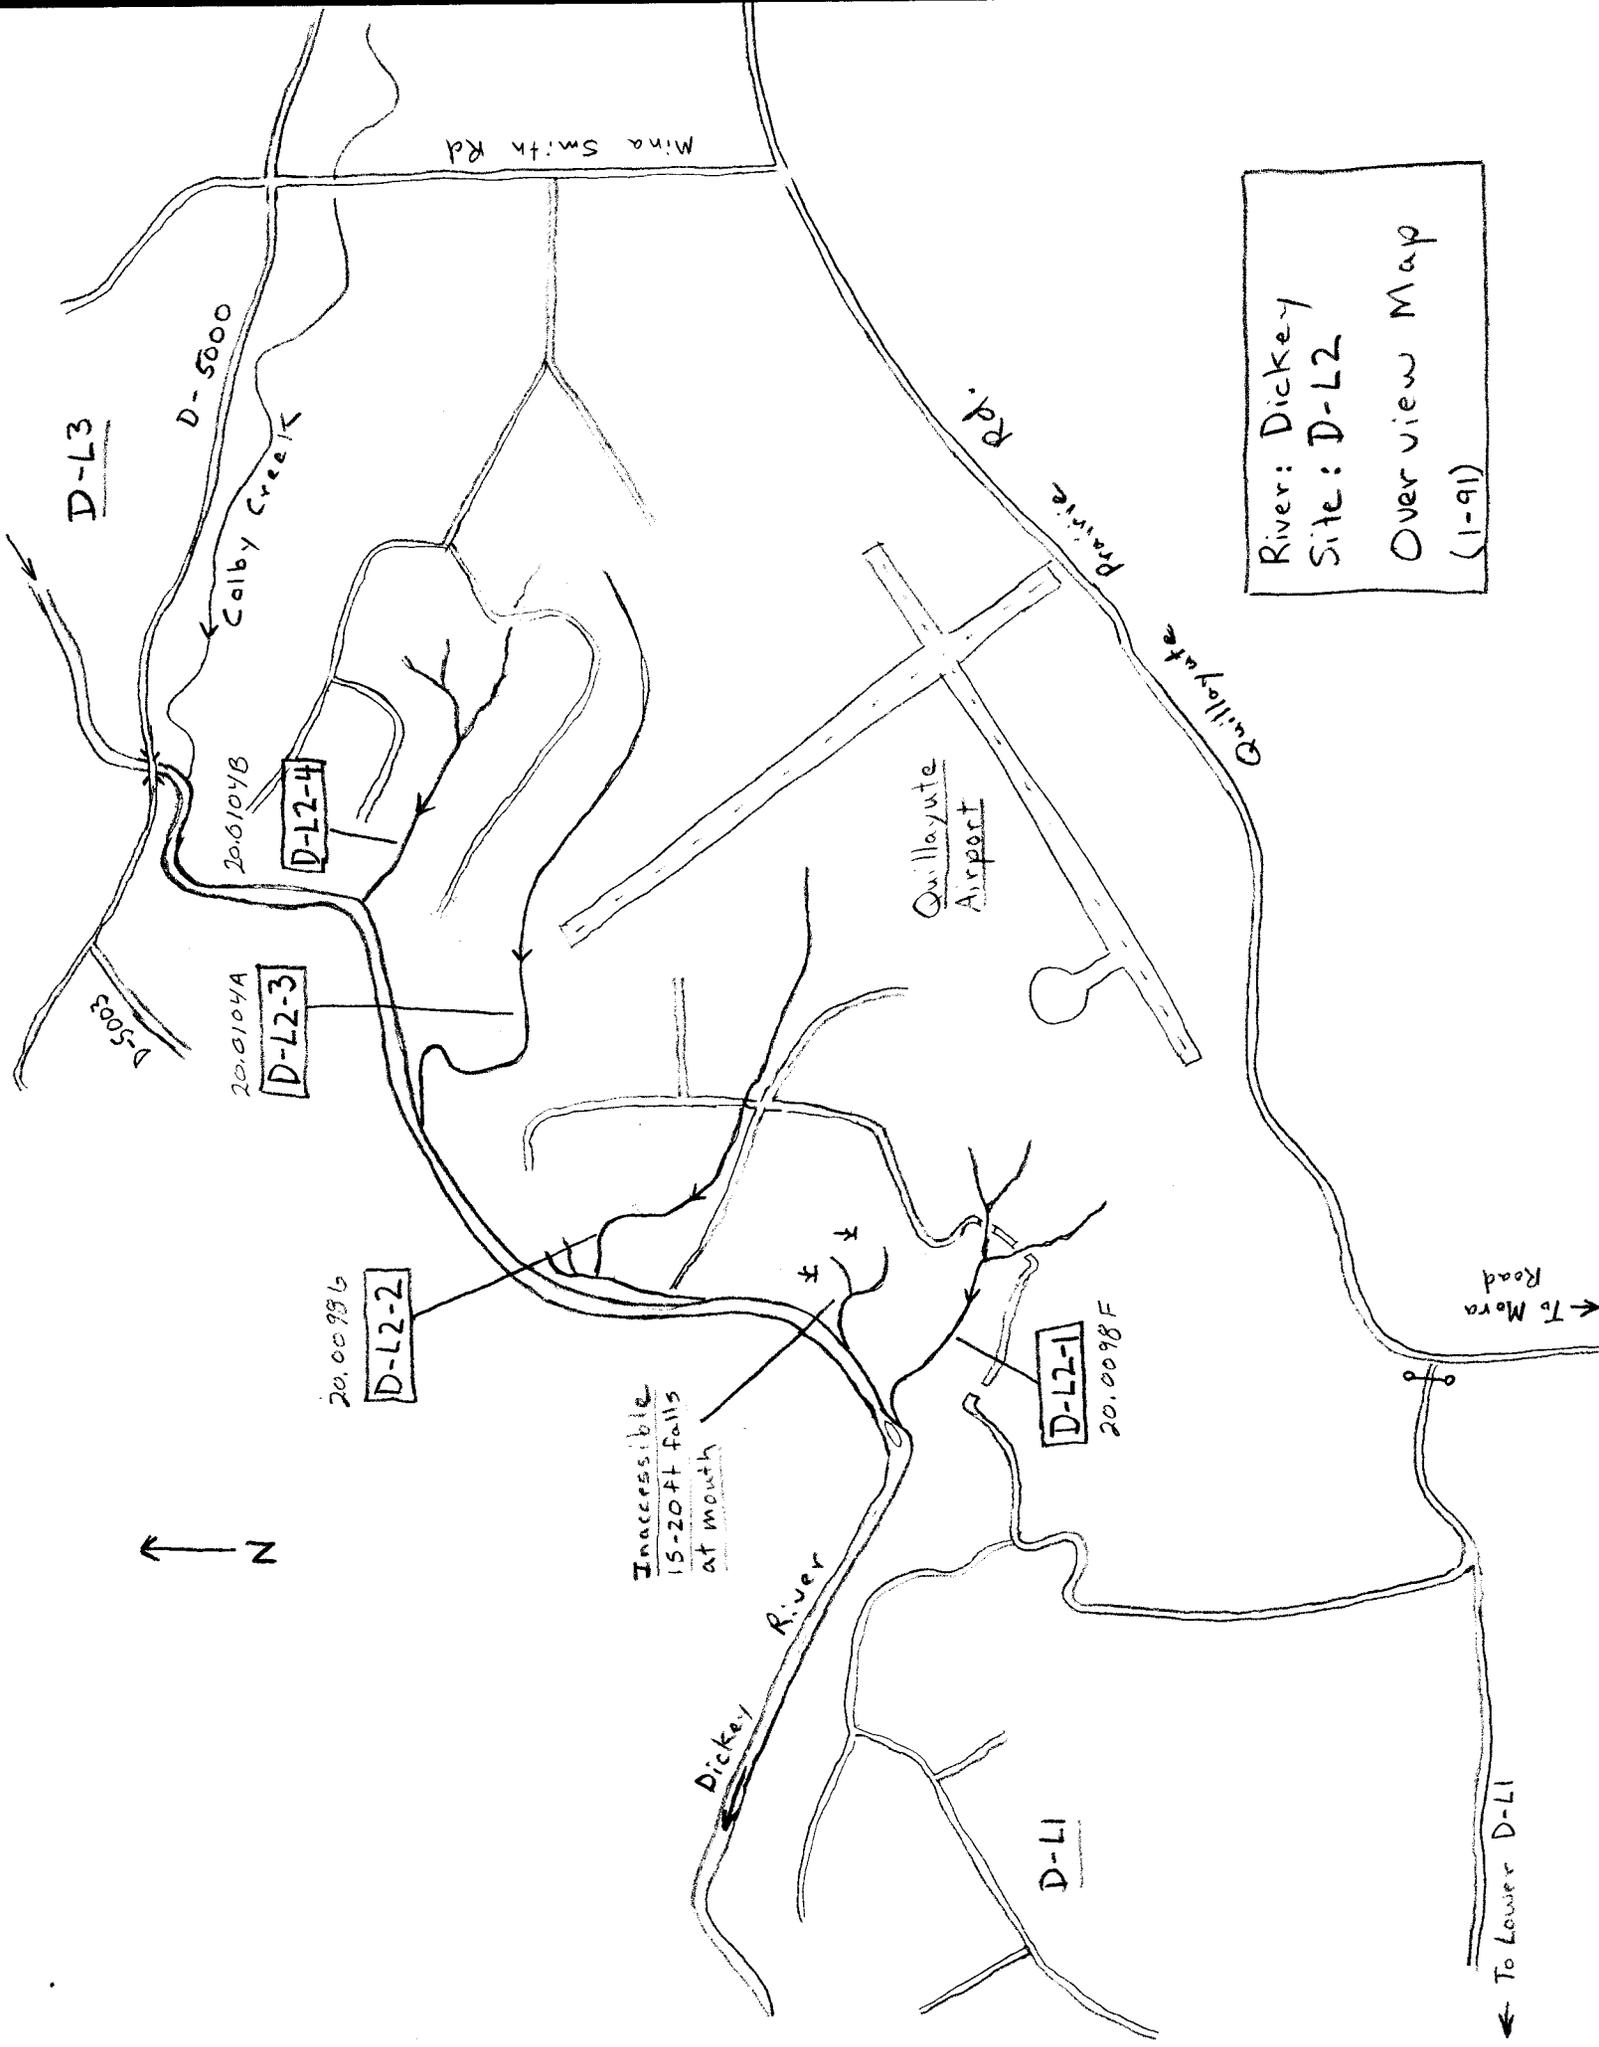
River: Dickey  
 Site: D-L2  
 Overview Map  
 (1-91)

Inaccessible  
 15-20 ft falls  
 at mouth

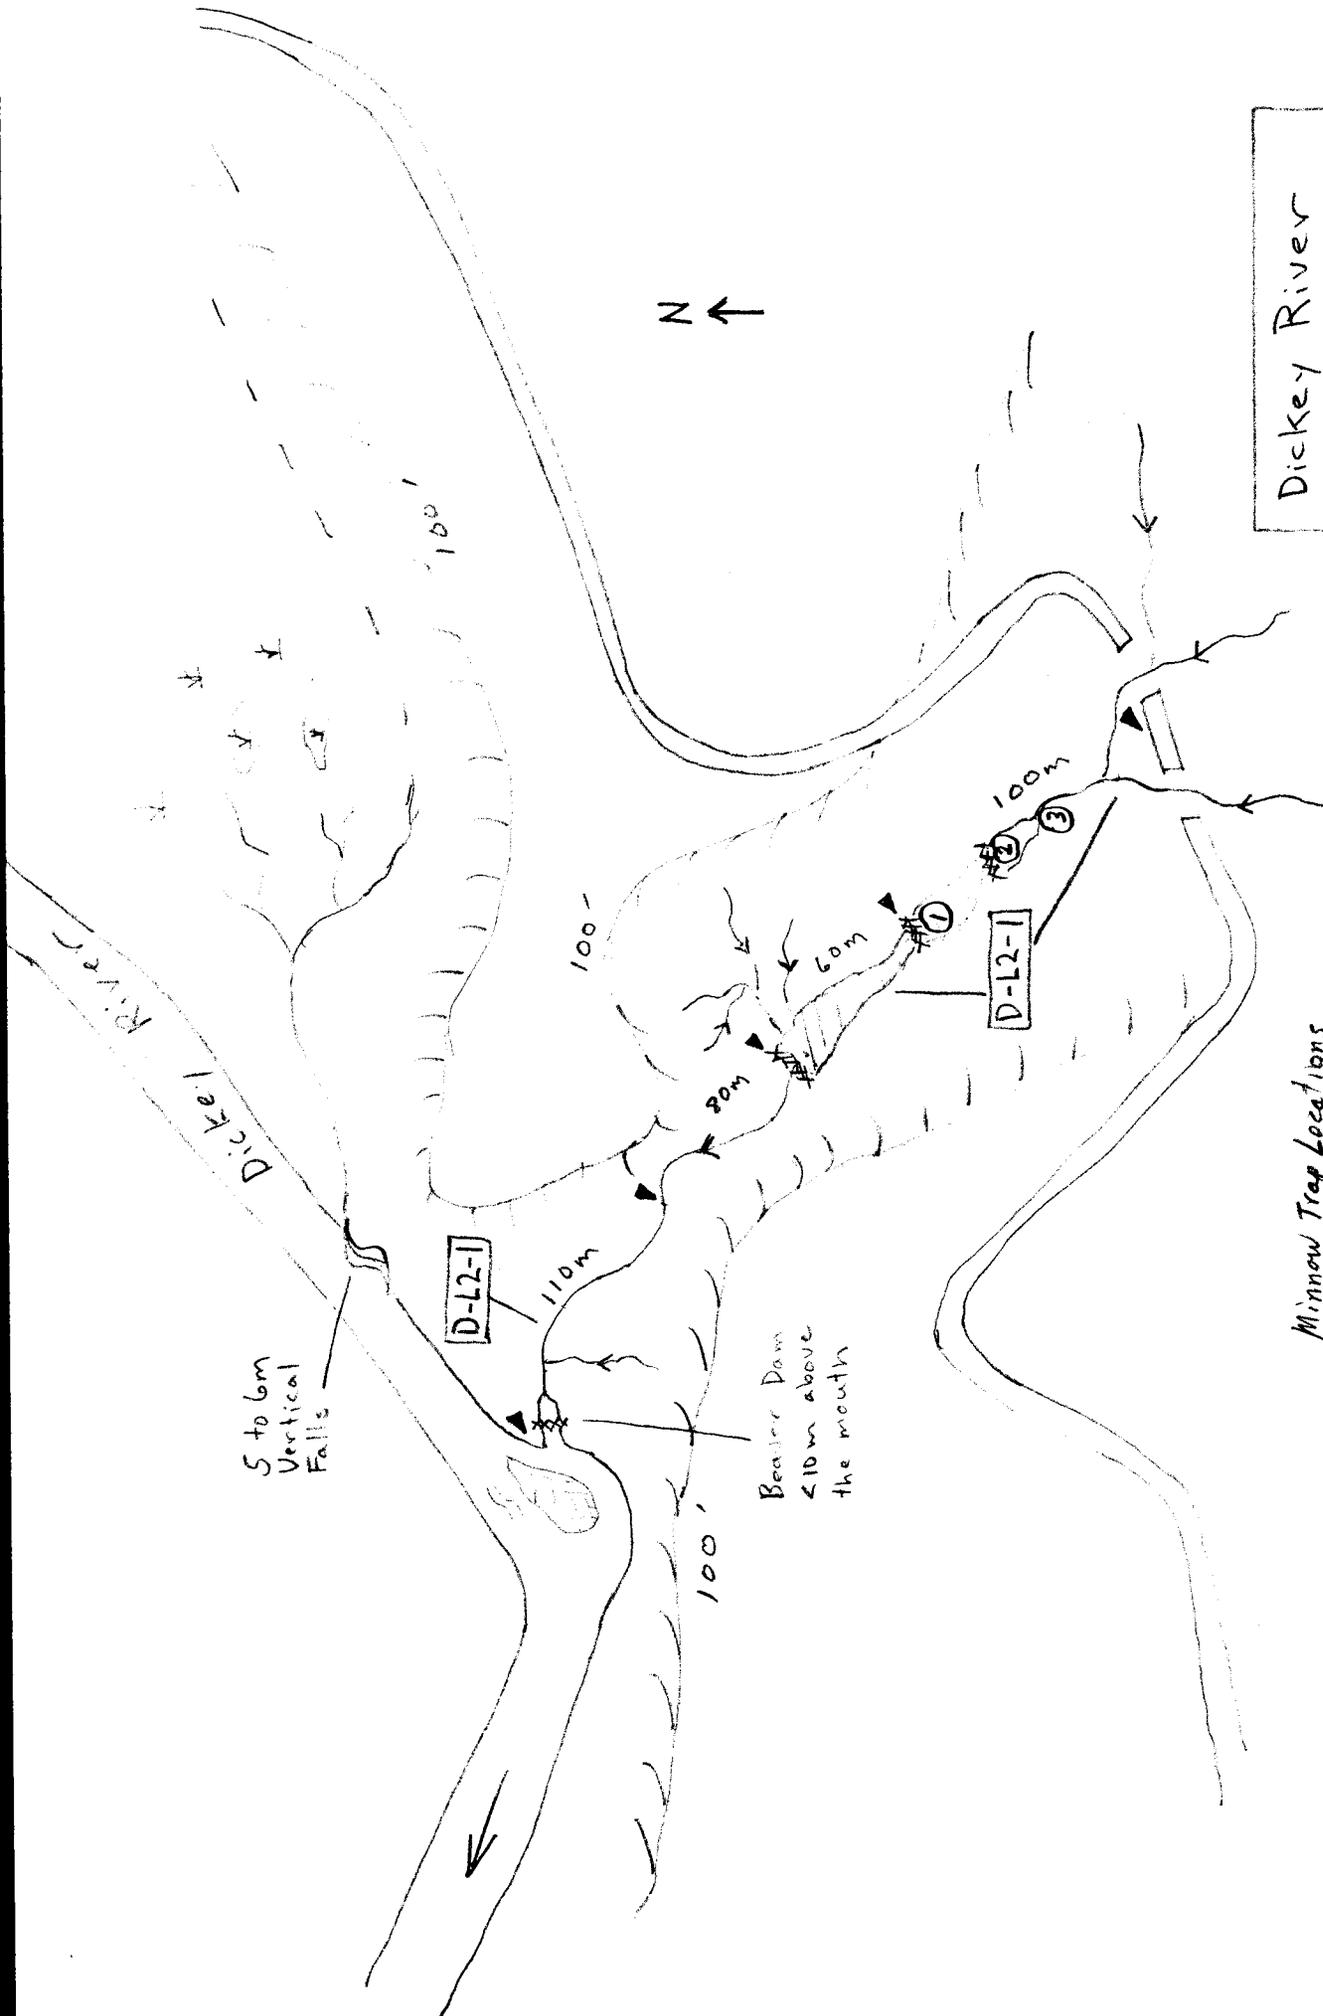
Dickey River  
 Site: D-L2  
 Channel: D-L2-1  
 Name: Airfield Springs

Minnow Trap Locations  
 ① ② ③
