SITE NUMBER: D-L2-02

LOCAL NAME: Cessna Springs

NORTH COAST OFF CHANNEL SITE INVENTORY DATA

NORTH COAST OFF-CHANNEL SURVEY
SUBSEQUENT SITE EVALUATION FORM

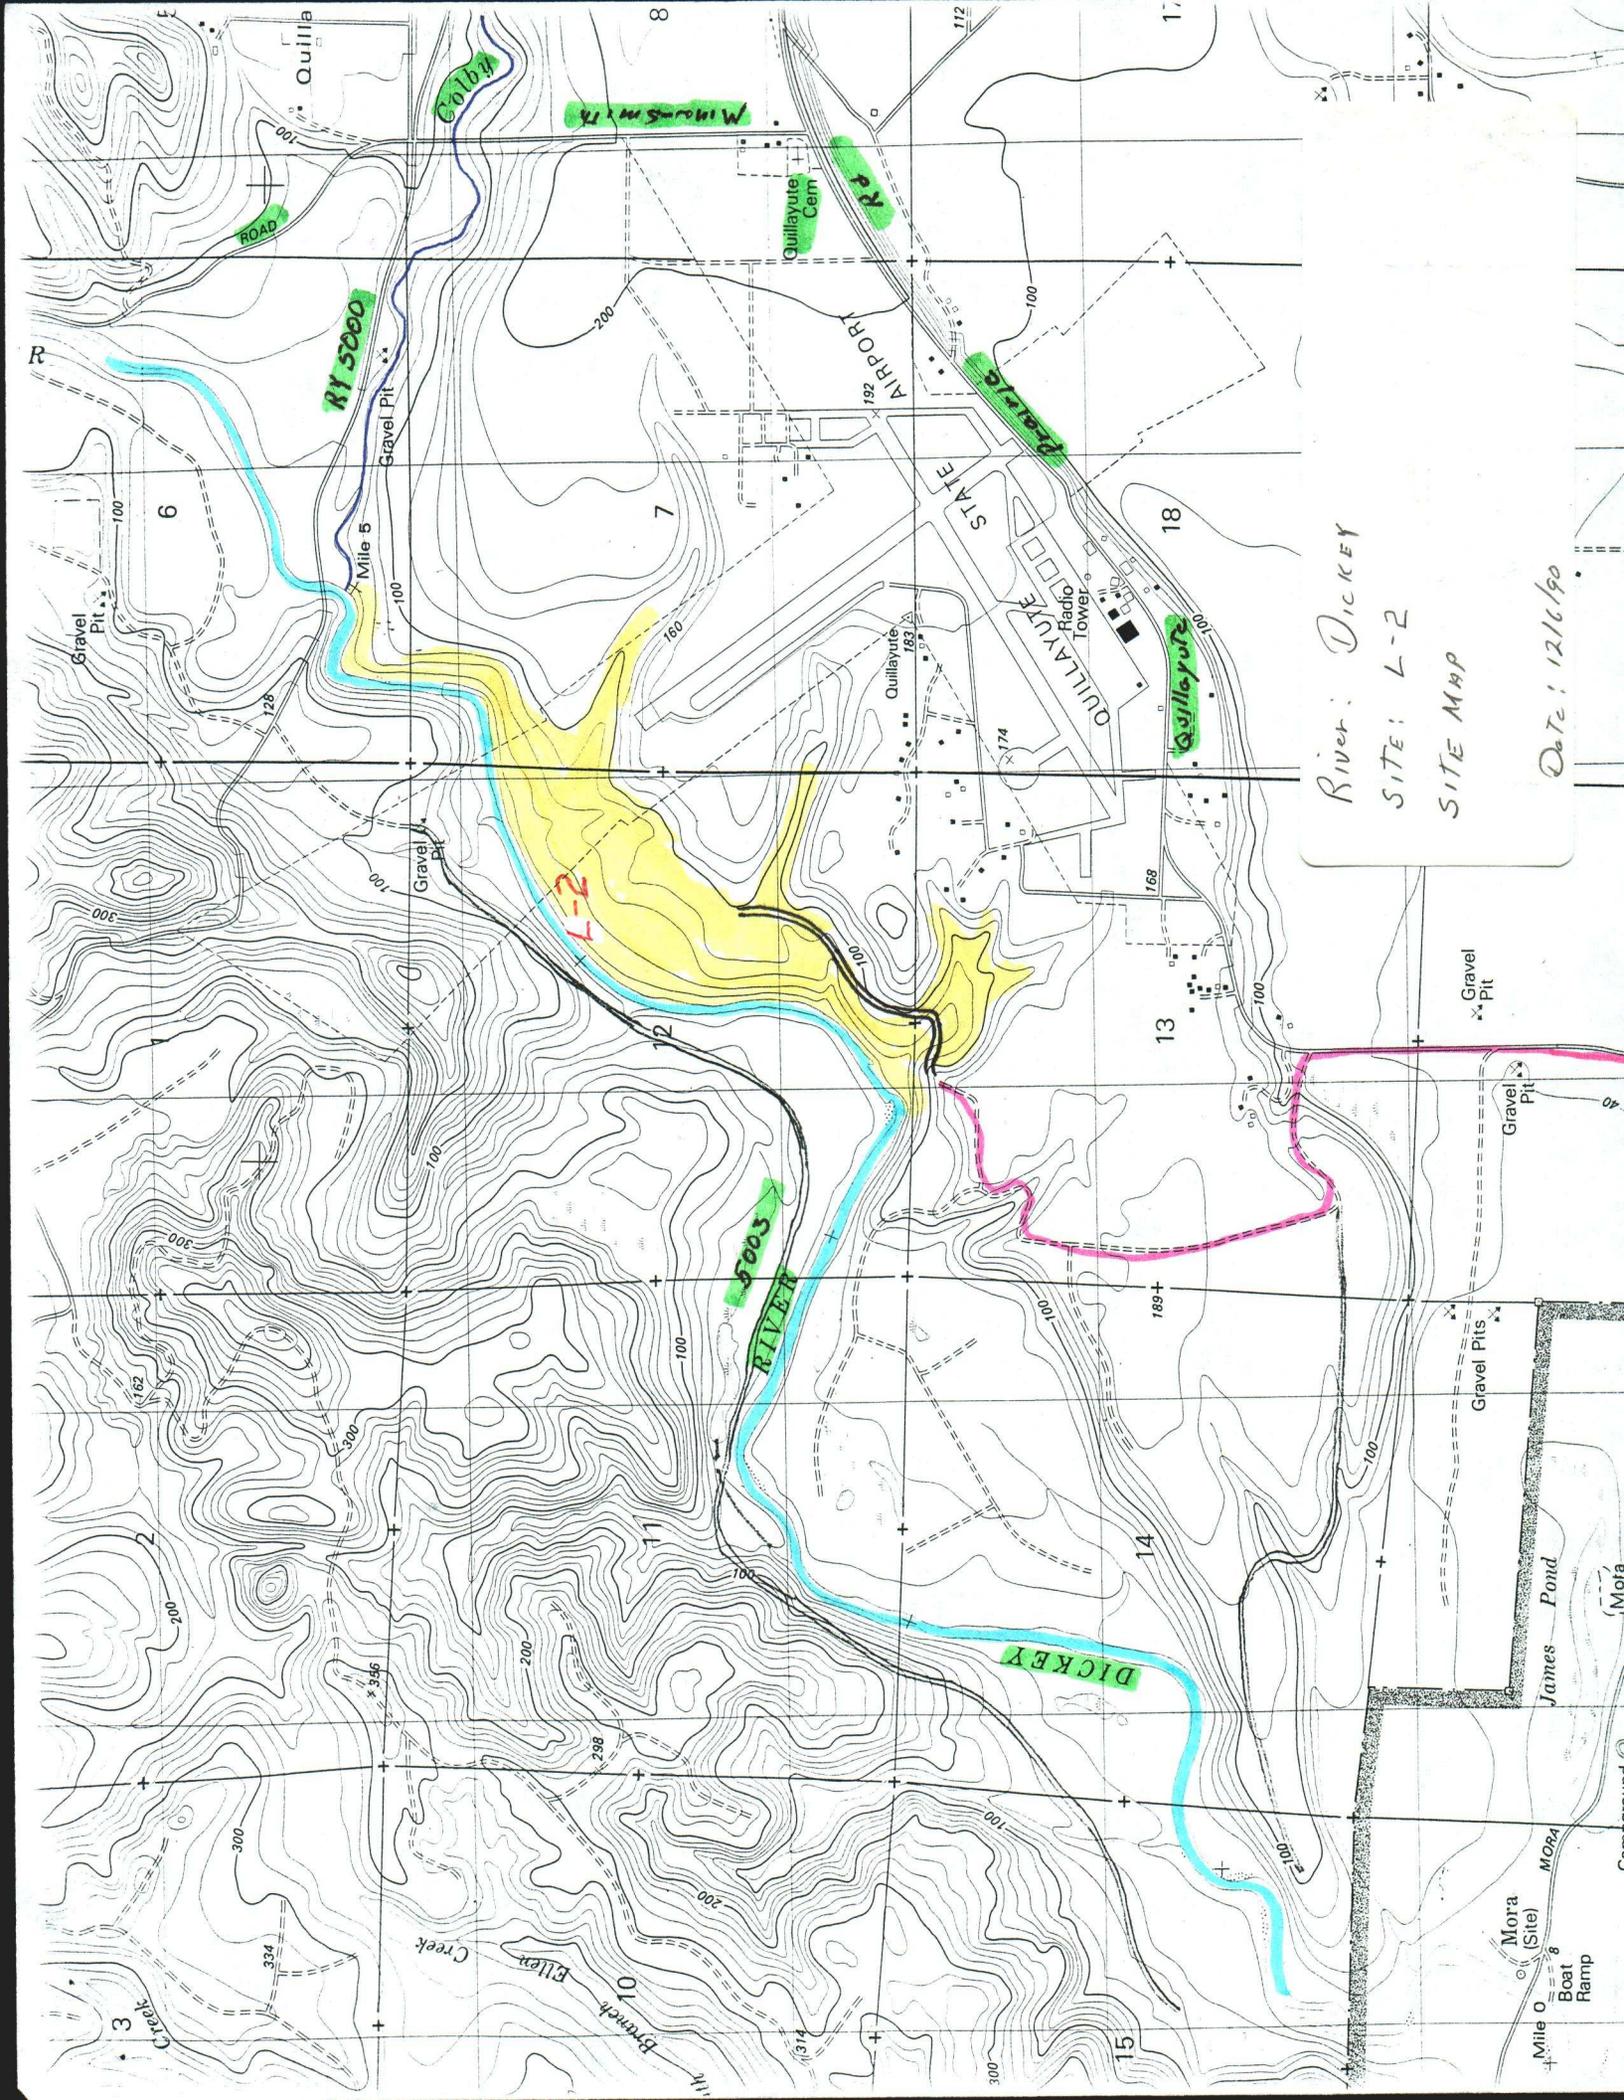
River: Dickey
SITE: L-2
SITE MAP
Date: 12/6/90

6-8' Cascade

Deeply
Incised
Channel

Water flows
under a large
stumps 40m
above mouth.
