SITE NUMBER: D-L3-07
LOCAL NAME: Allen Springs
WRIA: 20.0109A

NORTH COAST OFF CHANNEL SITE INVENTORY DATA

RIVER SYSTEM: Dickey **DATE:** 1/17/91 **OBSERVER:** Nettnin

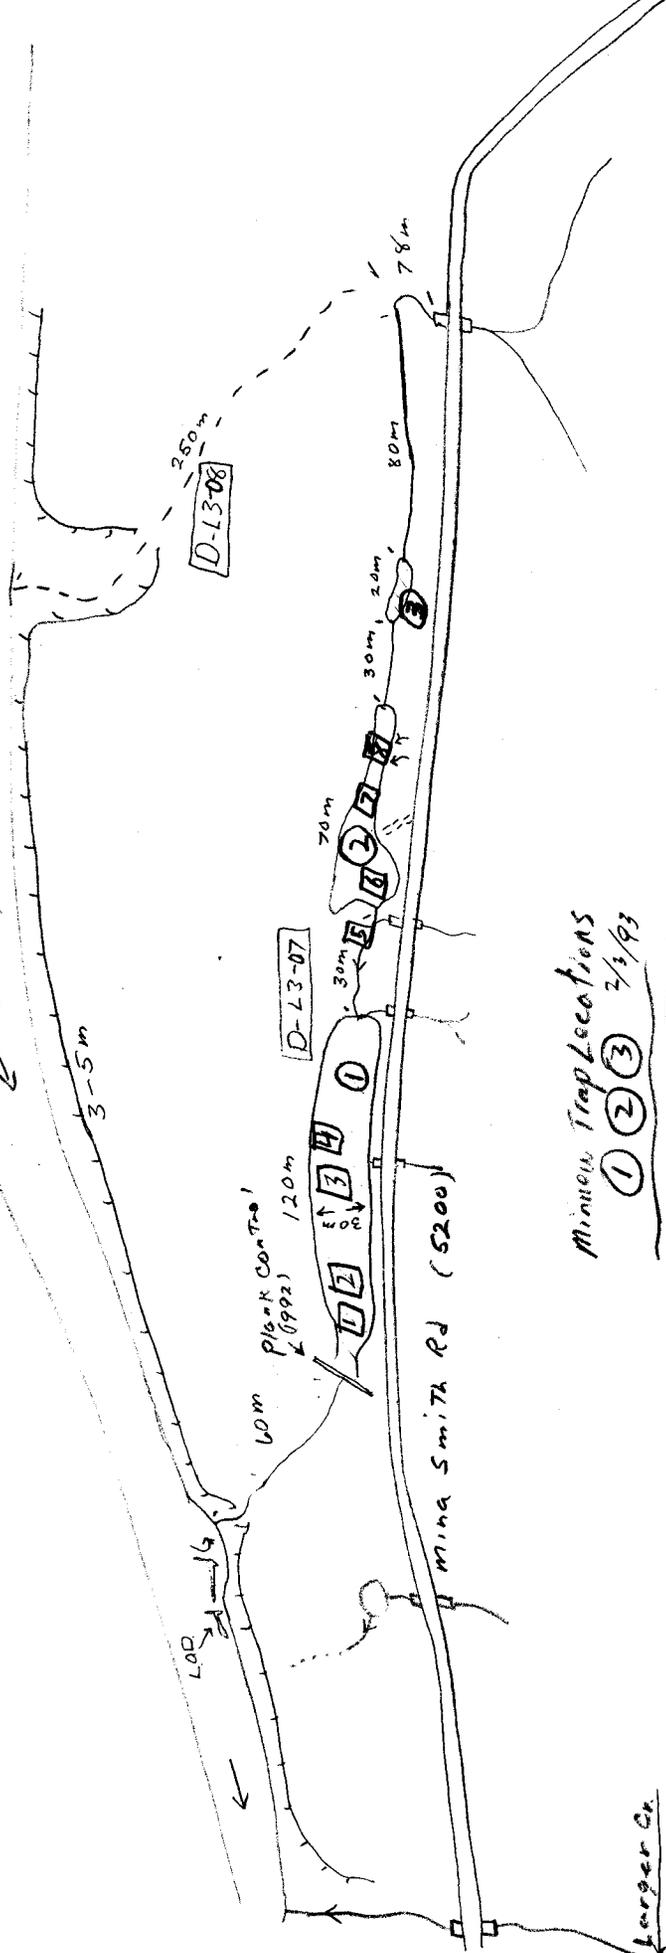
RIVER: DICKEY
 AREA: D-L3
 SITE: D-L3-07, D-L3-08
 LOCAL NAME: ALLEN SIPS
 MAP DATE: 2/91 Revised 8/92

Minnow Trap Locations

① ② ③ 2/3/93
