**SITE NUMBER:** D-R2-03  
**LOCAL NAME:** Unnamed  
**WRIA:**

**NORTH COAST OFF CHANNEL SITE INVENTORY DATA**

**RIVER SYSTEM:** Dickey      **DATE:** 12/12/90      **OBSERVER:** Nettnin

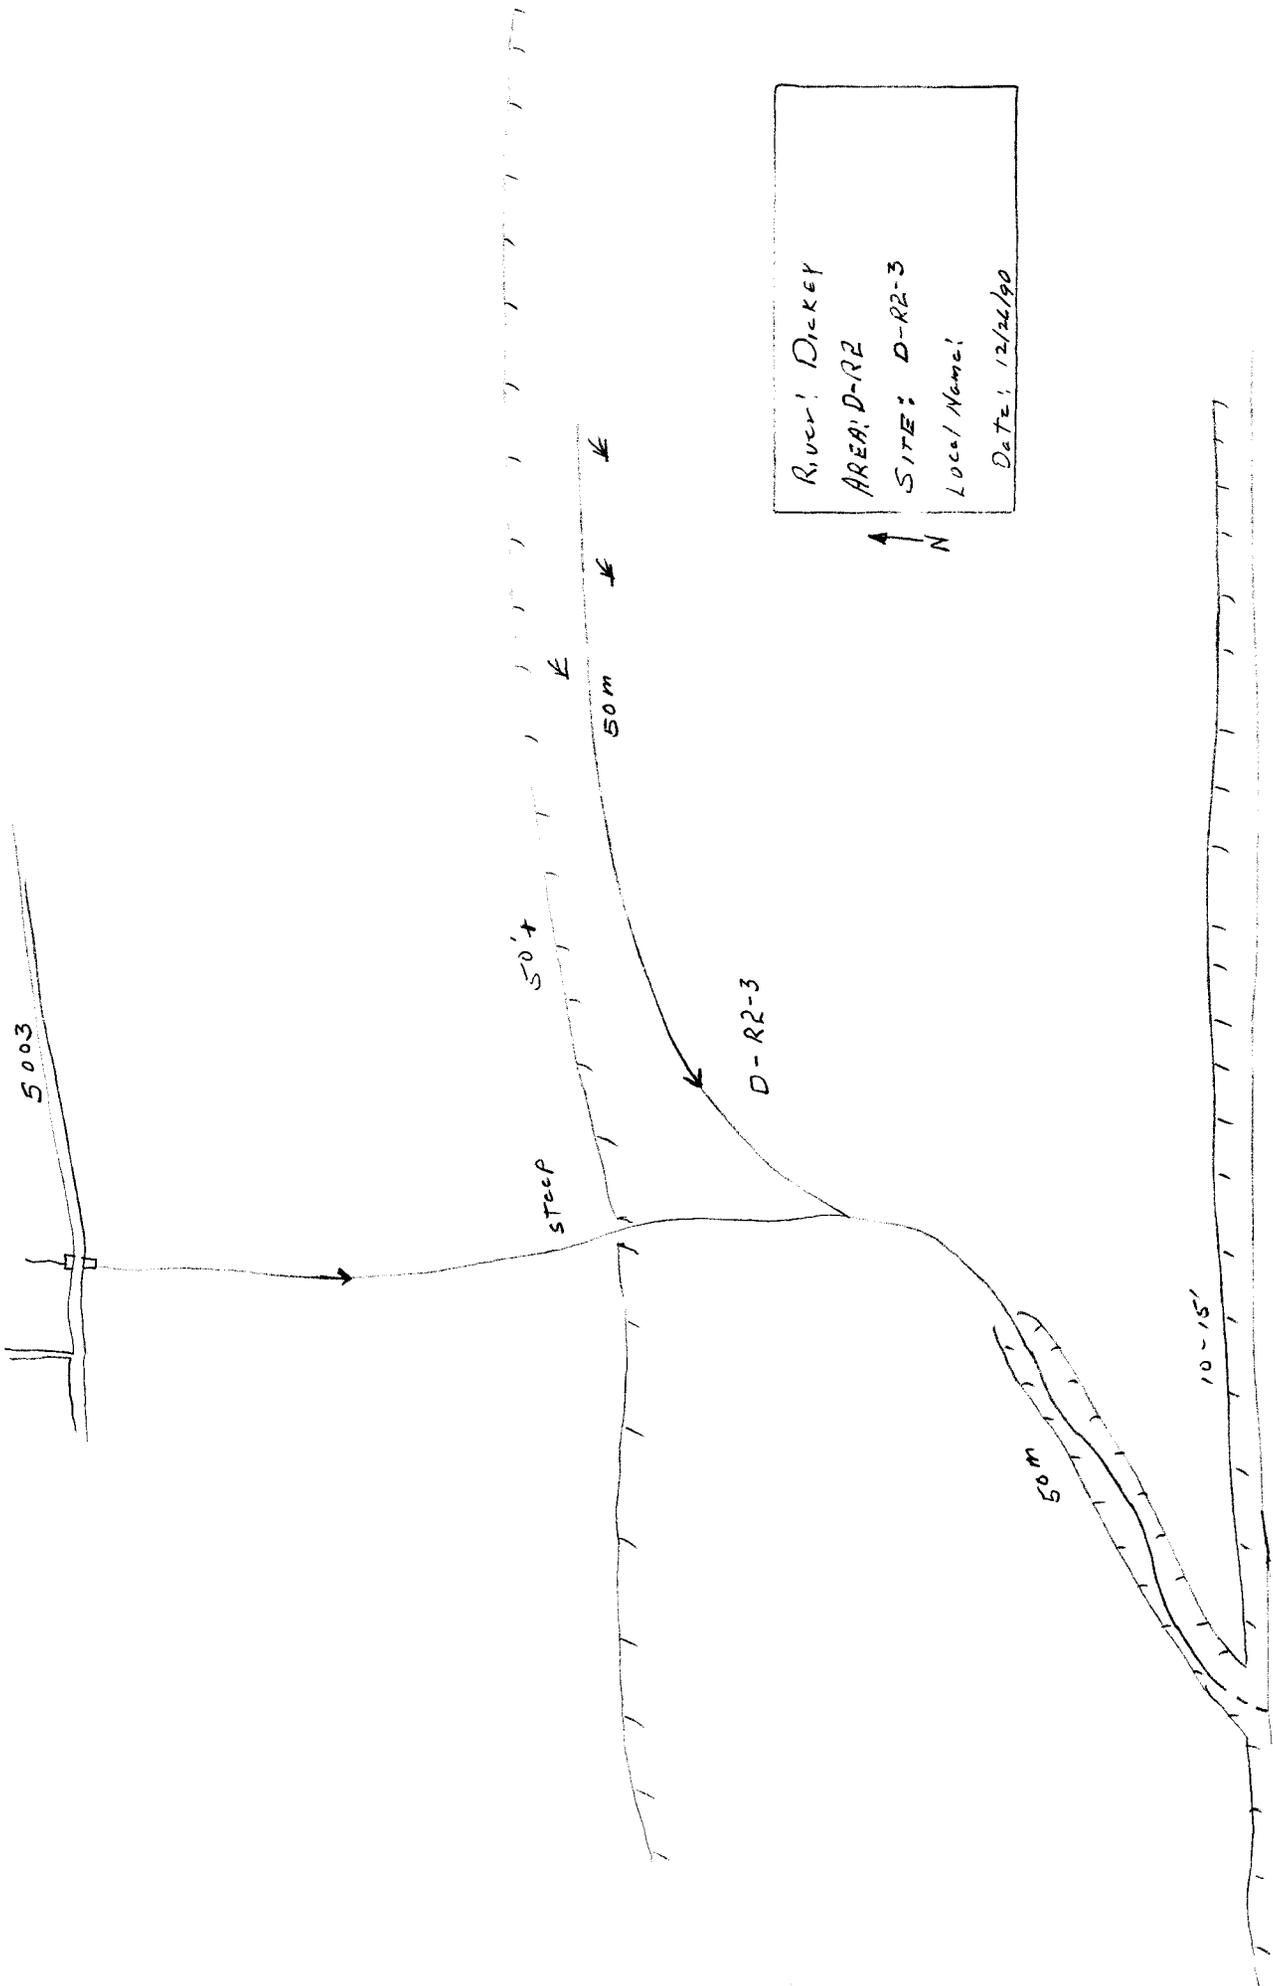
River: Dickey  
AREA: D-R2  
SITE: D-R2-3  
Local Name:  
Date: 12/24/90

**FISH ACCESS AND CURRENT USE:** Fish access appears poor. Flow goes sub-surface for about 3 m near the mouth of the channel. No fish observed.

**COMMENTS & RECOMMENDATIONS:** The lower 48 m reach of D-R2-03 is deeply incised. Excessive debris appears to be a problem in this reach. This is a small system with relatively low flows. It appears to be subject to flash flows during periods of heavy run off. It may tend to dry up during winter dry periods. To maximize use of this system, the egress needs improvement and some woody debris should be removed. The small, shallow, marshy area at the base of the terrace (i.e. at the upper end of the channel) could be deepened with explosives to create a small amount of short term rearing habitat. No machine access. Foot access is poor due to dense brush. Low priority.
