SITE INFORMATION

Site Identifier : DA1LB2 **Landowner Type :** Private
Site Name : **Landowner Name :**
WRIA : 03.0299X **Address :**
Region : NS **Address2 :**
Trib to : Day Cr **City :**
River Mile : 3.00 **State :**
River System : Day Cr **Zipcode :**
Legal Description : SE1/4S33T35NR6E **Phone :**
County : Skagit
Habitat Type : beaver pond

Area Overview :

A 60m by 60m beaver pond that appears to be passable during high flows, and offers some nice over-winter rearing habitat.

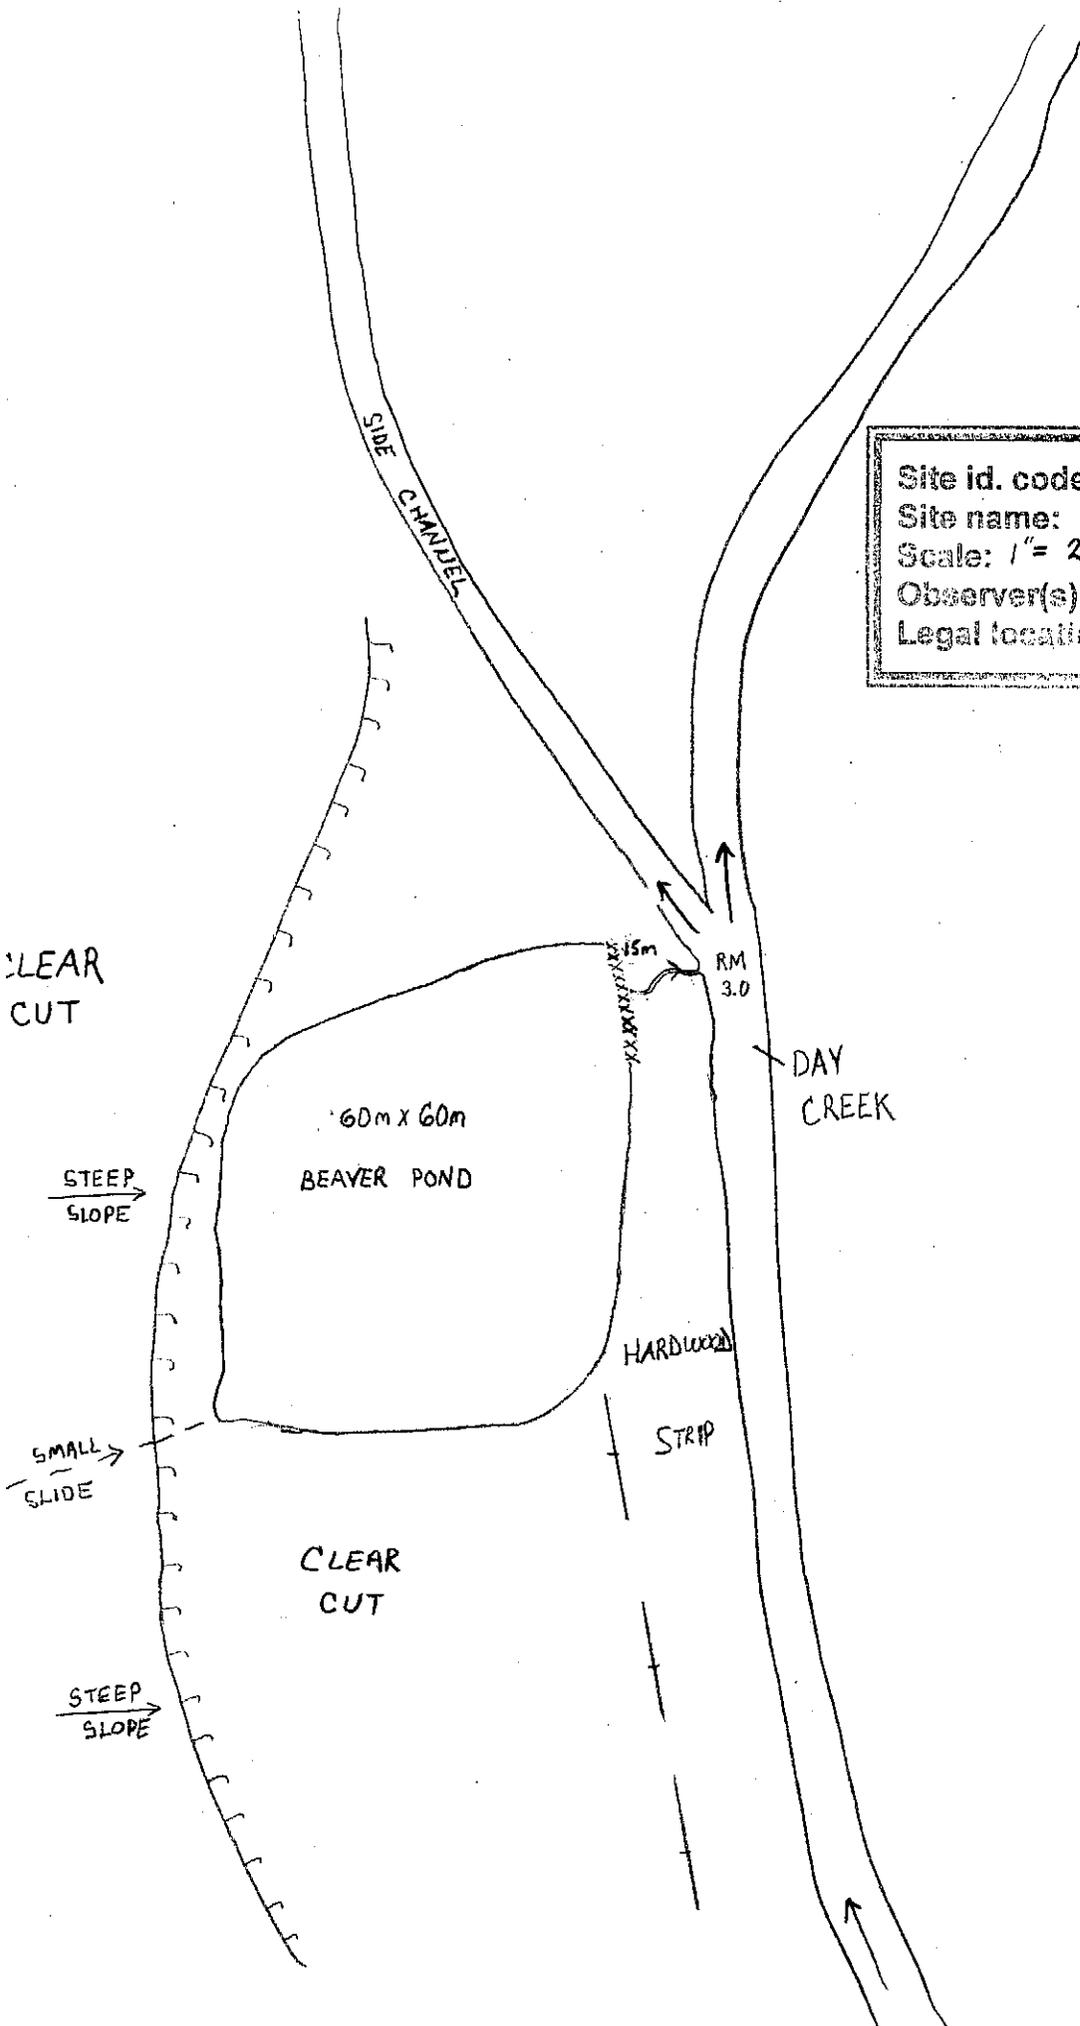
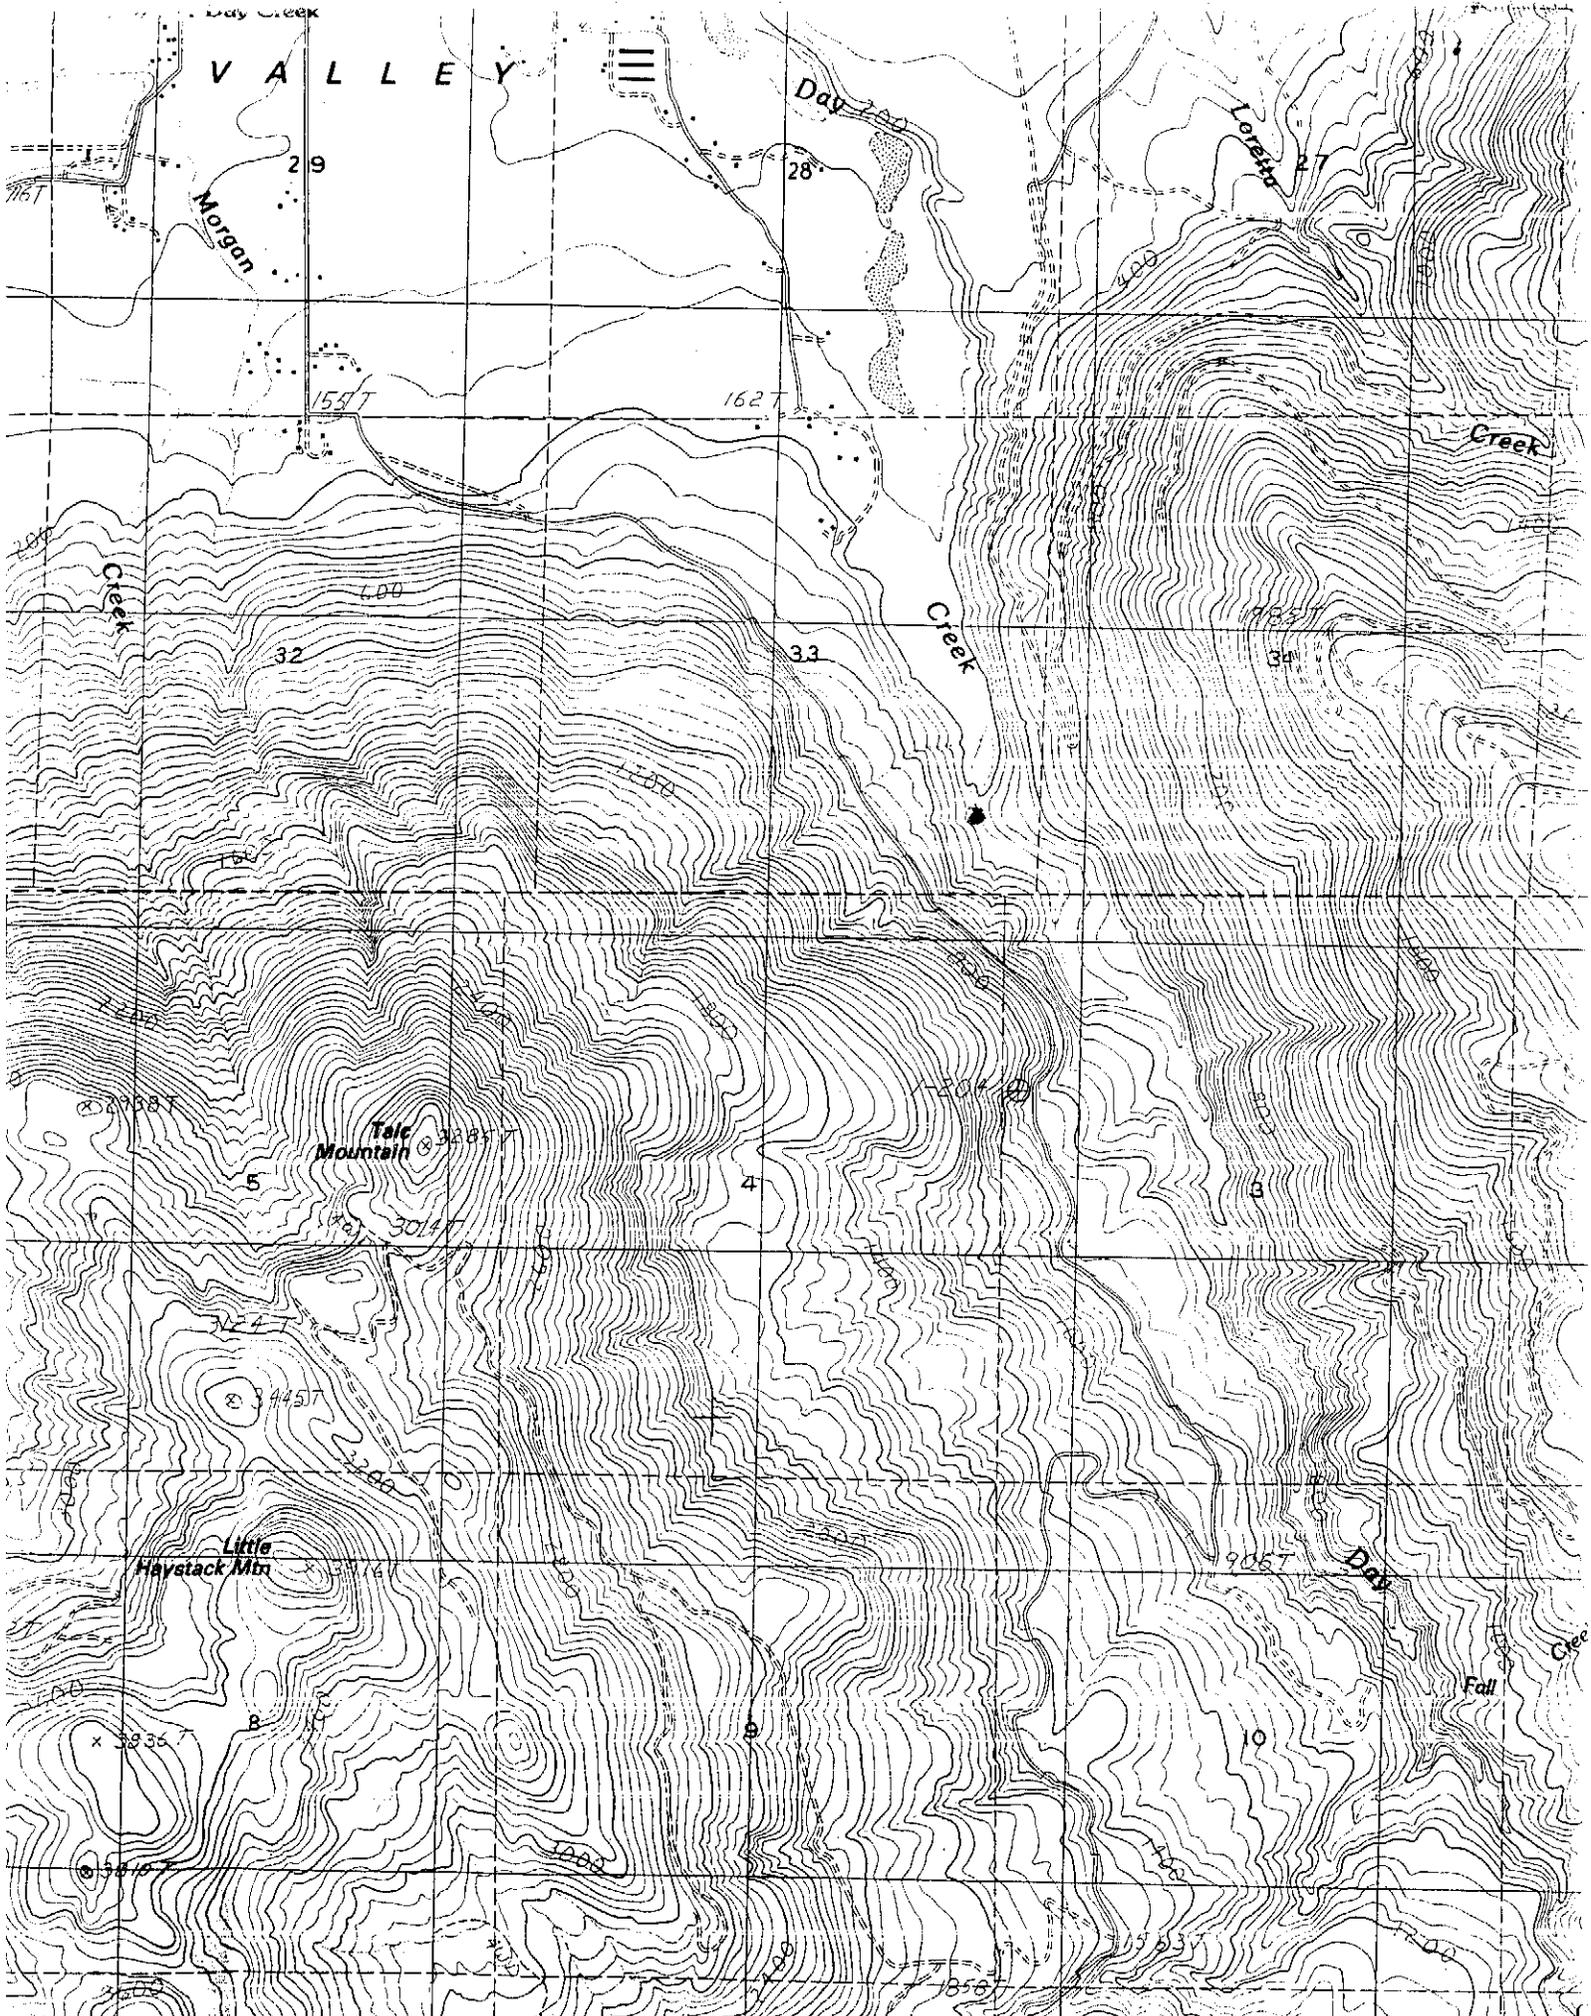
Site id. code: DAL B2
Site name:
Scale: 1" = 27m
Observer(s): MICHAEL OLIS
Legal location: SE 1/4 S33 T35N R6E

- FLOW - .1 CFS
- REC WTR TEMP - 41
- STREAM TEMP - 43.5
- ACCESS IS GOOD.
- 15M WW 1.5M (50/50 PH)
- SUBSTR IS MUCKY
- @ 24 M LONG BEAVER DAM - SOME WTR FLOWED AROUND DAM DURING HIGHER FLOWS, SUGGESTING THAT IT WAS PASSABLE
- THE BVA POND CREATED IS 62M X 60M W.
- MOSTLY SHALLOW (1M DEEP @ MOST)
