**SITE INFORMATION**

Site Identifier : EN2LB12 Landowner Type : Private  
 Site Name : Landowner Name :  
 WRIA : 03.0239X Address :  
 Region : NS Address2 :  
 Trib to : Walker Cr City :  
 River Mile : 2.70 State :  
 River System : EF Nookachamps Cr Zipcode :  
 Legal Description : NW1/4S5T33NR5E Phone :  
 County : Skagit  
 Habitat Type : wetland

Date : 12/7/99 Observer : Olis Survey Type : initial

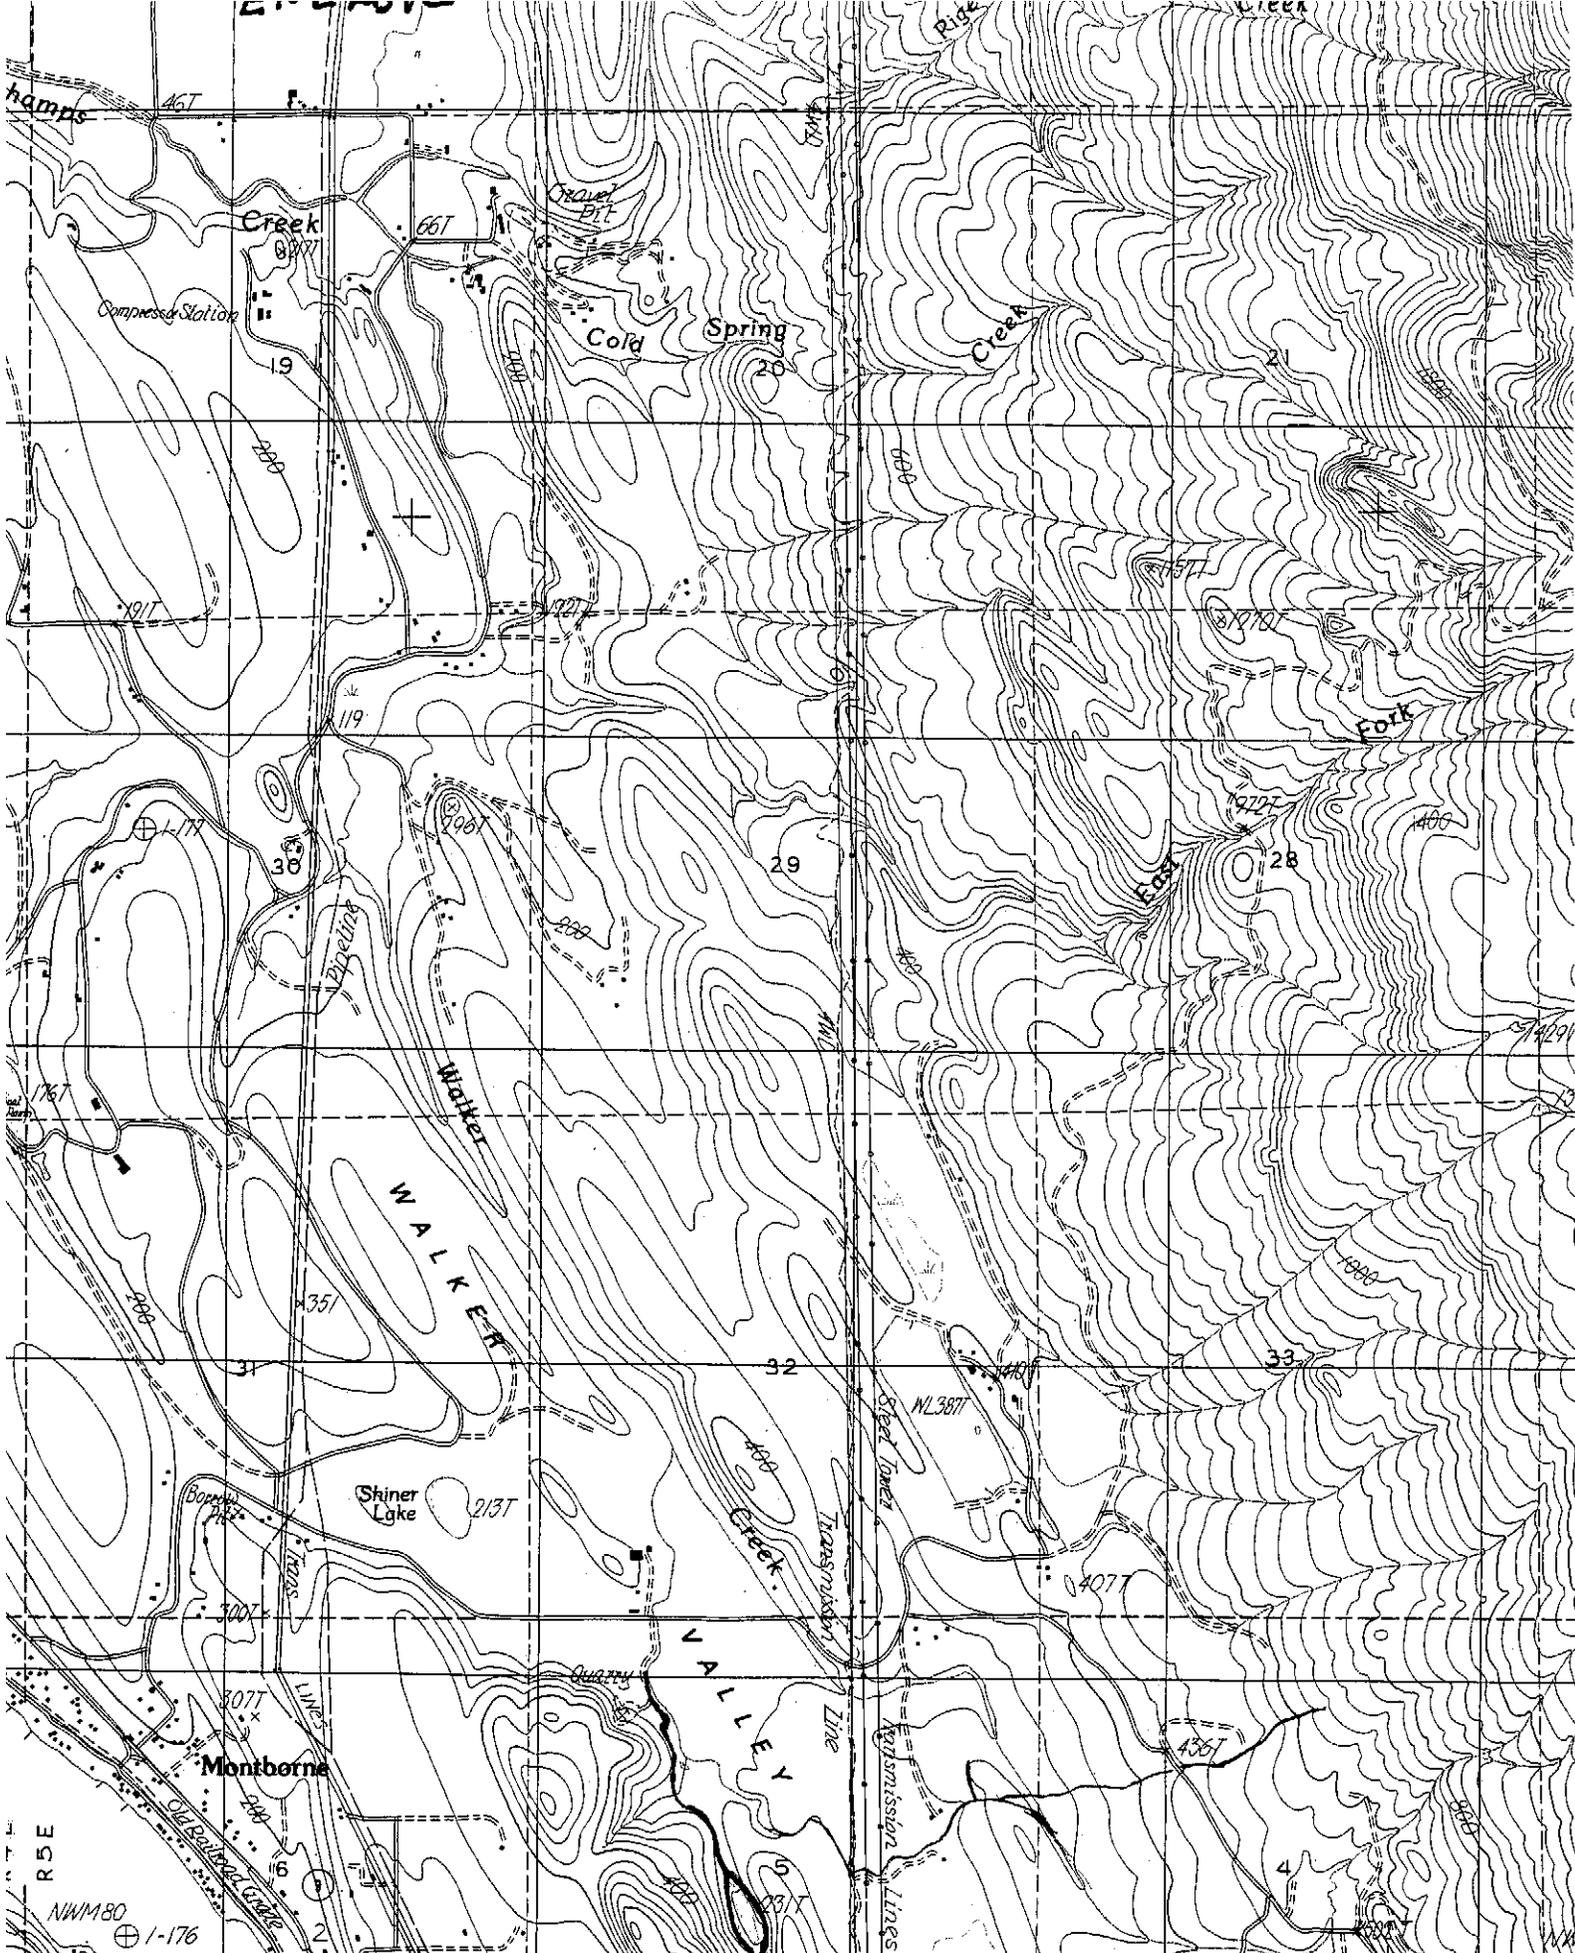
EN2 LB 12

GO ENTRY

ACCESS - POOL (GOOD)

A ≈ 200m FROM MOUTH  
TO NC-30

- WW 1m

- 8" SP HAB

1" GRAVEL

GOOD COVER

B ~ 250 m

- mostly in channel  
THAT FLOWS ALONG  
EDGE OF FIELD -
- PROB. COME FROM FLOOD
- LOWER END OF  
POND HAS A FEW  
SM. BUR DABS AND  
WATER TURTLES AND CAME

L POND

D SWAMP ABOUT  
POWER LINE  
BUC- ACTIVITY,  
CATTAILS, CANARY GRASS

DUCK WEED, RUSH
