SITE INFORMATION

Site Identifier : GR1RB1 **Landowner Type :** Private
Site Name : **Landowner Name :**
WRIA : 03.0377X **Address :**
Region : NS **Address2 :**
Trib to : Grandy Cr **City :**
River Mile : 0.70 **State :**
River System : Grandy Cr **Zipcode :**
Legal Description : NE1/4S15T35NR7E **Phone :**
County : Skagit
Habitat Type : beaver pond

Date : 01/16/1997 **Observer :** Olis **Survey Type :** initial

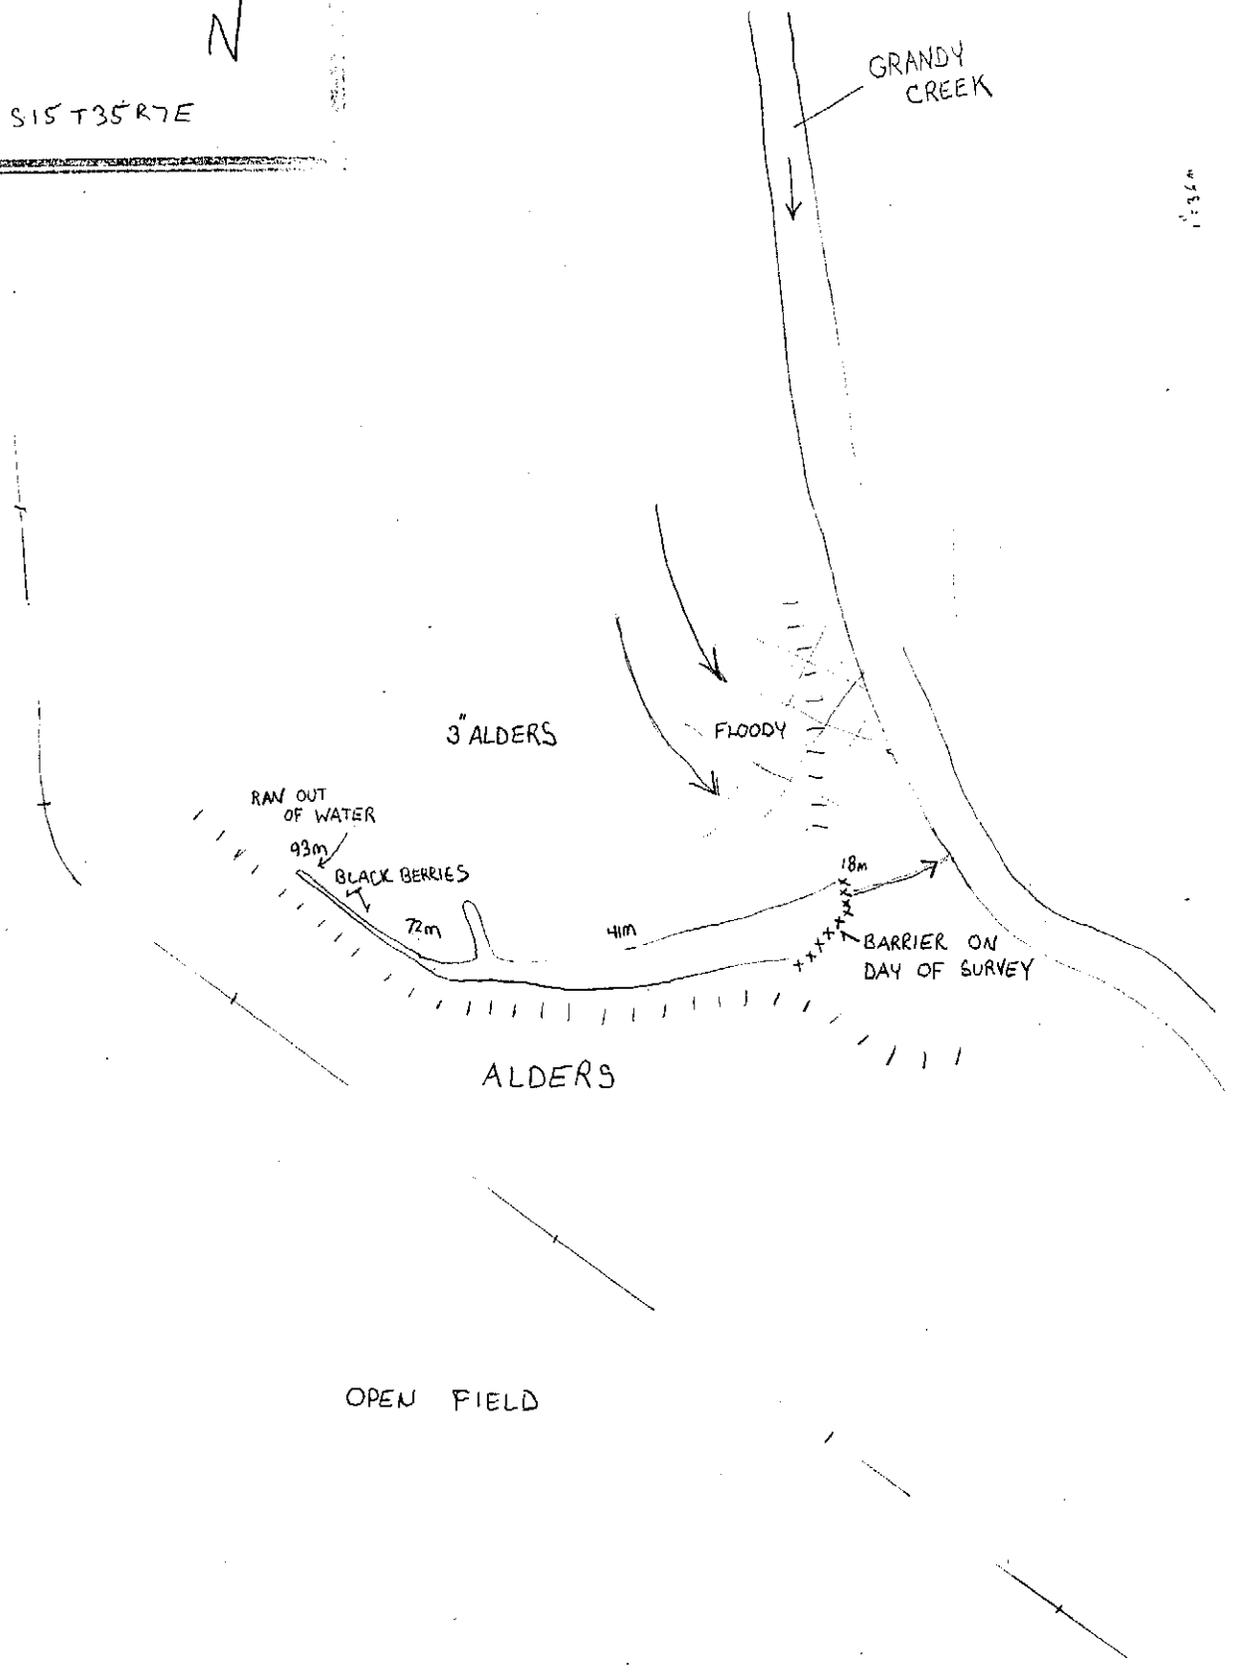
Site ID: GRI RB1
Site name:
Scale: 1" = 36m
Observer(s): OWS
Legal location: NE 1/4 S15 T35 R7E

FLOODY

RAN OUT OF WATER

BARRIER ON DAY OF SURVEY

- HARD TO ACCESS BECAUSE OF DUE DAM.
- CREATED NICE LITTLE POND FOR REARING
- FROZE OVER DURING SURVEY
- NO EDDY POOL @ ENTRY.
- RECENT BUR ACTIVITY
- NO SPAWNING HAB
