SITE NUMBER: H-0460 (H-R11)

LOCAL NAME: Pole Cr.

NORTH COAST OFF CHANNEL SITE INVENTORY DATA

RIVER SYSTEM: Hoh **DATE:** 8/20/87 **OBSERVER:** Young, Nettrin

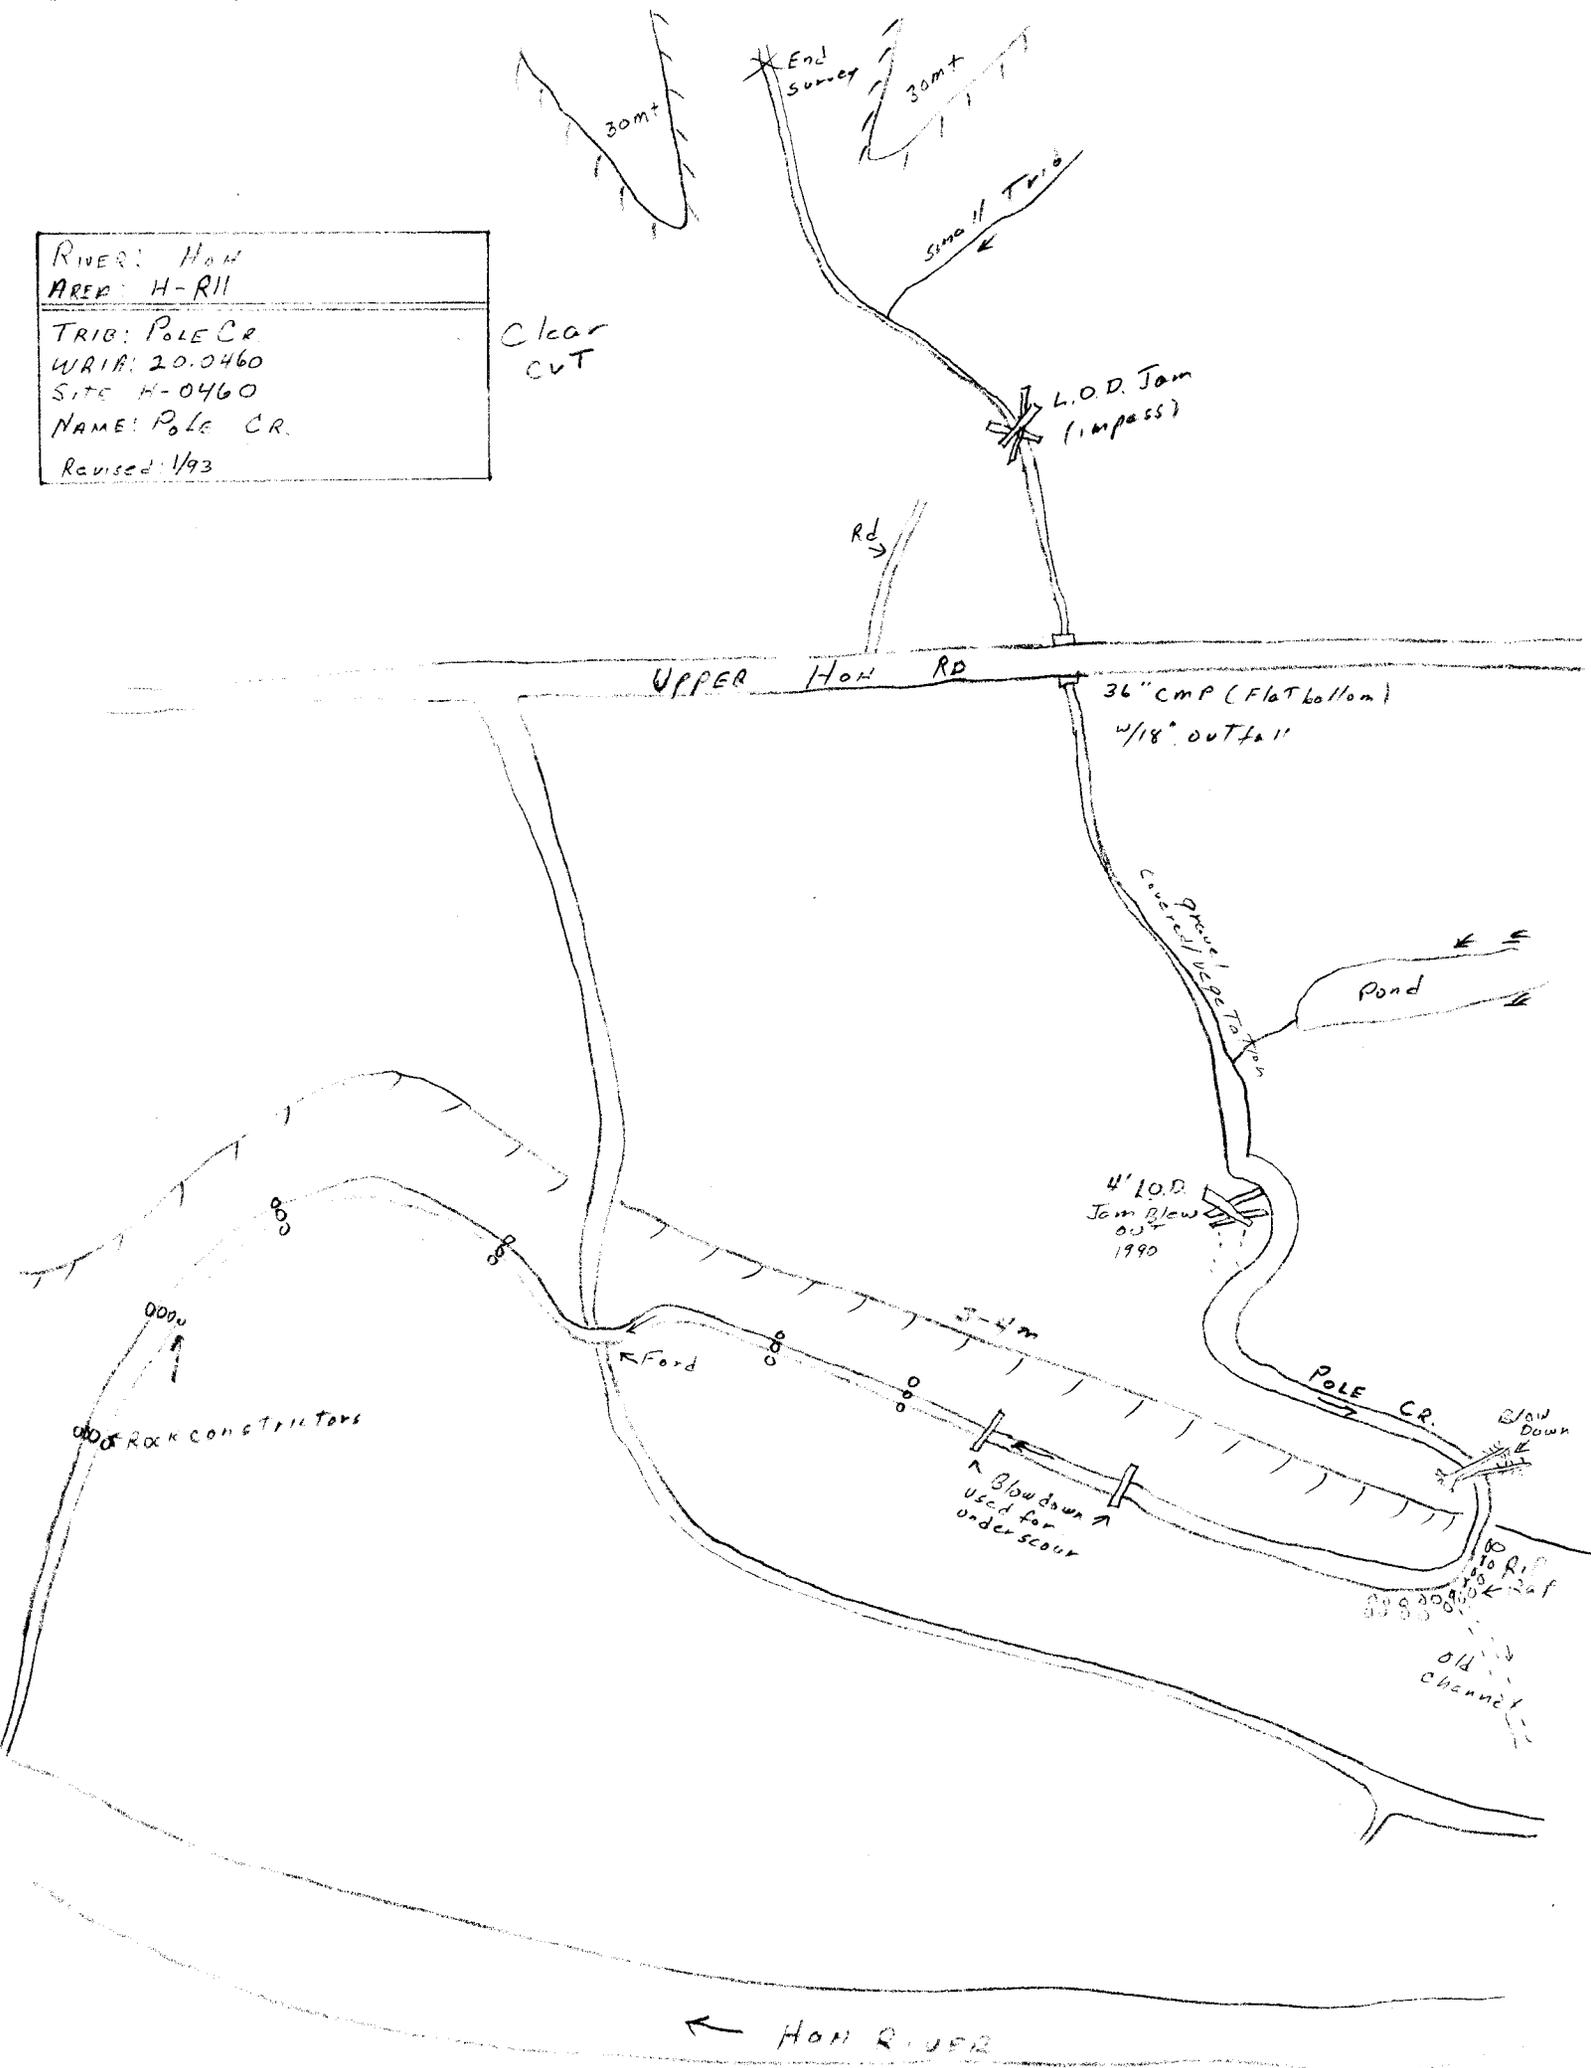
Pole CK. 20.0460

L.O.D. Jam (Impass)

36" cnp (flat bottom) w/18" outfall

4' debris jam

Dry Pond

steep access at mouth

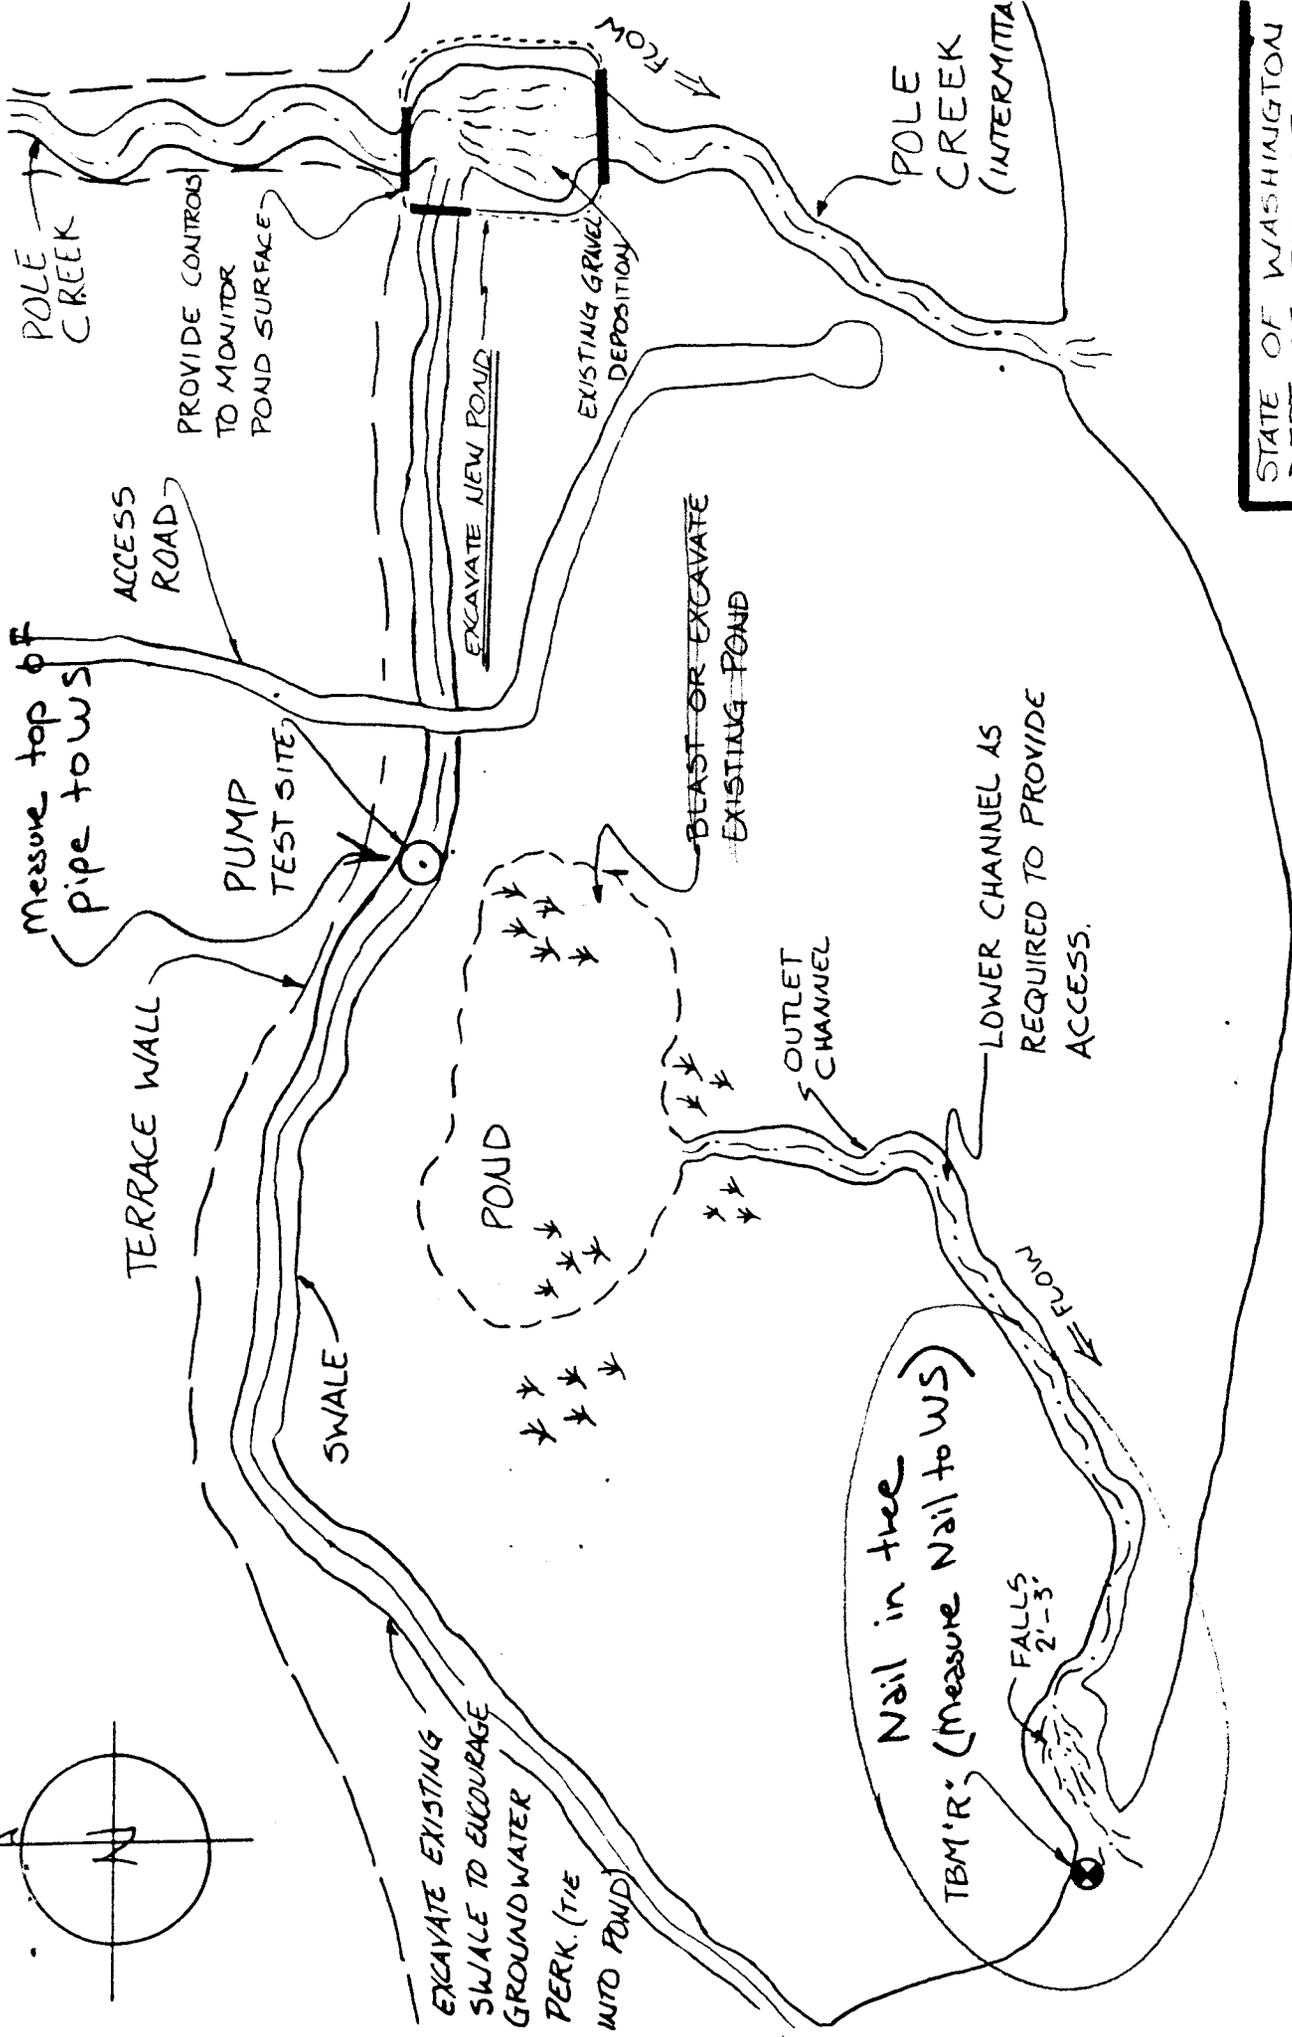
POLE CREEK
 PLAN
 VIEW SKETCH

FALLS
 2'-3'

EXISTING GRAVEL
 DEPOSITION

BEAST OR EXCAVATE
 EXISTING POND

LOWER CHANNEL AS
 REQUIRED TO PROVIDE
 ACCESS.

EXCAVATE NEW POND

PROVIDE CONTROLS
 TO MONITOR
 POND SURFACE

EXCAVATE EXISTING
 SWALE TO ENCOURAGE
 GROUND WATER
 PERK. (TIE
 INTO POND)
