SITE NUMBER: H-R6-08
LOCAL NAME: Unnamed
WRIA: 20.0440R

NORTH COAST OFF CHANNEL SITE INVENTORY DATA

RIVER SYSTEM: Hoh River **DATE:** 8/11/87 **OBSERVER:** Young/Nettrin

Hoh River
 SITE: H-R6
 Channel: H-R6-08
 Anderson Ranch

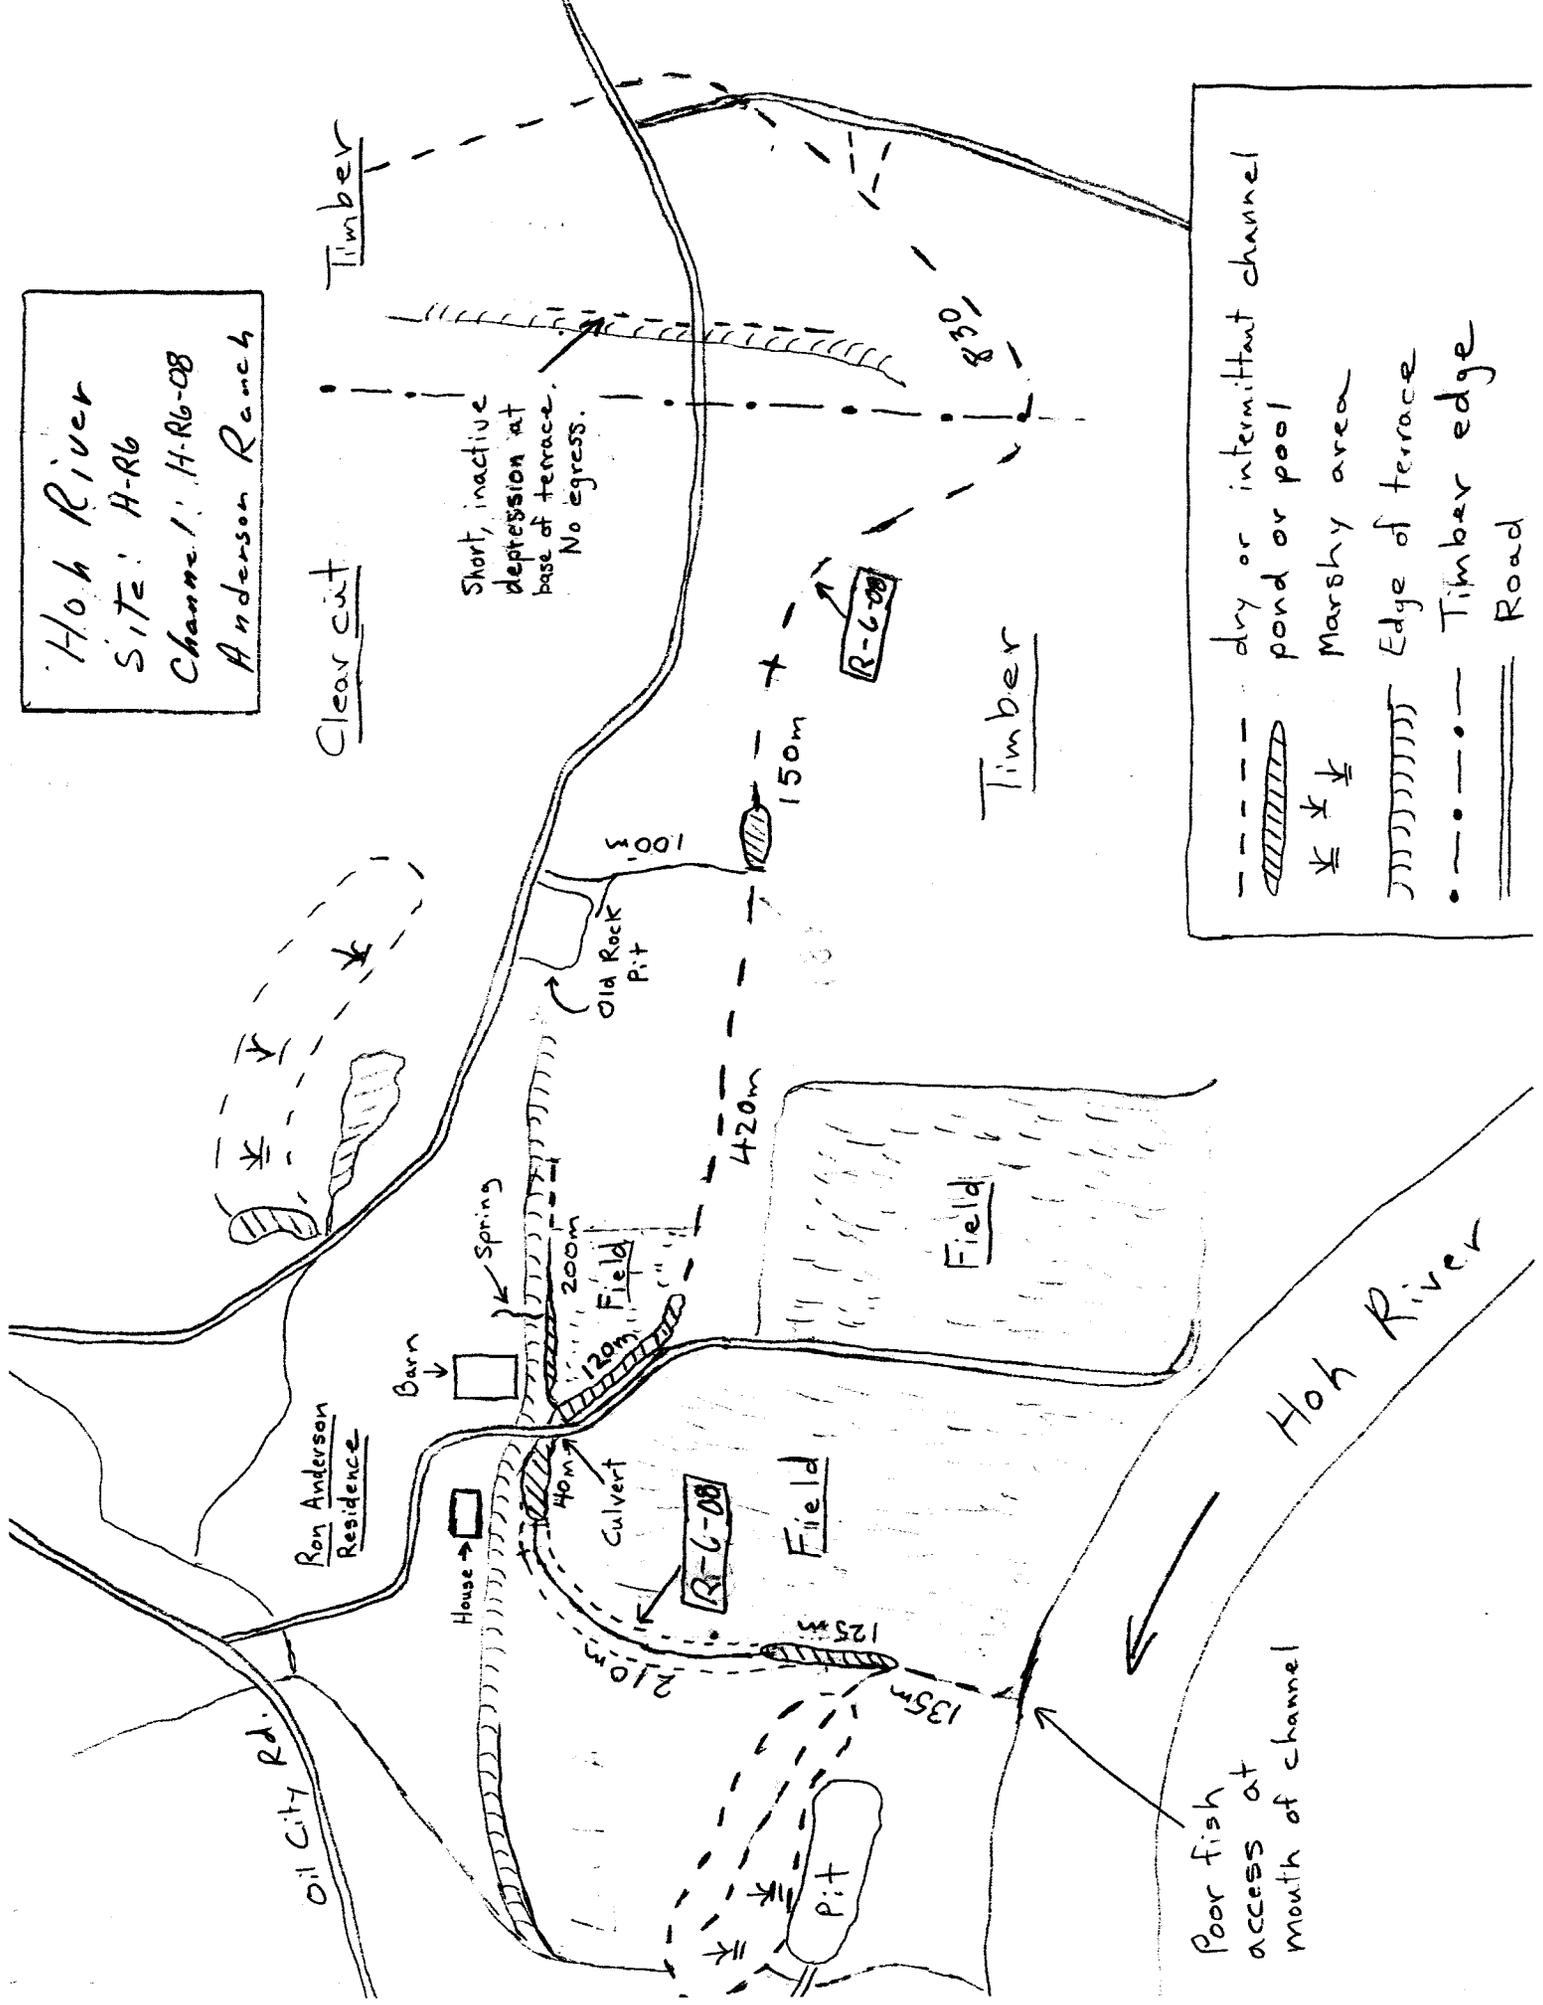
Short, inactive depression at base of terrace. No egress.

Poor fish access at mouth of channel
