**SITE INFORMATION**

<b>Site Identifier :</b> HN1LB4	<b>Landowner Type :</b> County
<b>Site Name :</b>	<b>Landowner Name :</b> Skagit Co.
<b>WRIA :</b> 03.0268X	<b>Address :</b>
<b>Region :</b> NS	<b>Address2 :</b>
<b>Trib to :</b> Red Cr	<b>City :</b>
<b>River Mile :</b> 0.50	<b>State :</b>
<b>River System :</b> Hansen Cr	<b>Zipcode :</b>
<b>Legal Description :</b> NE1/4S17T35NR5E	<b>Phone :</b>
<b>County :</b> Skagit	<b>Coordinates</b> East: 1,590,284.06 North: 1,168,645.22
<b>Habitat Type :</b> terrace tributary

**Date :** 3/5/98      **Observer :** Barkdull      **Survey Type :** initial

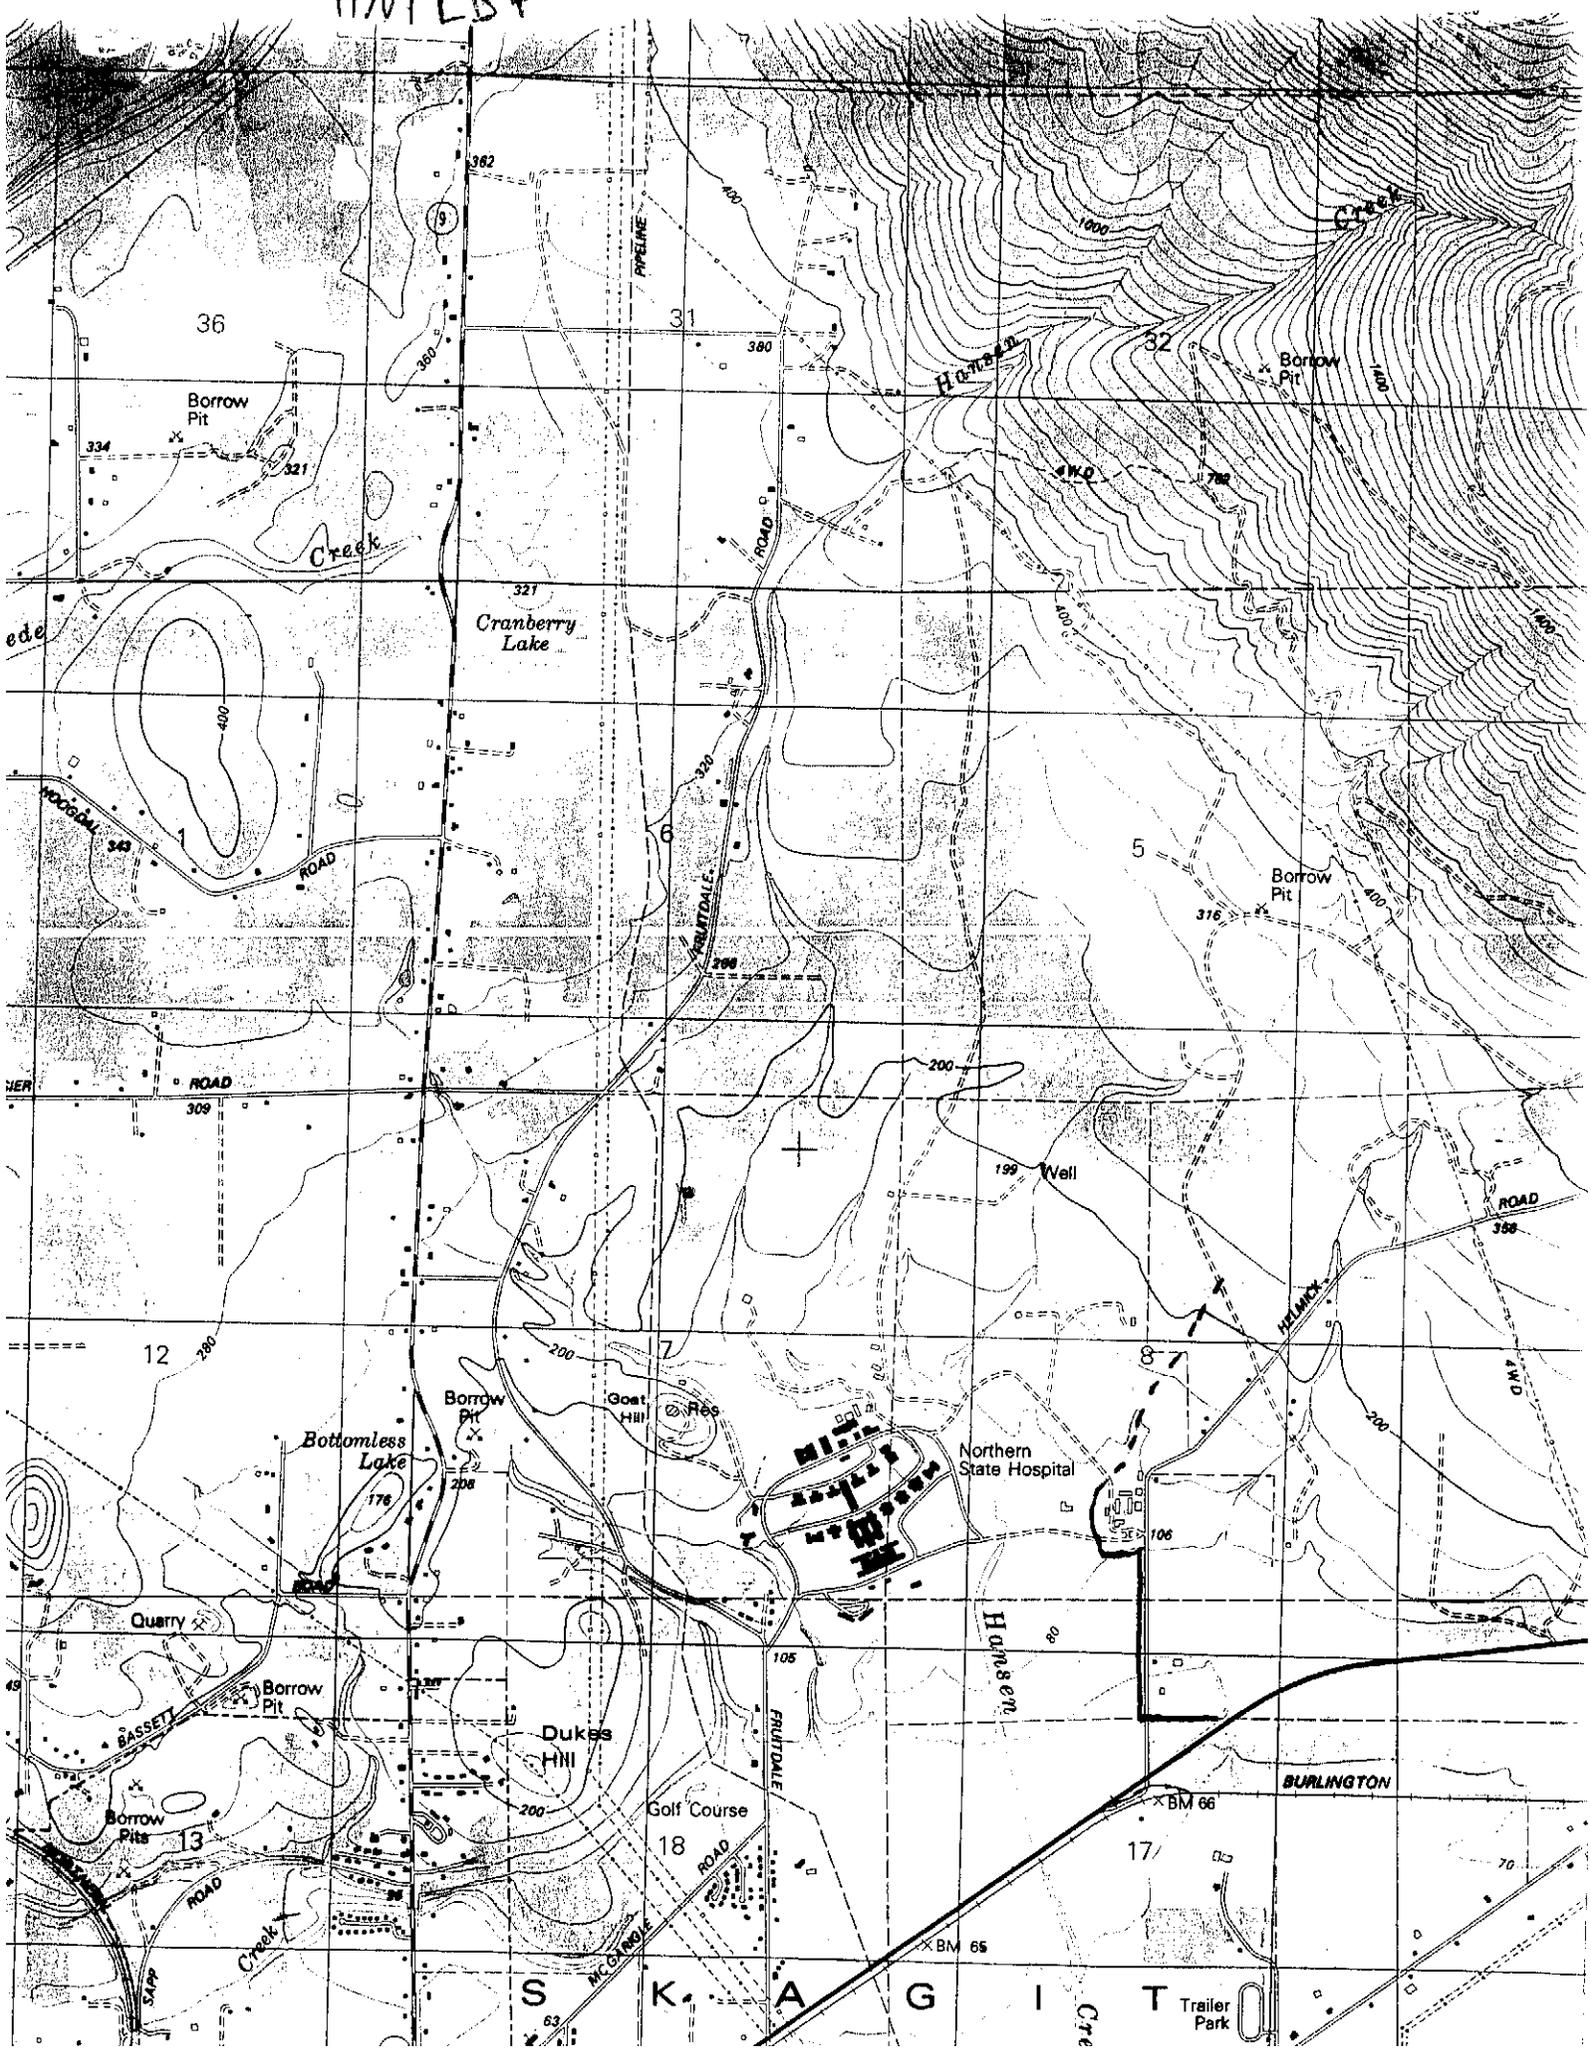
Site id. code: HVI LB4  
Site name:  
Scale: 1" = 133 m  
Observer(s): B. Burkduff  
Legal location: NE 1/4 S 17, T35N, R5E

**Area Overview :**  
Site is a small surface stream that at one time drained into the large wetland around Highway 20 that was part of Hansen Creek but now the area is drained and the creek put into a ditch for most of its length. The section of creek that wasn't ditched has been stomped to death by cattle and no longer has a defined channel. Probably very little fish use occurs.

Describe spawning habitat: A patch of very silty, poor quality gravel exists at the base of the hill just below the access road for the farm.

Describe pond and other rearing habitat: Most of the habitat is in a ditch with no overhead cover except for grass. Through the farm the stream lacks a channel and runs through a swale dominated by canary grass.

Project type: Rebuild channel, and revegetate banks.

ADDITIONAL COMMENTS: A very abused system, probably not worth the effort needed to rehabilitate it.
