SITE INFORMATION

Site Identifier : HN2LB2 **Landowner Type :** Private
Site Name : **Landowner Name :** Crown Pacific
WRIA : 03.0271X **Address :**
Region : NS **Address2 :**
Trib to : 03.0271 **City :**
River Mile : 1.00 **State :**
River System : Hansen Cr **Zipcode :**
Legal Description : SW1/4S5T35NR5E **Phone :**
County : Skagit
Habitat Type : terrace tributary

Field Survey Information

Date : 2/10/98 **Observer :** Barkdull **Survey Type :** initial

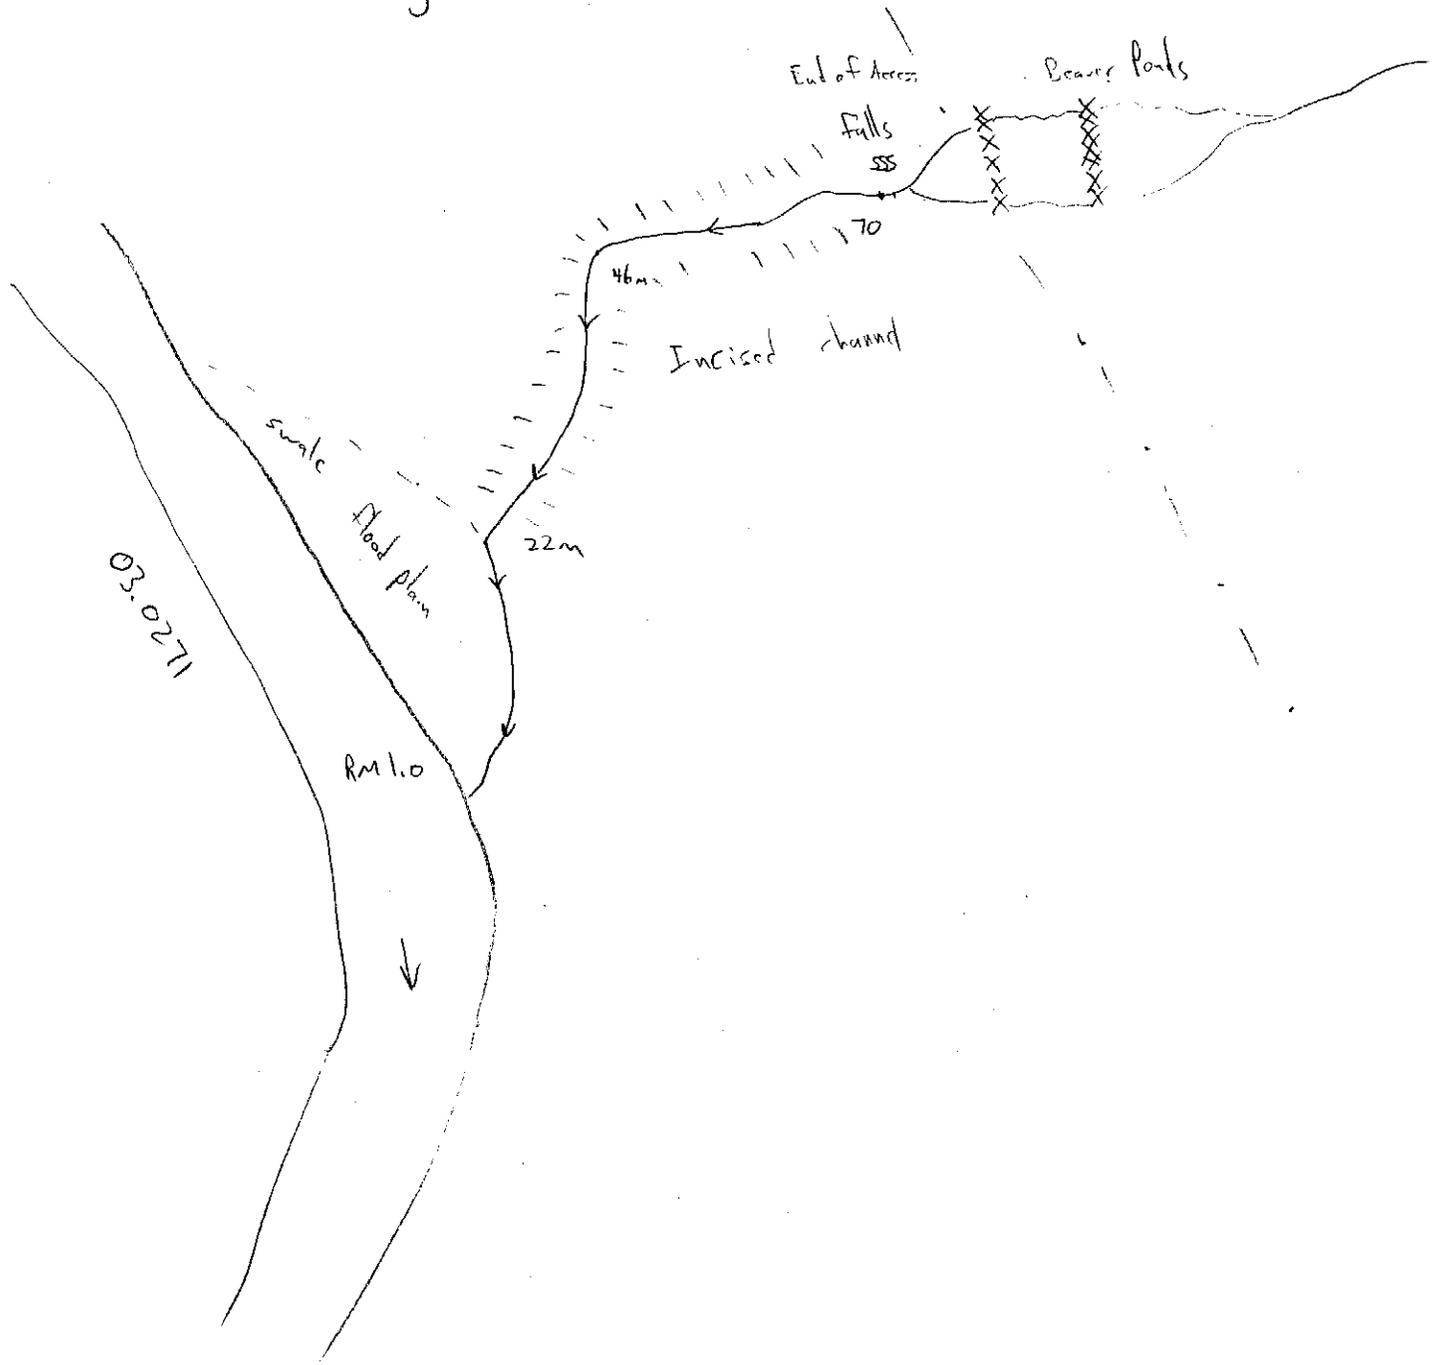
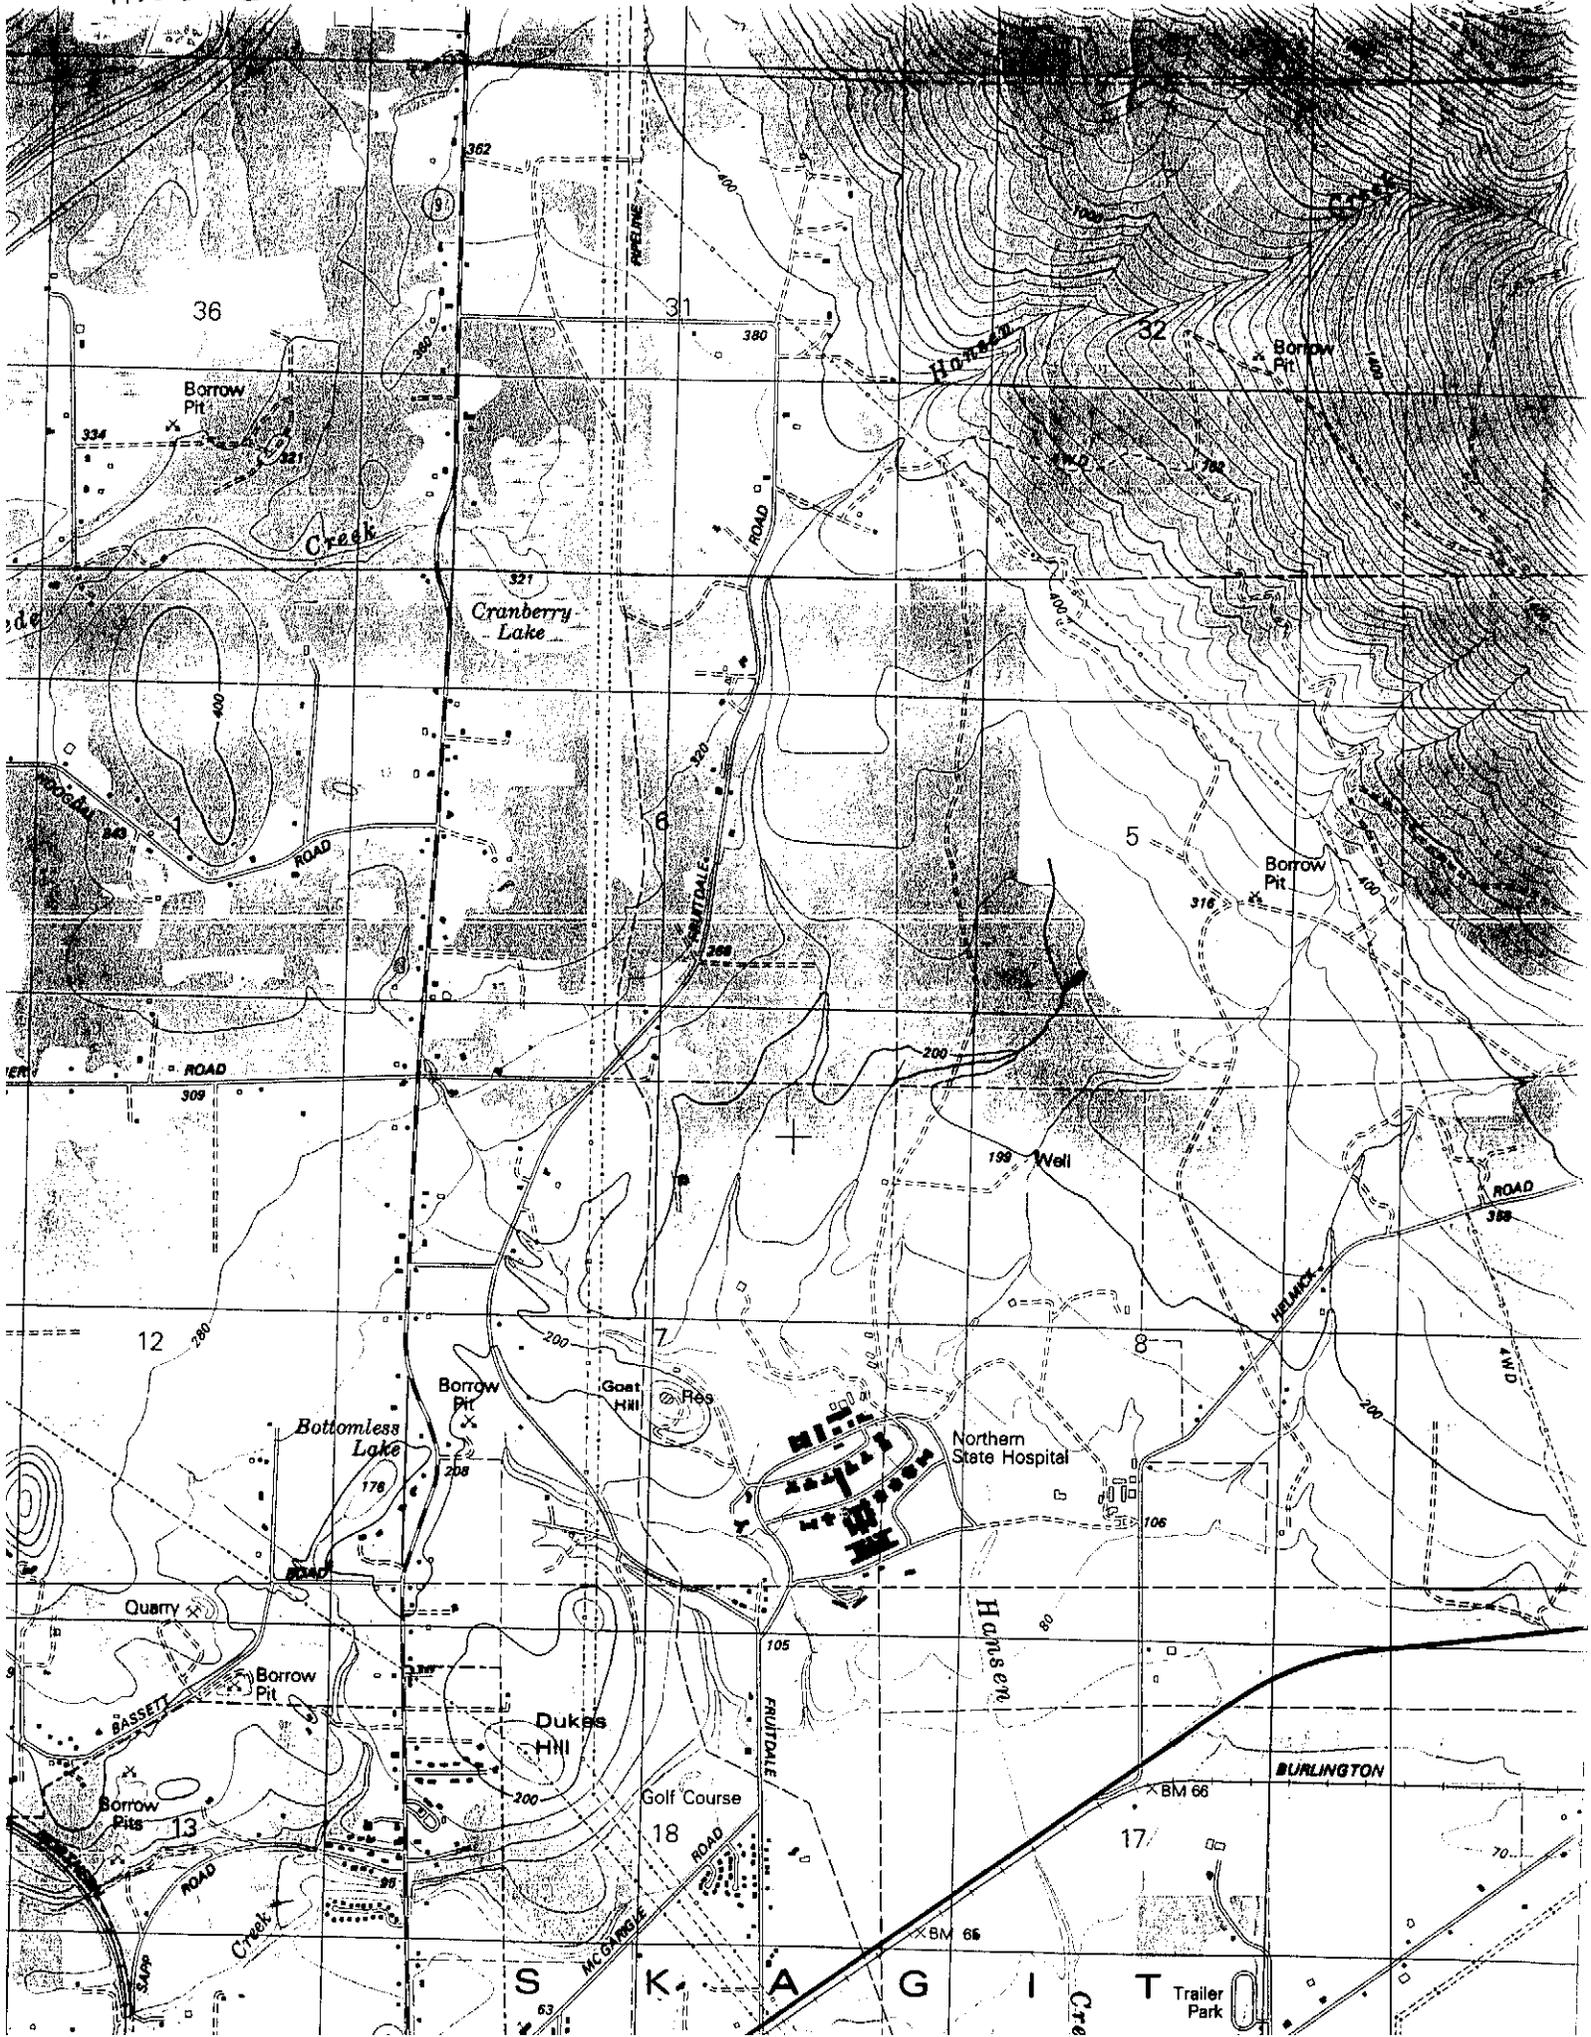
Site id. code: HN2 LB2
Site name:
Scale: 1" = 20 m
Observer(s): B. Barddall
Legal location: SW 1/4 S5, T35N, R5E

10 yr old clear cut

old growth

03.0271

Rm 1.0
