SITE INFORMATION

Site Identifier : HN2RB2 **Landowner Type :** Private
Site Name : **Landowner Name :**
WRIA : 03.0272X **Address :**
Region : NS **Address2 :**
Trib to : 03.0272 **City :**
River Mile : 0.40 **State :**
River System : Hansen Cr **Zipcode :**
Legal Description : NW1/4S7T35NR5E **Phone :**
County : Skagit
Habitat Type : terrace tributary

Field Survey Information

Date : 02/18/1998 **Observer :** Olis **Survey Type :** initial

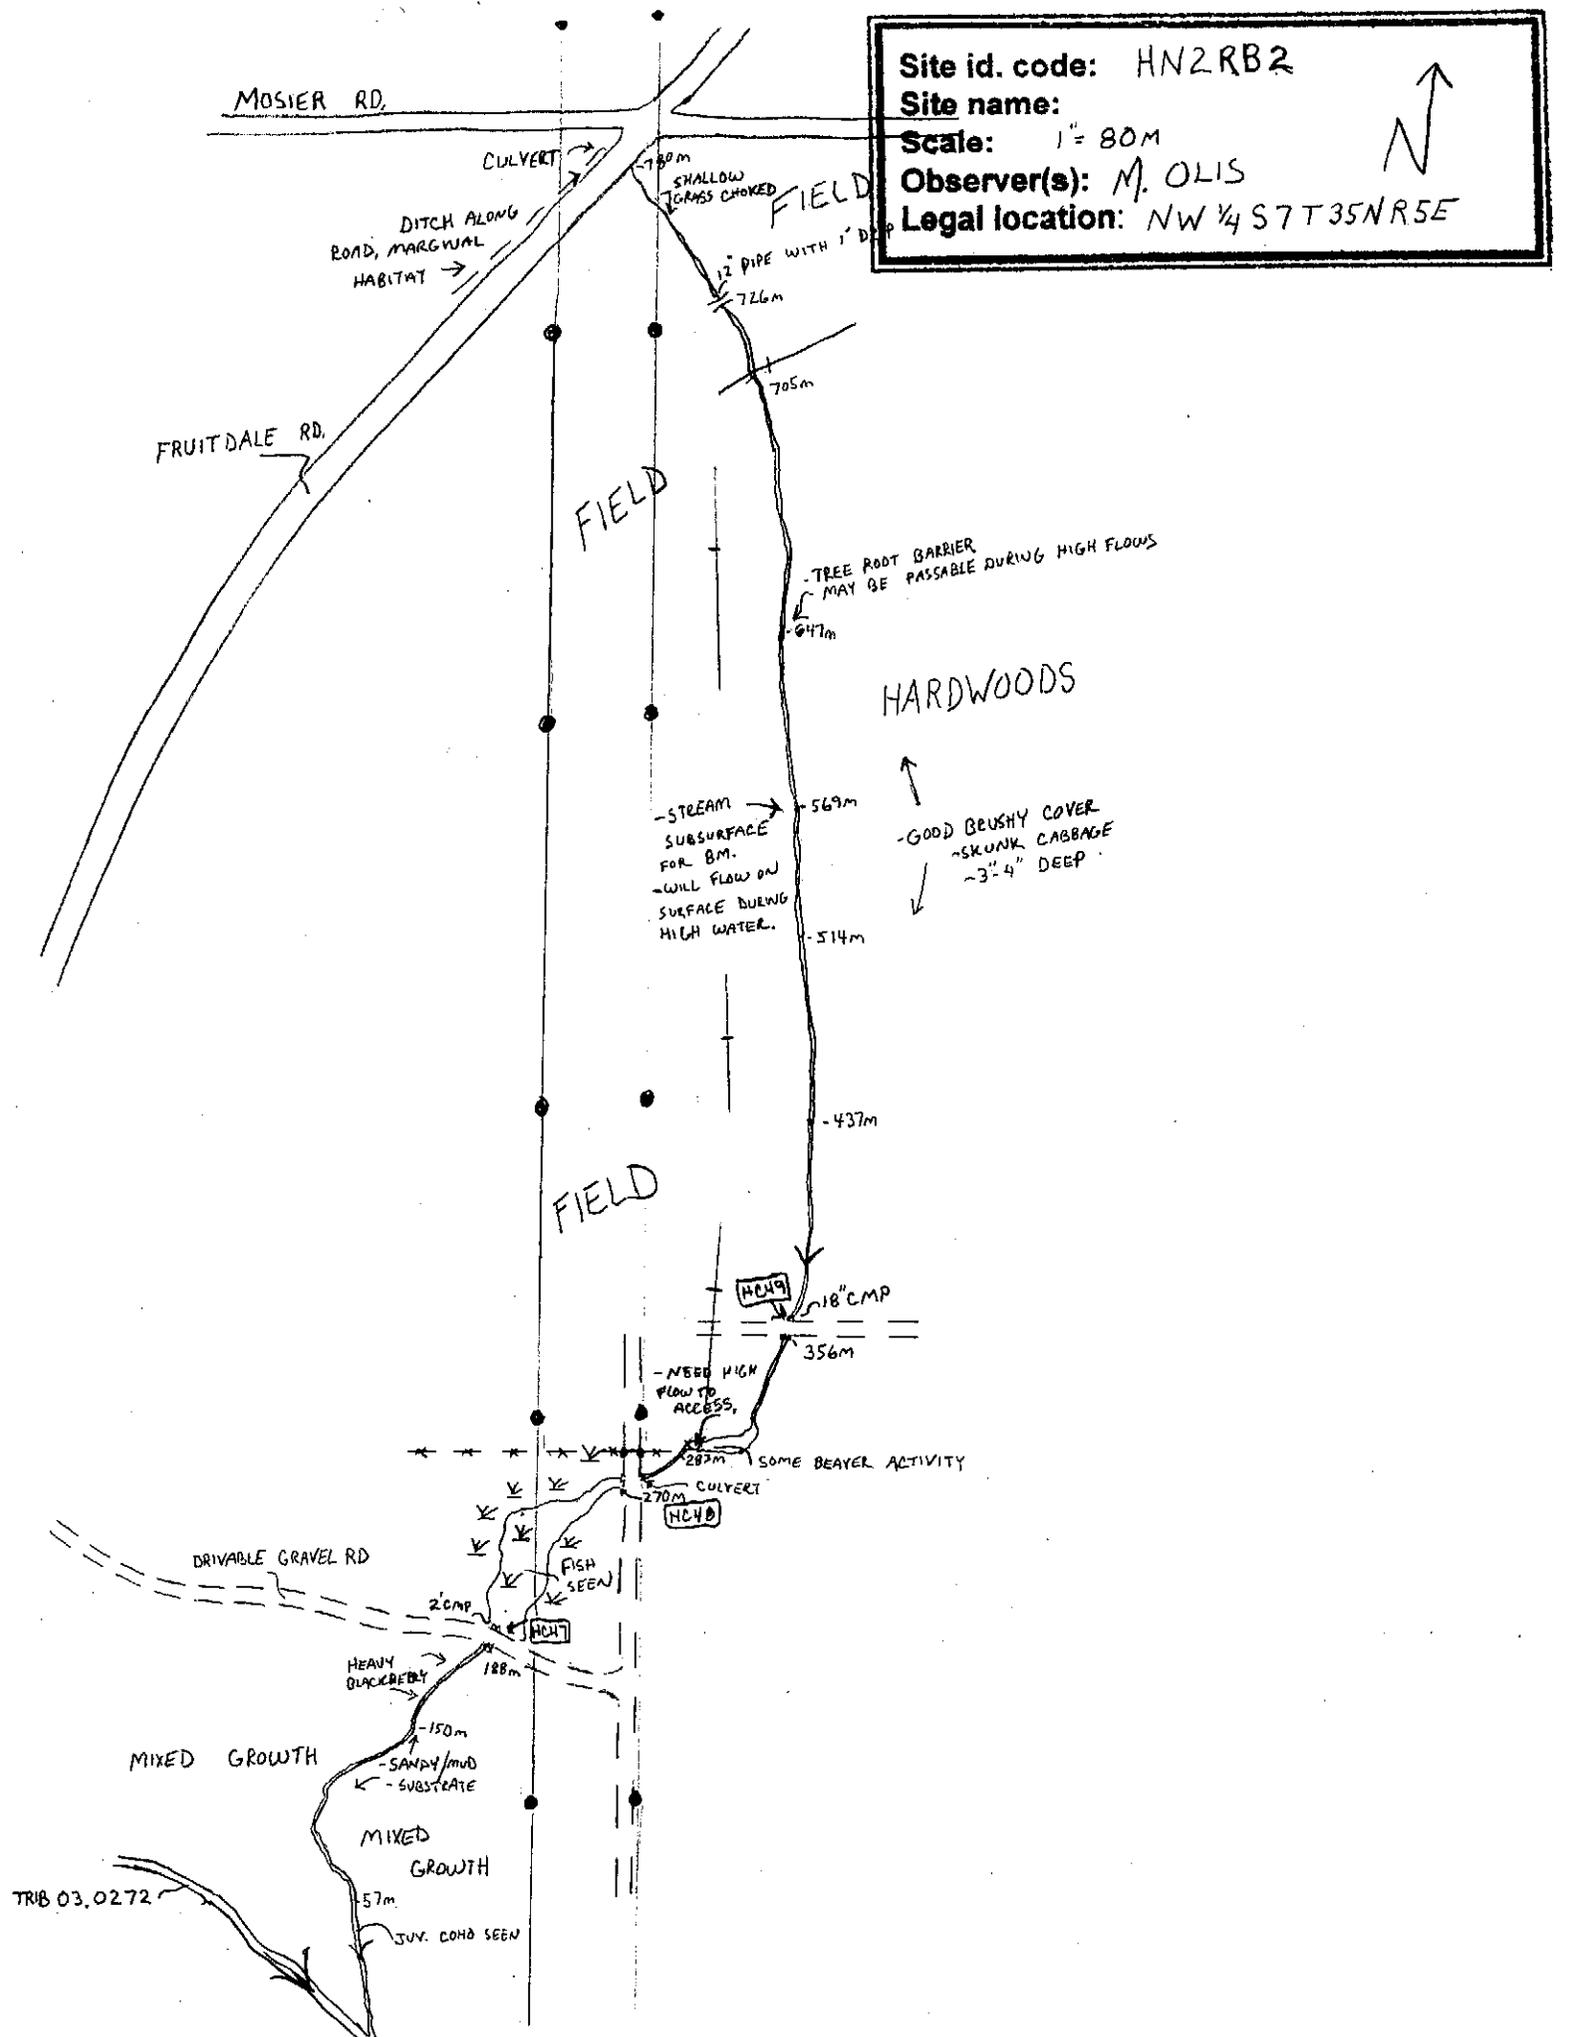
ENHANCEMENT OPPORTUNITIES: The 2' cmp at 188m appears to have a slight slope to it with a 2" drop at the downstream end. Fish are migrating up but it appears that the situation could be improved.

ADDITIONAL COMMENTS: The section of stream above the small pond area has a couple of points where fish passage is only possible during higher flows. Refer to sketch.

DITCH ALONG ROAD, MARGINAL HABITAT

12" PIPE WITH 1" DIA

TREE ROOT BARRIER MAY BE PASSABLE DURING HIGH FLOODS

-STREAM SUBSURFACE FOR BM. -WILL FLOW ON SURFACE DURING HIGH WATER.

-GOOD BRUSHY COVER "SKUNK CABBAGE" ~3"-4" DEEP

-NEED HIGH FLOW TO ACCESS.

SOME BEAVER ACTIVITY

FISH SEEN

JUV. COHO SEEN

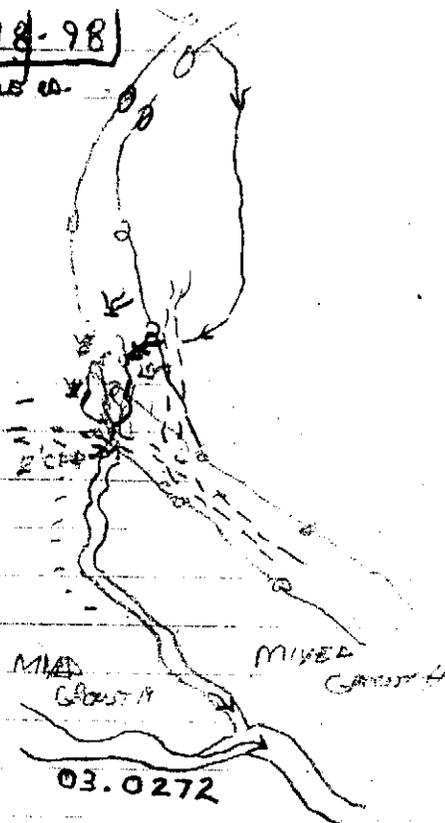
- FLOW < 0.1
- WTR TEMP - 45.5
- REC WTR TEMP - 45.5
- SM. POOL @ EASTLY AS WELL AS JUV. SALMONID

- SLOW MOVING - POOLED
- SANDY/MUD SUBSTR.
- TREE COVER BUT LITTLE BRUSH
- ANOTHER JUV. SEEN

- PIPE IS SLOPED
AT 3% - PROB. BARRIED
DURING CERTAIN
VELOCITIES,

- DEFINITELY COULD
BE BETTER.

- MARS. PASSAGE TODAY.

- SWAMPY
- @ ROAD AND CULVERT
- CULVERT PASSABLE?

- WTR MAY FLOW
OVER DURING STORM
EVENTS. NOT PASSABLE
TODAY

- END OF FISH
ACCESS, STEM JUST
A TRICKLE AND @
A POINT WHERE

569 m STEM GOES
SUBSURFACE - IT MAY
FLOW ON SURFACE DURING
FLOOD EVENTS
WILL CONTINUE

- @ TREE ROOT
NOT PASSABLE TODAY
BUT R MAY BE DURING
HIGHER FLOWS. 1' DROP

- @ 12" PIPE
(CONNECTING FIELDS)
1' DROP JUST UPSTREAM
OF PIPE. MARG.
PASSAGE.

GRASS CHOKED, SHALLOW
DOUBTFUL FISH USE,
- @ FRUITDALE RD. AND
CULVERT, THIS SYSTEM
CONTINUES IN DITCH
ALONG FRUITDALE ROAD
MARGINAL HAB.

- CULVERT @ 270m IS POSSIBLE BARRIER DIFFICULT TO TELL,

- LOW FLOODING
- NO SPAWNING HAB.
- SOME EXCELLENT REARING IN PLACES.
- GOOD MEANDEE & POOL RATIO.
- SALMONIDS SEEN
- CULVERT @ 188m IS 3% SLOPED. ~~COULD~~ COULD BE ENHANCED - LEVELLED AND MAY BE RAISED.
