**SITE INFORMATION**

**Site Identifier :** HN2RB3 **Landowner Type :** Private  
**Site Name :** **Landowner Name :**  
**WRIA :** 03.0267X **Address :**  
**Region :** NS **Address2 :**  
**Trib to :** Hansen Cr **City :**  
**River Mile :** 4.90 **State :**  
**River System :** Hansen Cr **Zipcode :**  
**Legal Description :** NE1/4S7T35NR5E **Phone :**  
**County :** Skagit  
**Habitat Type :** terrace tributary

**Field Survey Information**

**Date :** 02/11/1998 **Observer :** Olis **Survey Type :** initial

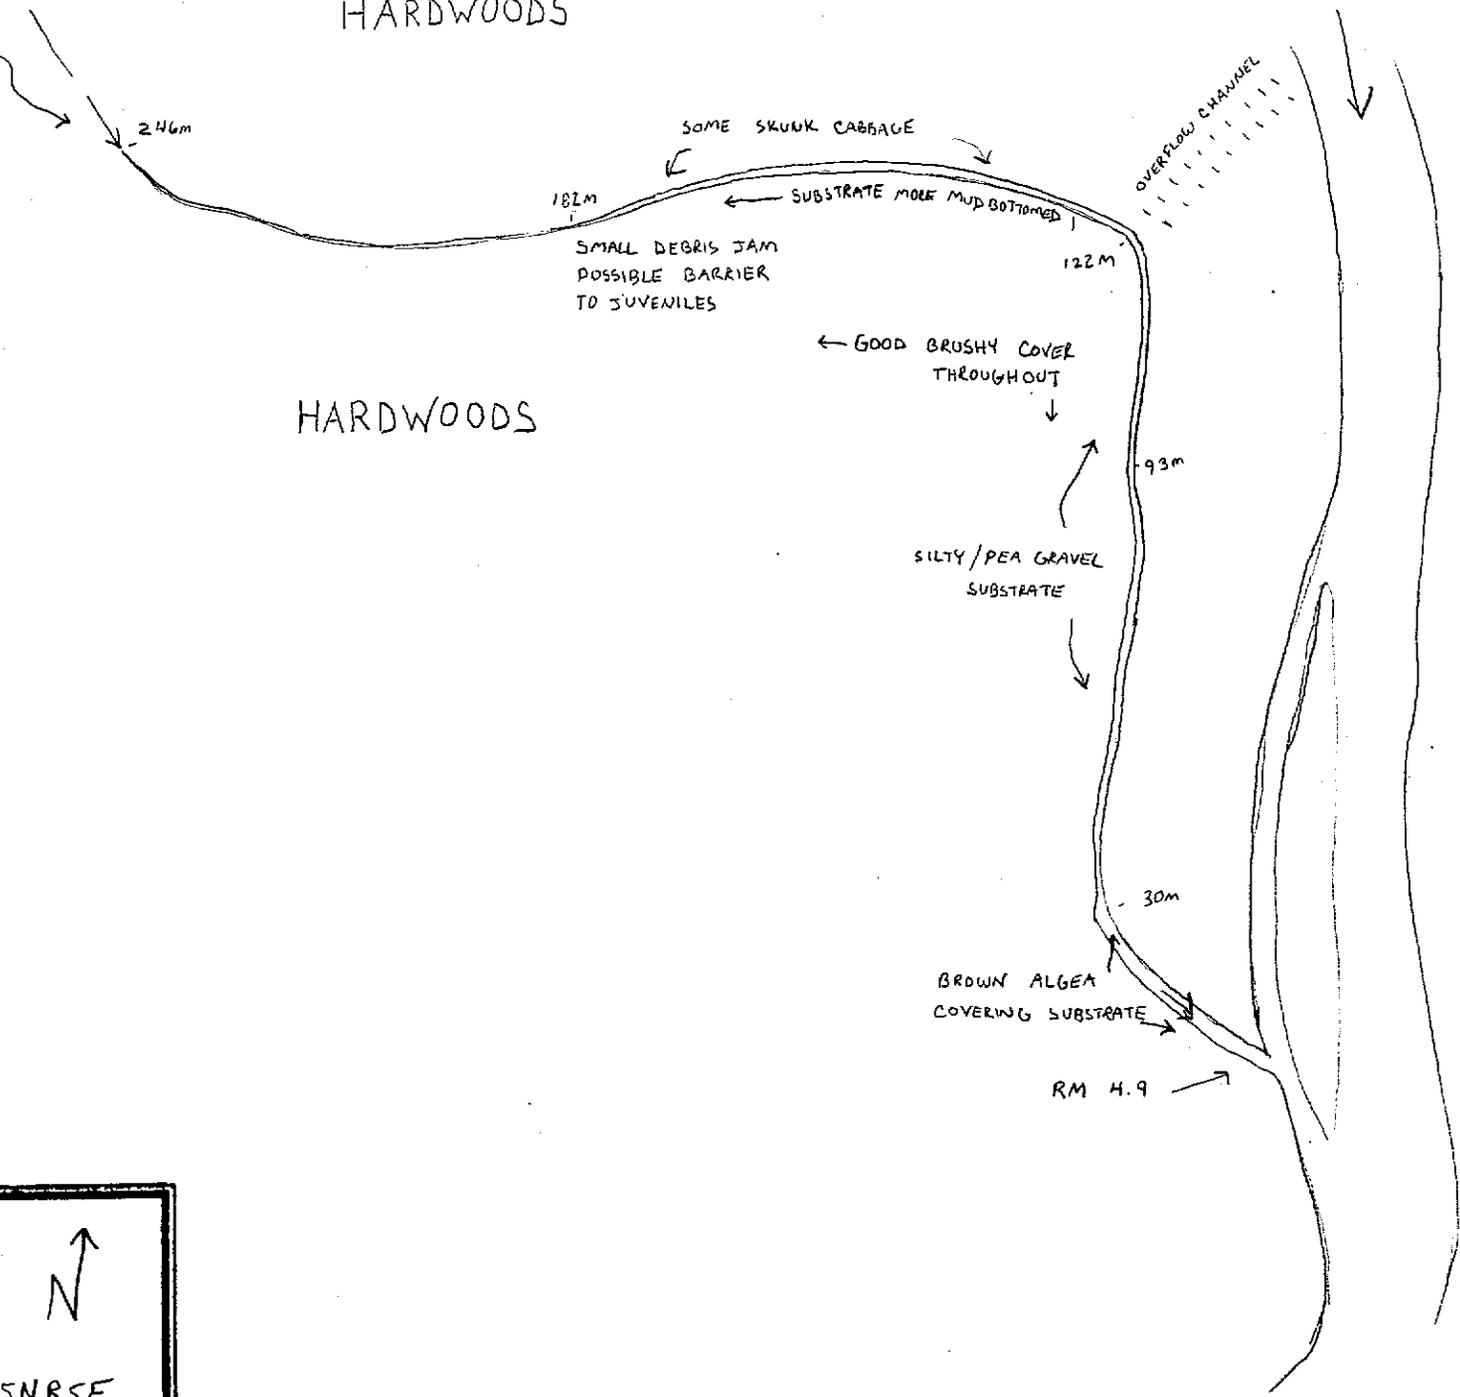
Site id. code: HN2 RB3

- STREAM IS A TRICKLE AT THIS POINT
- END OF HABITAT

HARDWOODS

HANSEN CREEK
