**SITE INFORMATION**

**Site Identifier :** MO1LB5 **Landowner Type :** Private  
**Site Name :** **Landowner Name :**  
**WRIA :** 03.0293X **Address :**  
**Region :** NS **Address2 :**  
**Trib to :** Morgan Cr **City :**  
**River Mile :** 1.95 **State :**  
**River System :** Morgan Cr **Zipcode :**  
**Legal Description :** SW1/4S29T35NR6E **Phone :**  
**County :** Skagit  
**Habitat Type :** terrace tributary

**Field Survey Information**

**Date :** 01/20/1998 **Observer :** Olis **Survey Type :** initial

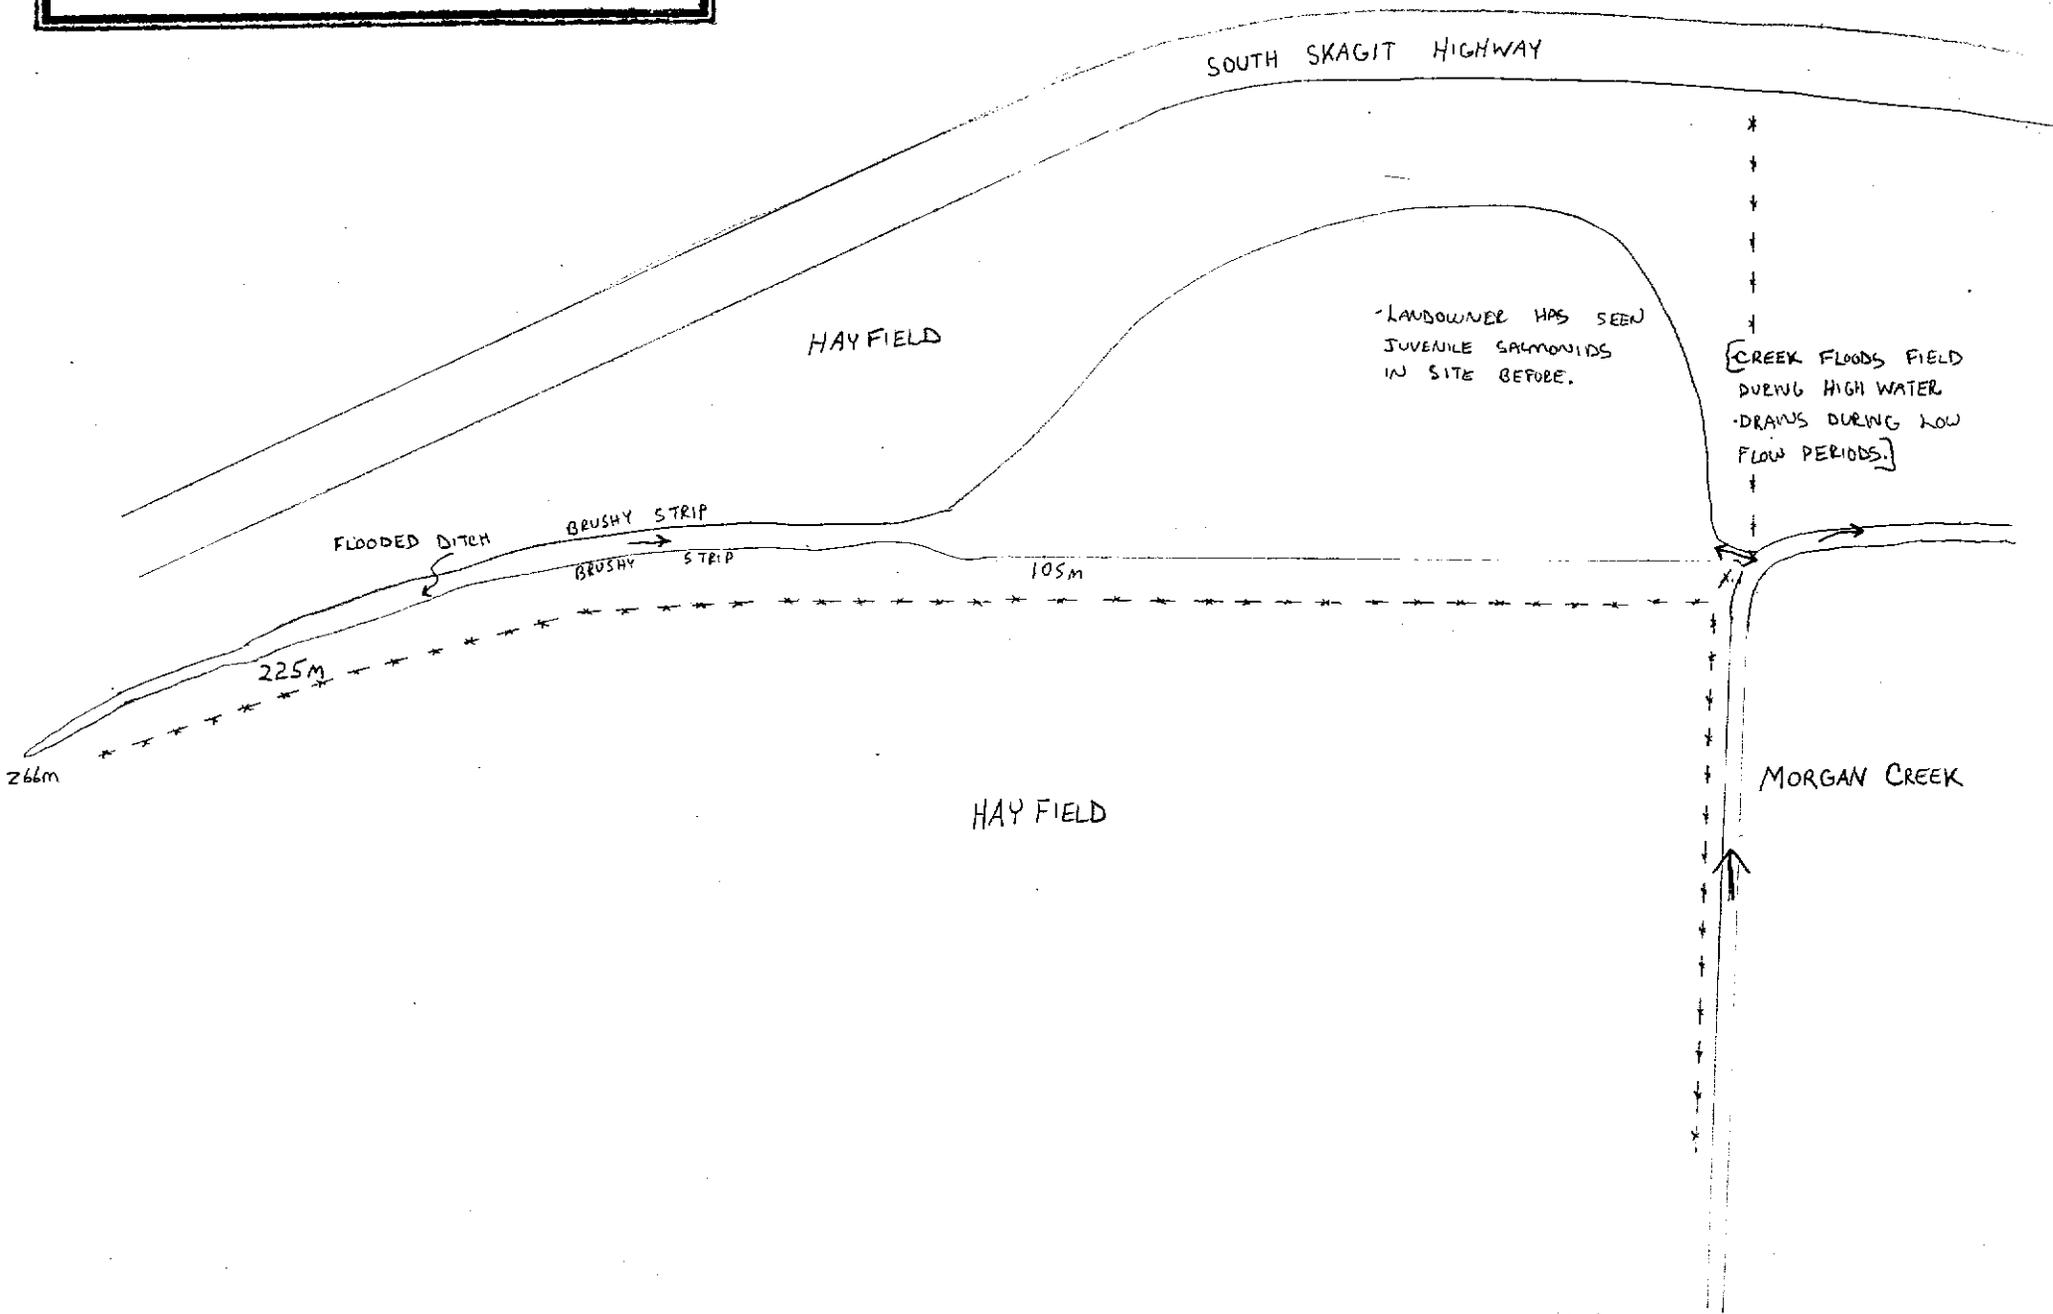
Site id. code: M01LB5

Describe pond and other rearing habitat: Pond is a seasonally flooded hayfield. There is no wooded structure or aquatic vegetation. There is some canary grass present and some brush along the ditch line. The channel above the pond is a brush lined ditch that is mostly pooled habitat. Substrate is muddy throughout the site.

Describe: The site gets seasonally flooded but it appears to be a gradual event as there appears to be no damage.

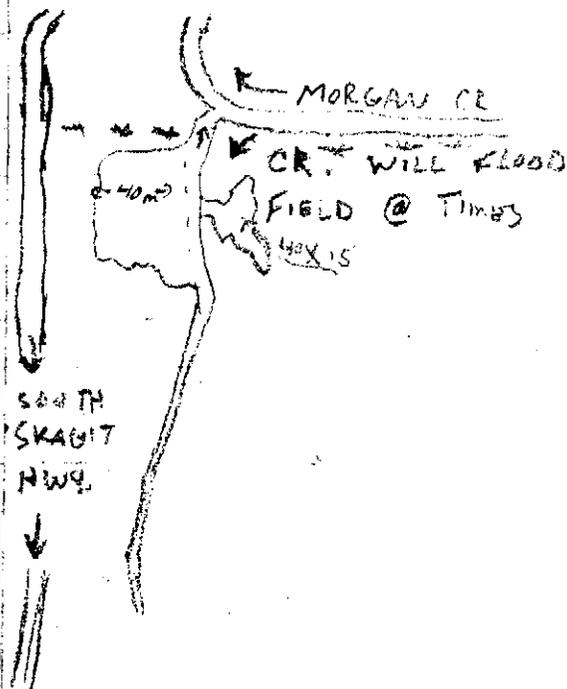
M014B.5

O.O ENTRY

FLOW - VERY LITTLE  
RWTR. TEMP - 42  
STRM TEMP - 43  
ACCESS - POOL

10500 WW 40m POOL  
- FLOODED HAY FIELD  
- DITCHED LINED w/ BRUSH  
- SEEMS TO BE NO FLOW  
- SUBSTR. MUDDY

225m WW 3m POOL  
- WTR RESTRICTED TO  
DITCH OR CH.

225m - BRUSH ON  
BANKS IN STANDING  
WTR.

250m 2m WW

266m 1m WW  
- END OF HAB  
- WTR TEMP 43°

- SURFACE FED - WTR  
FROM FIELD DRAIN.
- WTR WILL PERIODICALLY  
ENTER SITE FROM  
MAW SYSTEM.

- HIGH FLOODING BUT  
NOT DAMAGING.
- LAND OWNER HAS  
SEEN FINGER LINGS  
IN SITE
- NO SPAWNING HAB.
