Site id. code: P12RB9
 Site name:
 Scale: 1" = 35m
 Observer(s): OHS
 Legal location: NE 1/4 S8 T33N R5E

P12 RB 9

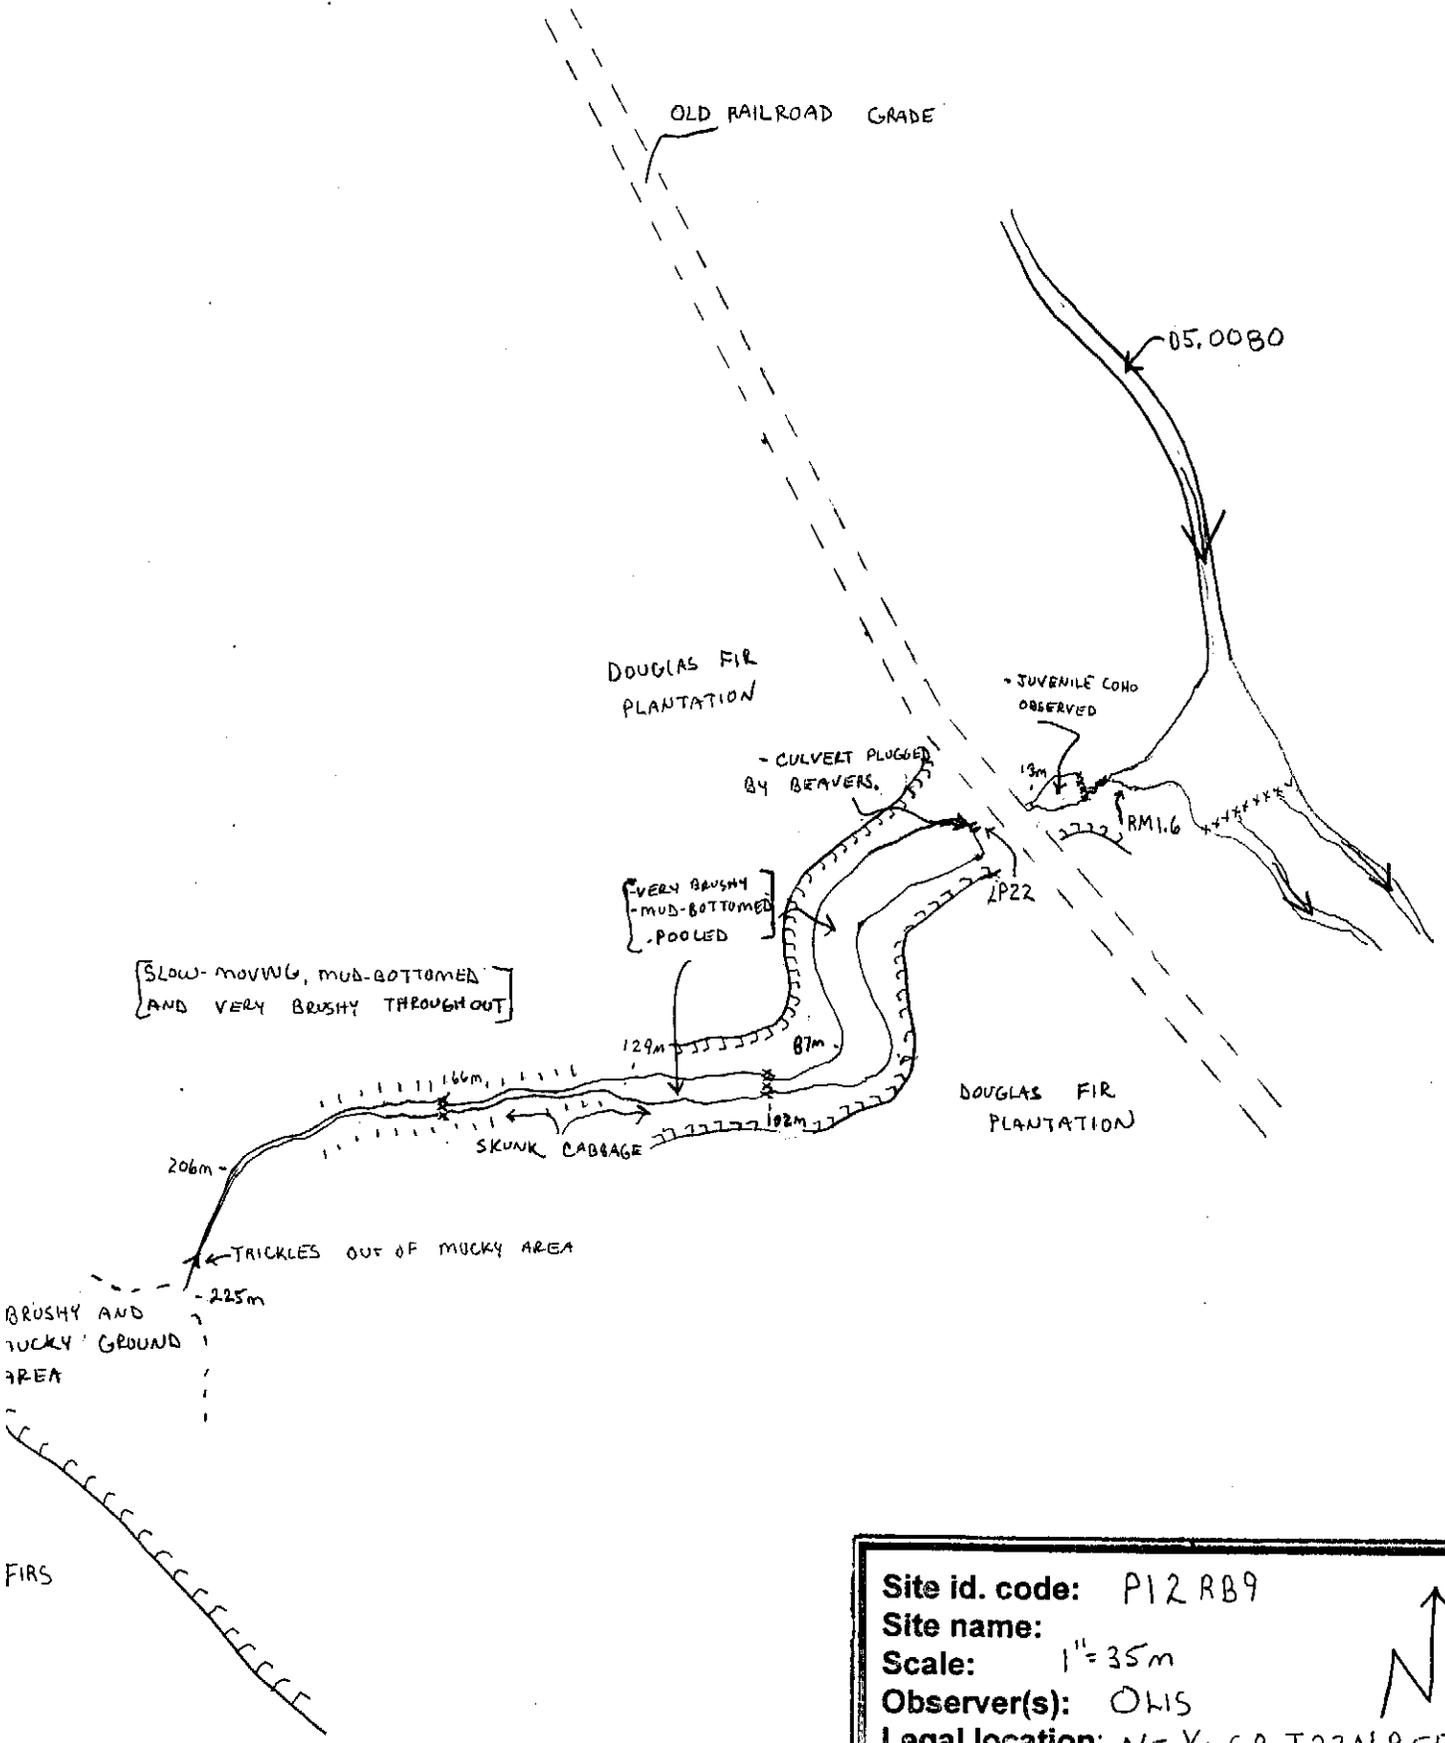
Describe pond and other rearing habitat: Immediately downstream of the old railroad grade culvert is a 10 meter by 5 meter pool made by a small beaver dam. The upstream end of the culvert is plugged by the beavers and this creates a pooled area that is 55 meters long by 8 meters wide. It is heavily brushed along the banks with a small amount of aquatic vegetation present. From 87 meters to 102 meters, the channel narrows, the substrate is very muddy and there is some skunk cabbage present. At 102 meters, there is a small beaver dam that makes a 27 meter long by 6 meter wide pool. At 166 meters is another small beaver dam that makes a 10 meter long by 4 meter wide pool. Upstream from this point, the channel continues to narrow until at 225 meters, the stream is 0.25 meters wide as it flows out of a brushy and mucky ground area.

Describe: It appears that the plugged culvert would make this site difficult for juveniles to enter.

Describe: There were several coho juveniles observed immediately below the culvert, but none upstream.

ENHANCEMENT OPPORTUNITIES: It seems that the plugged culvert is blocking juveniles from entering this site. The culvert could be unplugged and maybe a few baffles could be installed to retain some of the impounded water that is upstream.
