SITE INFORMATION

Site Identifier : SA12LB1 **Landowner Type :** Federal
Site Name : **Landowner Name :** USFS
WRIA : 03.1204X **Address :**
Region : NS **Address2 :**
Trib to : SF Sauk R **City :**
River Mile : 1.10 **State :**
River System : Sauk R **Zipcode :**
Legal Description : SW1/4S16T30NR11E **Phone :**
County : Snohomish
Habitat Type : terrace tributary

Field Survey Information

Date : 07/01/1996 **Observer :** Barkdull **Survey Type :** initial

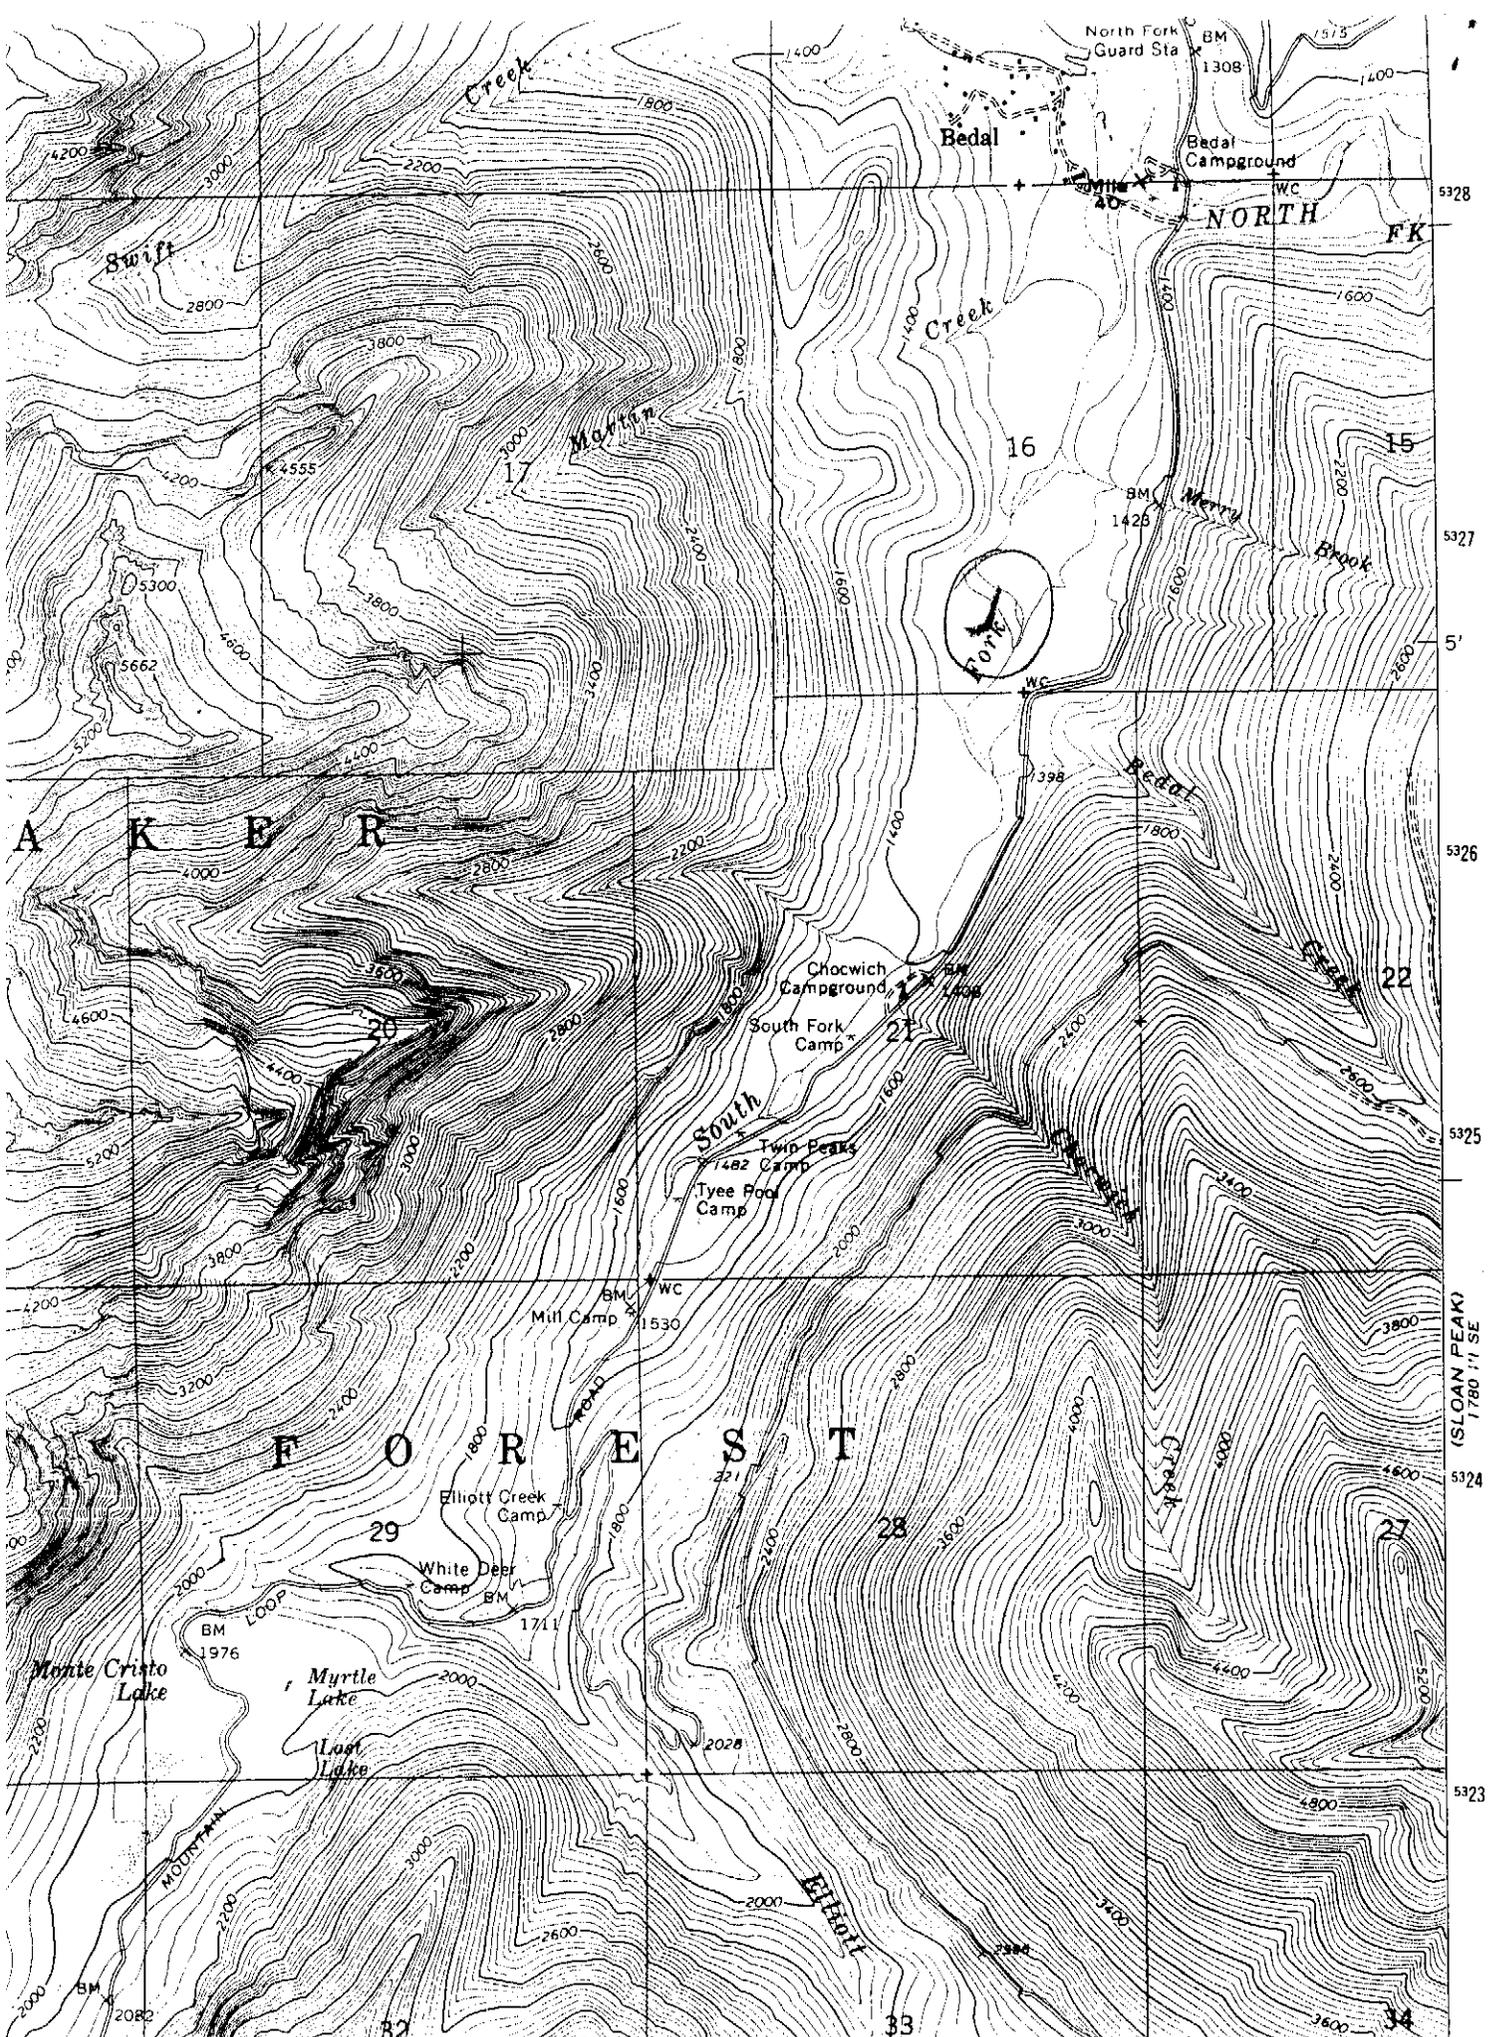
SA 12 LBI
Sw 16, T 30M R11 E

7/1/96 S.F. Tank
00 to 3' coals to River a. l. cts
12 to 4' coals
61 to 10' coals
160 to 10' coals
126 to 10' coals L¹ too small for fish
206 to 10' coals
see previous site
see next site (tr?) seen
