**SITE INFORMATION**

**Site Identifier :** SA1LB1 **Landowner Type :**  
**Site Name :** **Landowner Name :**  
**WRIA :** 03.0667X **Address :**  
**Region :** NS **Address2 :**  
**Trib to :** 03.0667 **City :**  
**River Mile :** 1.50 **State :**  
**River System :** Sauk R **Zipcode :**  
**Legal Description :** SE1/4S34T35NR9E **Phone :**  
**County :** Skagit  
**Habitat Type :** terrace tributary

**Date :** 02/28/1996 **Observer :** Olis **Survey Type :** initial

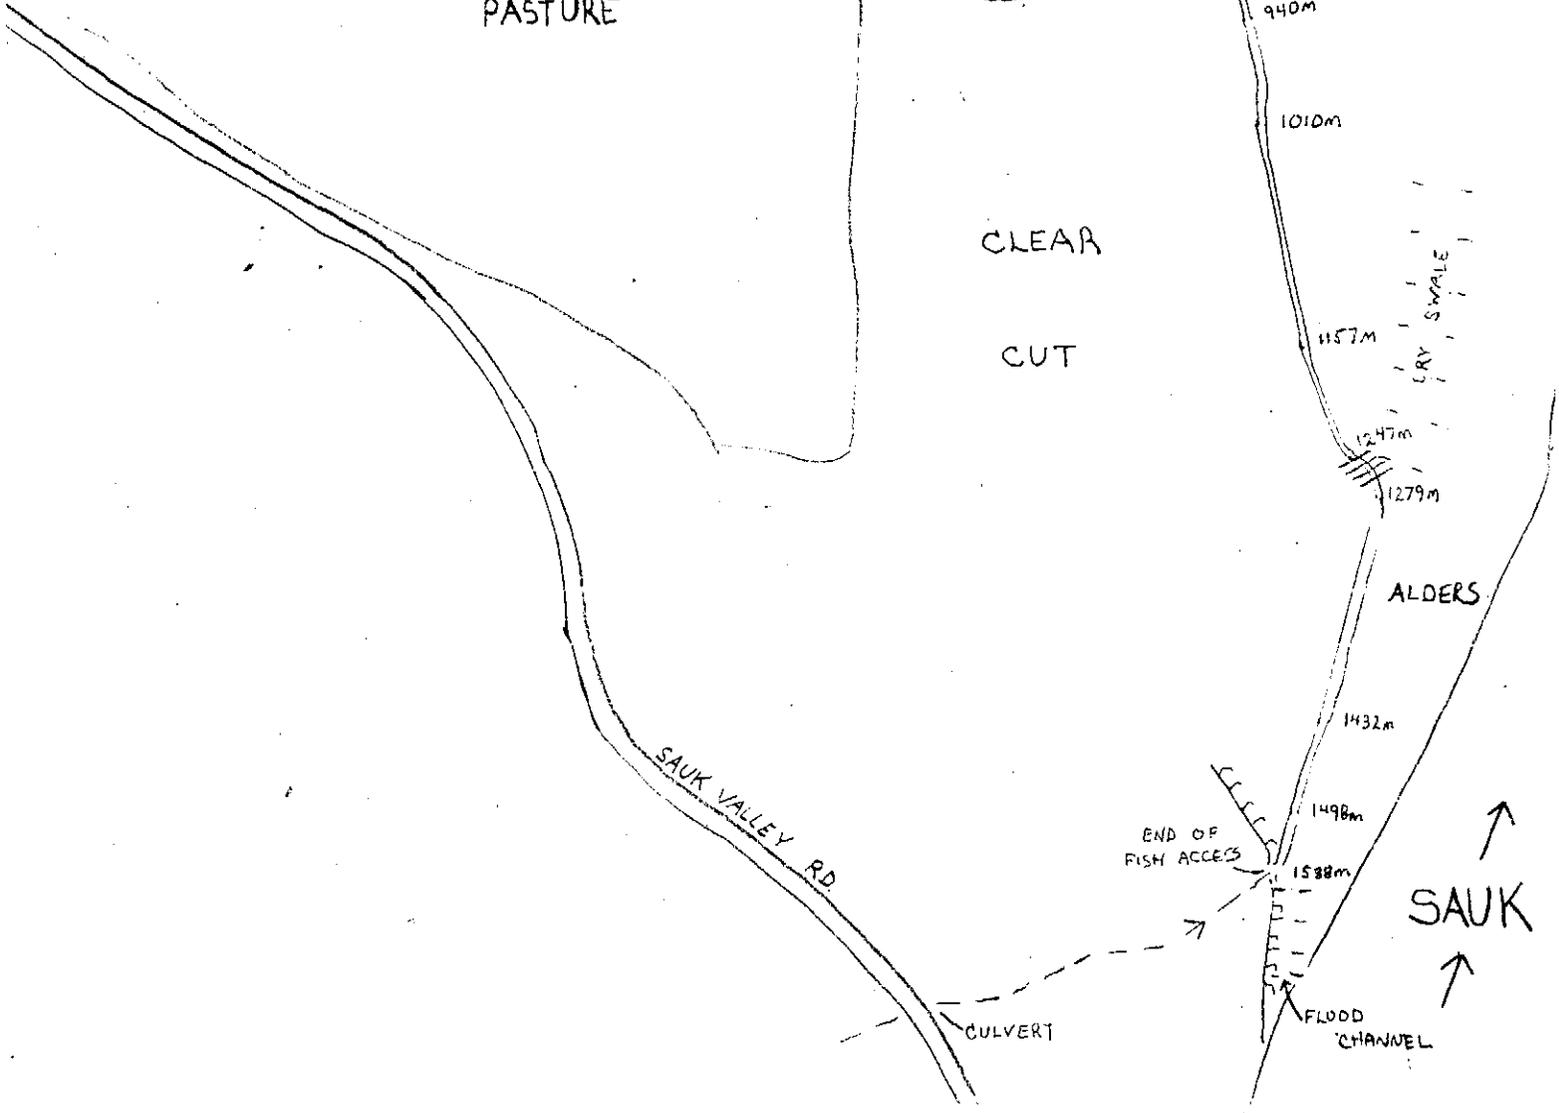
Site no. code: SA12B1  
 Date drawn:  
 Scale: 1" = 125m  
 Surveyor(s): MICHAEL OLIS  
 Legal location: SE 1/4 S34 T35 N9E

SECTION WILL DRY UP DURING LOW FLOWS

END OF FISH ACCESS
