SITE INFORMATION

Site Identifier : SA6LB1 **Landowner Type :** Private
Site Name : **Landowner Name :**
WRIA : 03.0673X **Address :**
Region : NS **Address2 :**
Trib to : Sauk R **City :**
River Mile : 18.15 **State :**
River System : Sauk R **Zipcode :**
Legal Description : SE1/4S6T32NR10E **Phone :**
County : Snohomish
Habitat Type : terrace tributary

Field Survey Information

Date : 04/01/1997 **Observer :** Olis **Survey Type :** initial

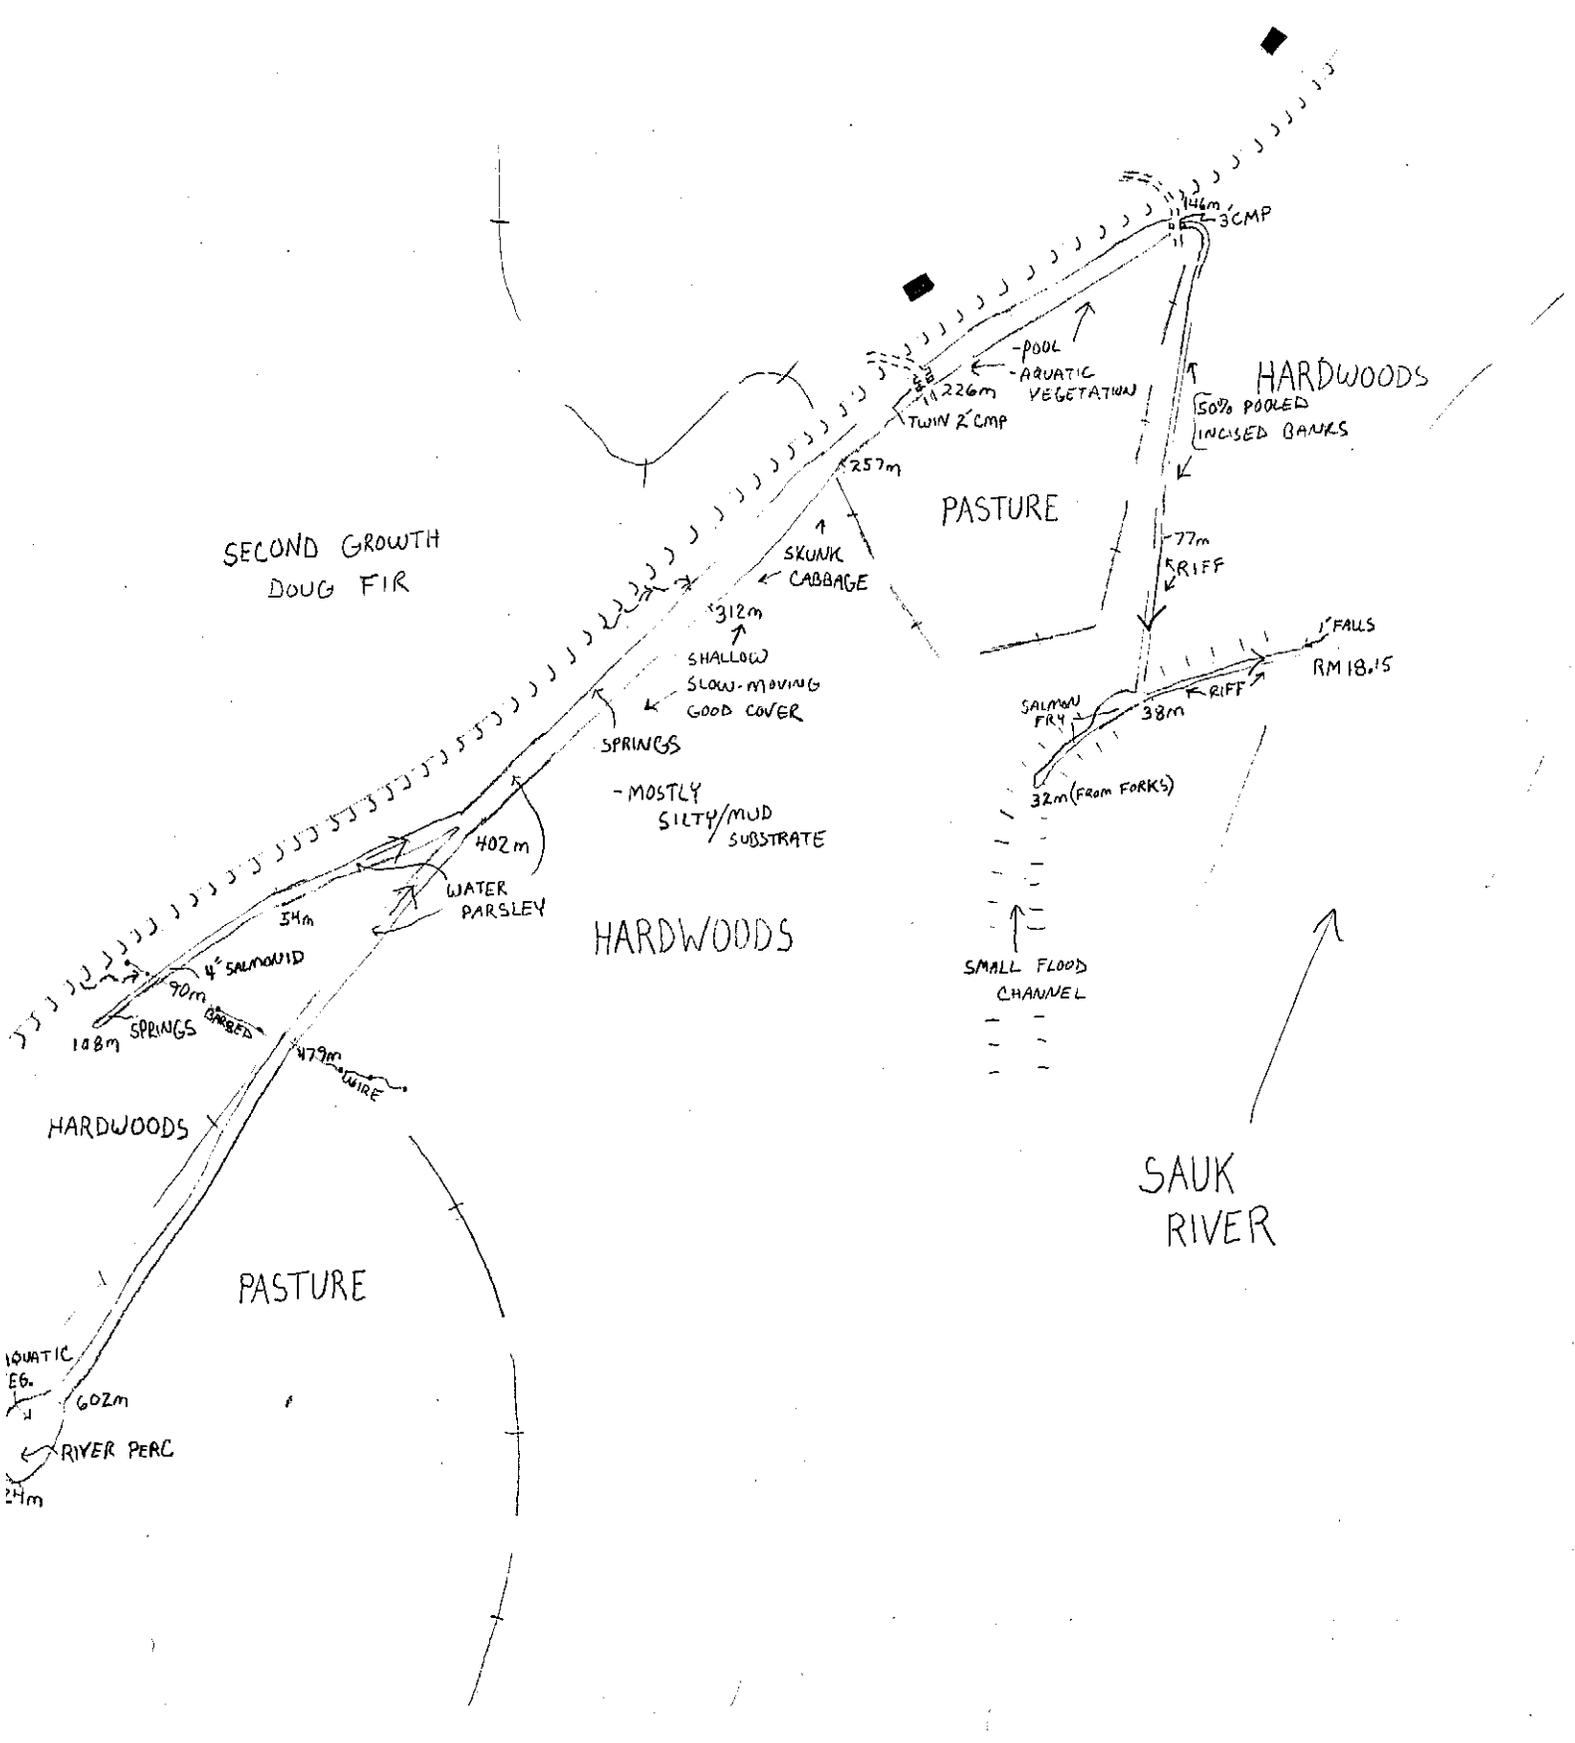
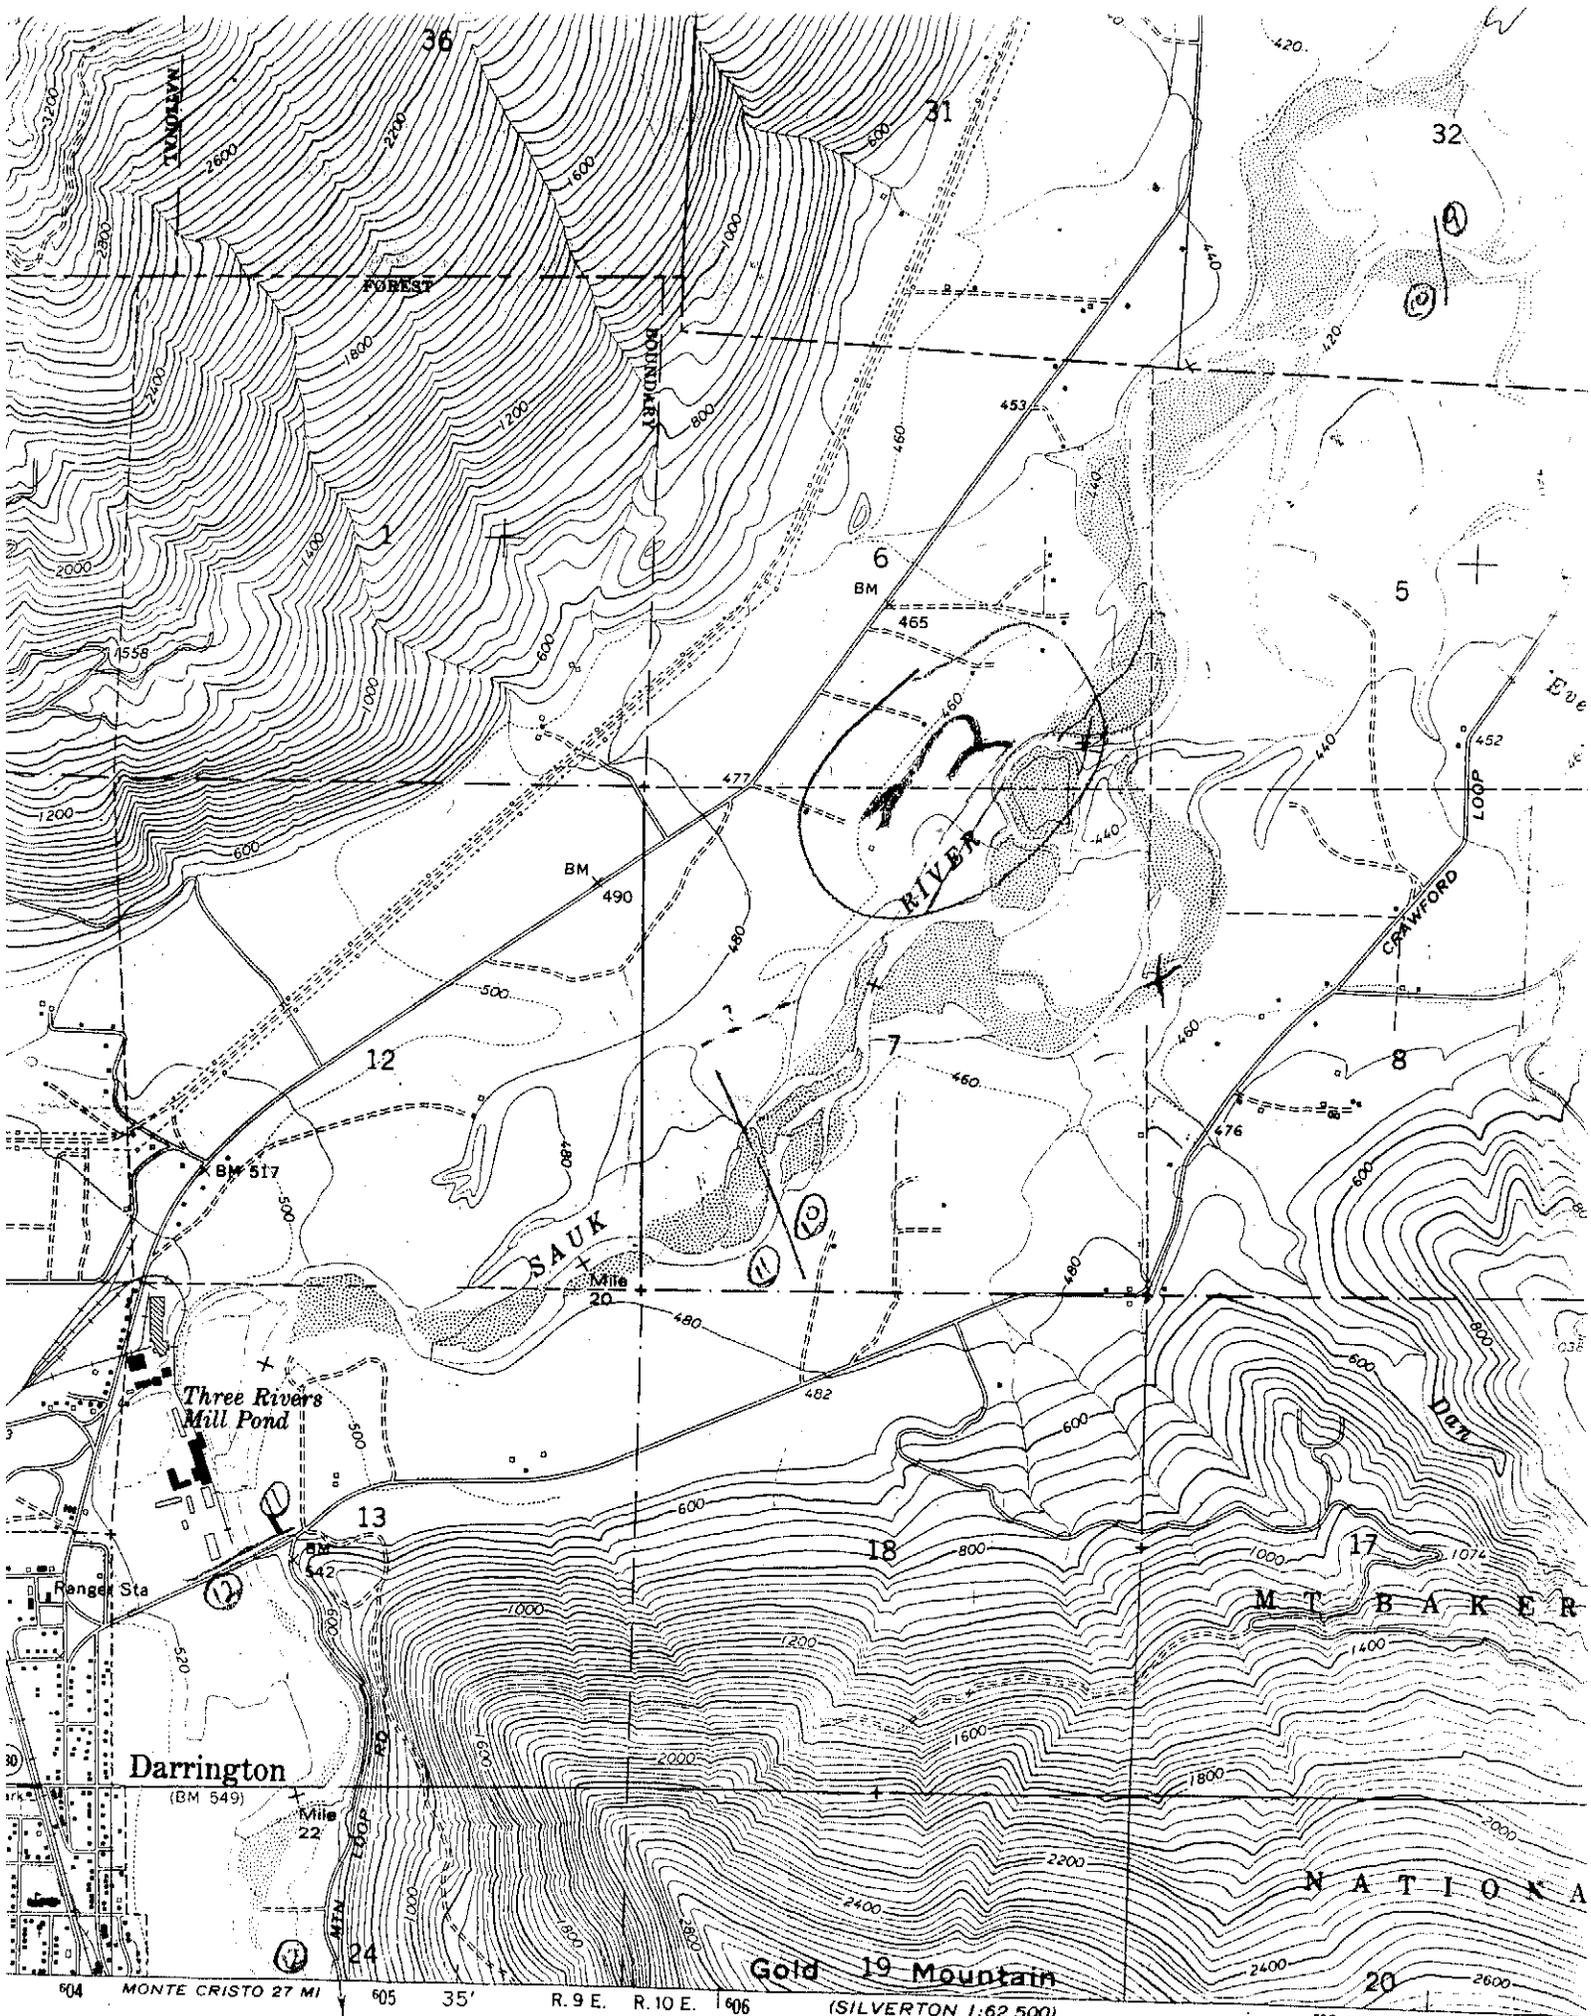
Site ID code: SA6LB1

0.0 ENTRY

- FLOW - 1 CFS
- WTR TEMP - 47°
- REC WTR TEMP - 40.5°
- ACCESS - EDDY POOL - 1 FALLS
W/ GOOD PLUNGE POOL

226m WW 6m POOL

- FULL OF VEGETATION & JUVENILES
- NO COVER ON BANKS
- APPEARS TO DRY OUT?
- @

TWO 2' CMP
- CULVERTS 80% PASSABLE
- SET @ 8% SUBMERGE

Project type: At 226m up this site, there are twin, 2' culverts that are set at about 6%. They appear to pass fish but one larger pipe, set flat would greatly improve fish passage or possibly, the landowner could be talked into removing the culverts, since it appears to be just a horse path over the culverts. Also there are two pastures that this system flows through. There are three horses in one field and about eight cattle in the other. It might be a good idea to fence along the creek to keep them out.
