**SITE INFORMATION**

**Site Identifier :** SK13RB2 **Landowner Type :** County  
**Site Name :** **Landowner Name :** Skagit Co. Parks  
**WRIA :** 03.1339A **Address :**  
**Region :** NS **Address2 :**  
**Trib to :** Skagit R **City :**  
**River Mile :** 67.25 **State :**  
**River System :** Skagit R **Zipcode :**  
**Legal Description :** SE1/4S26T35NR9E **Phone :**  
**County :** Skagit  
**Habitat Type :** terrace tributary

**Field Survey Information**

**Date :** 12/9/1998 **Observer :** Barkdull **Survey Type :** Initial

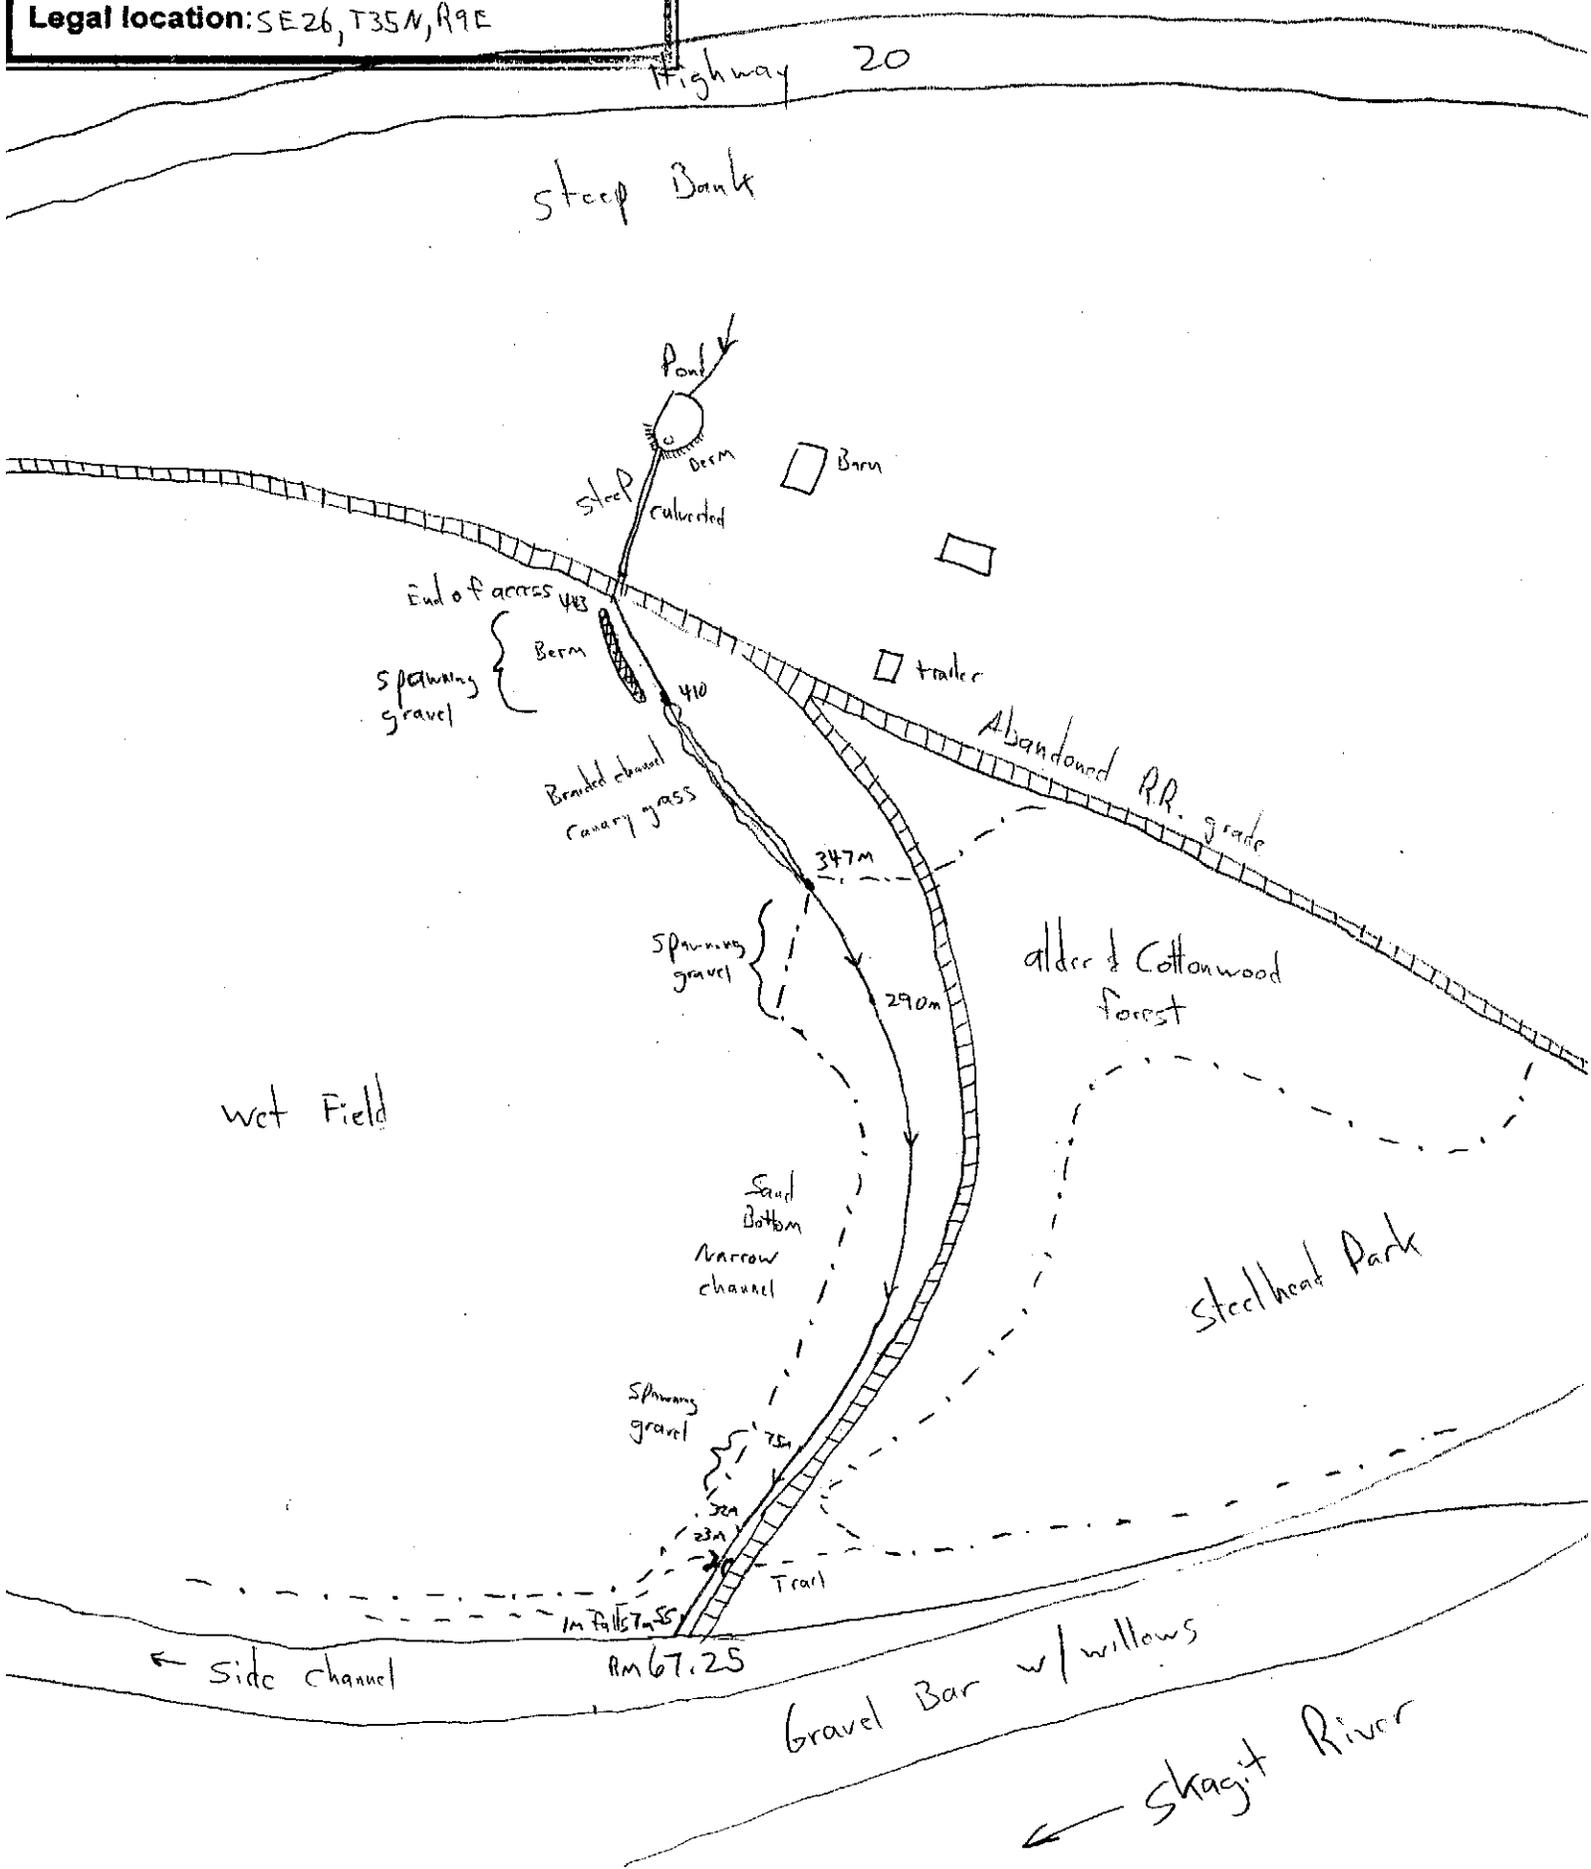
Site id. code: SK13RB  
Site name: Steerhead Park  
Scale: 1"=65m  
Observer(s): B. Barkdull  
Legal location: SE26, T35N, R9E

Site is an intermittent surface stream that has been rerouted and ditched along an old railroad grade back to the river. A one meter falls near the mouth prevents access to juveniles in the fall but some adult spawning occurs.

Describe: A one meter falls, seven meters above the mouth, prevents access except to adult coho.

ADDITIONAL COMMENTS: This stream could be rerouted into an improved channel or the existing channel modified to increase access, improve spawning and increase rearing habitat. Anadromous access ends at a culvert but nothing is to be gained by replacing it because the stream quickly increases in gradient.

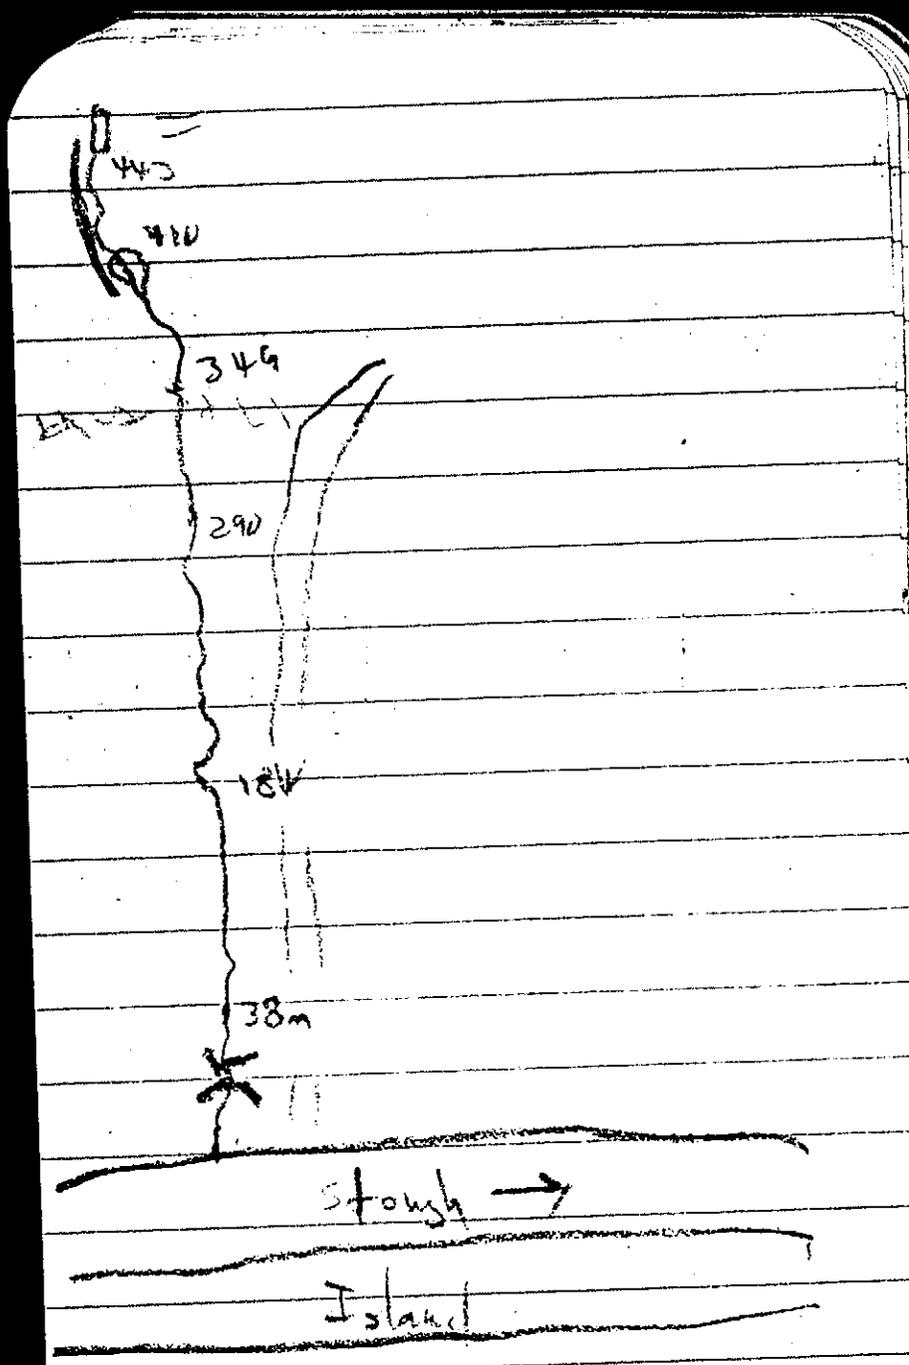
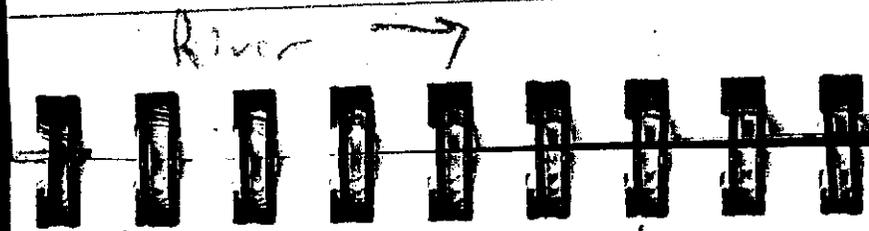
12/9/98 trip to stream alongside  
Rudolph at Park Steelhead

- 0.0 2.0 3 cfs 46' River #6
- 7 1.5 1m falls 15% gr
- 23 1.5 very incised, Budge
- 38 1.5 " " start of gravel
- 75 2.0 1 Redd, end of gravel
- 187 2.0 end Bottom 1% gr
- 290 2.0 Pea gravel starts
- 347 2.2 slowly changes to gravel  
at tree line
- 410 Braided, 3.5m <sup>gradient 2%</sup> coarse gravel
- 443 2.0 Piked LB 2 conc
- 3 Redds at Culvert
- End of line Pond above
- SE26, TSSM, RQE
